TECHNICAL BULLETIN

Procedures for Repairing EIFS

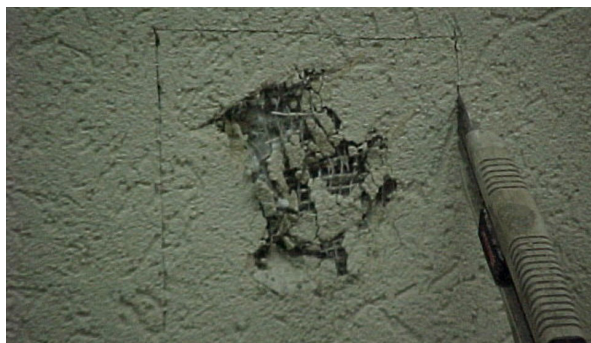
1. Cut around the damaged area with a razor knife, cutting through all layers, to the substrate or the water-resistive barrier (if the system is an EIFS with Drainage). Make sure the patch area is large enough to easily work within, even if the damaged area is small.

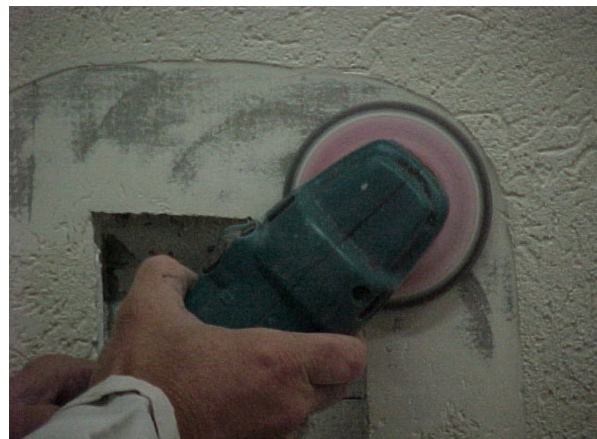
2. Carefully remove the EIFS lamina.
3. Remove the damaged EPS. Inspect the water-resistive barrier and repair as necessary if damaged during EIFS removal.

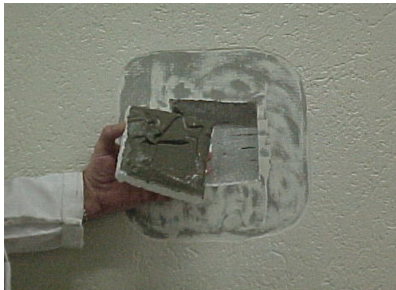
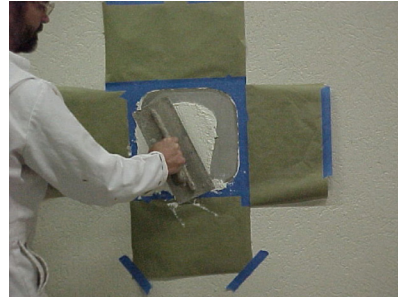
6. Cut new EPS to the shape of the EPS void, creating a tightly fitting repair. Apply LaHabra A/BC or A/BC 1-Step Base Coat to the new EPS and press it into place. Allow the adhesive to dry. Insert EPS slivers into any gap greater than 1/16-inch wide. Do not fill gaps between insulation board with base coat. Sand or rasp the surface flush with adjacent EPS.

Note: For mechanically fastened EIFS, small areas of EPS can be friction fit. Larger areas of damage will require stud to stud removal to fasten new EPS.

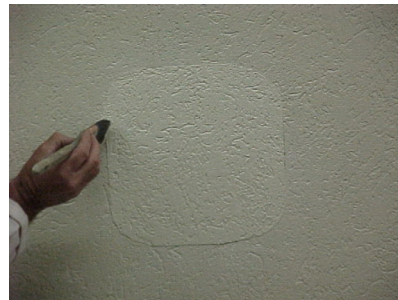
7. Mask the existing finish around the repair area.
8. Cut LaHabra Standard Reinforcing Mesh so that it overlaps at least 1" onto existing base coat and mesh. Embed LaHabra Standard Reinforcing Mesh into A/BC or A/BC 1-Step, ensuring that fresh base coat and mesh is level with the existing lamina. Use a double layer of Standard when repairing damaged corners. Allow to dry and scrape any trowel marks prior to finish application.
9. Apply color and texture matched LaHabra finish. Float the finish to match existing finish. Remove the masking tape before the finish dries and use a brush to blend the wet edge of the finish into existing finish and allow to dry.

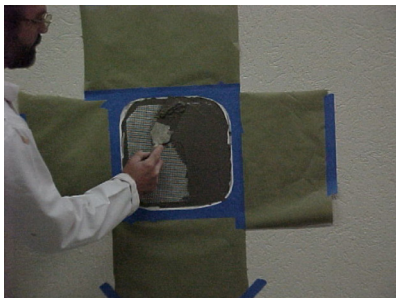
3. Assess the root cause of cracking to select the appropriate repair method.
 - If cracking is caused by excessive gap between insulation boards, remove base coat and mesh surrounding the crack. Fill the crack with EPS slivers. Do not fill gaps between insulation board with base coat. Shave or rasp foam flush with the surrounding insulation. Embed LaHabra Standard Reinforcing Mesh in A/BC or A/BC 1-Step Base Coat over the repaired insulation board and extending at least 2 1/2" onto existing base coat and creating a smooth transition from existing base coat to new base coat.
