CASE STUDY

PROJECT	Harborview Condominiums
LOCATION	Greenwich, CT
CLIENT	Castle Management
A/E/C	Salamone & Associates, P.C.
CONTRACTOR	Milestone Restoration, Inc.
PRODUCT(S)	Decothane SP
SIZE	10,000 SF

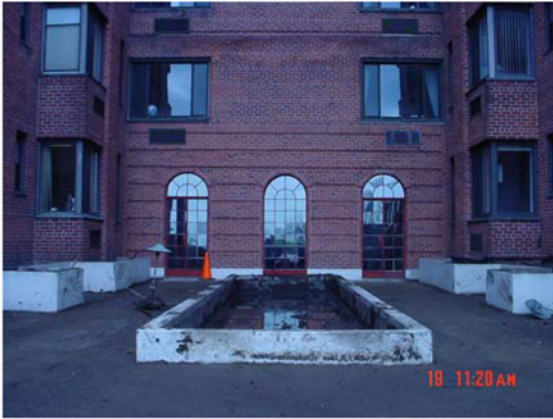
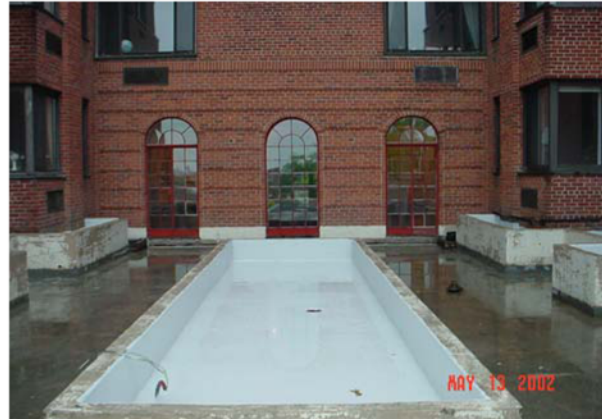
Having exceeded its expected useful life, the plaza and planter waterproofing at Harborview Condominiums was leaking into the facility's parking garage. As a result, the condominium board decided it was also a good time to give the plaza a make-over. Setting the ground rules for the designer, the building owner was adamant that the waterproofing solution be long lasting, seamless and decorative.

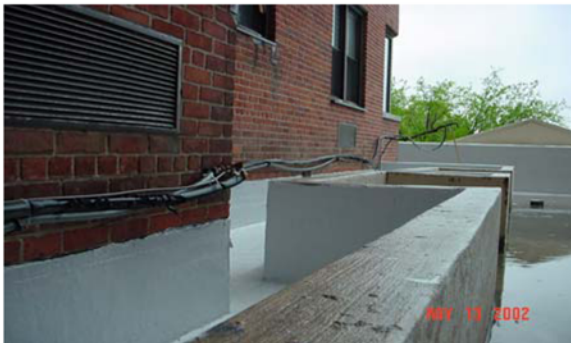
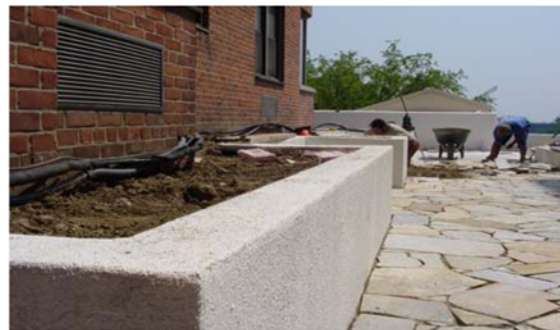
Following the complete removal of plant materials and plaza finishes, including pavers, a pitching slab, and existing bitumen based waterproofing, the structural concrete slab was prepared for the application of a **Decothane® SP** waterproofing membrane. The **Decothane** membrane was applied to all horizontal and vertical plaza and planter surfaces, providing a seamless, decorative waterproofing system. After the installation of a prefabricated drainage and protection course and a pitching slab, the owner chose a decorative fieldstone finish set in a sand bed.
