SIKA AT WORK

American University of the Caribbean – St. Maarten

LIQUID APPLIED ROOFING & WATERPROOFING

Sikalastic® RoofPro Liquid Applied Membrane

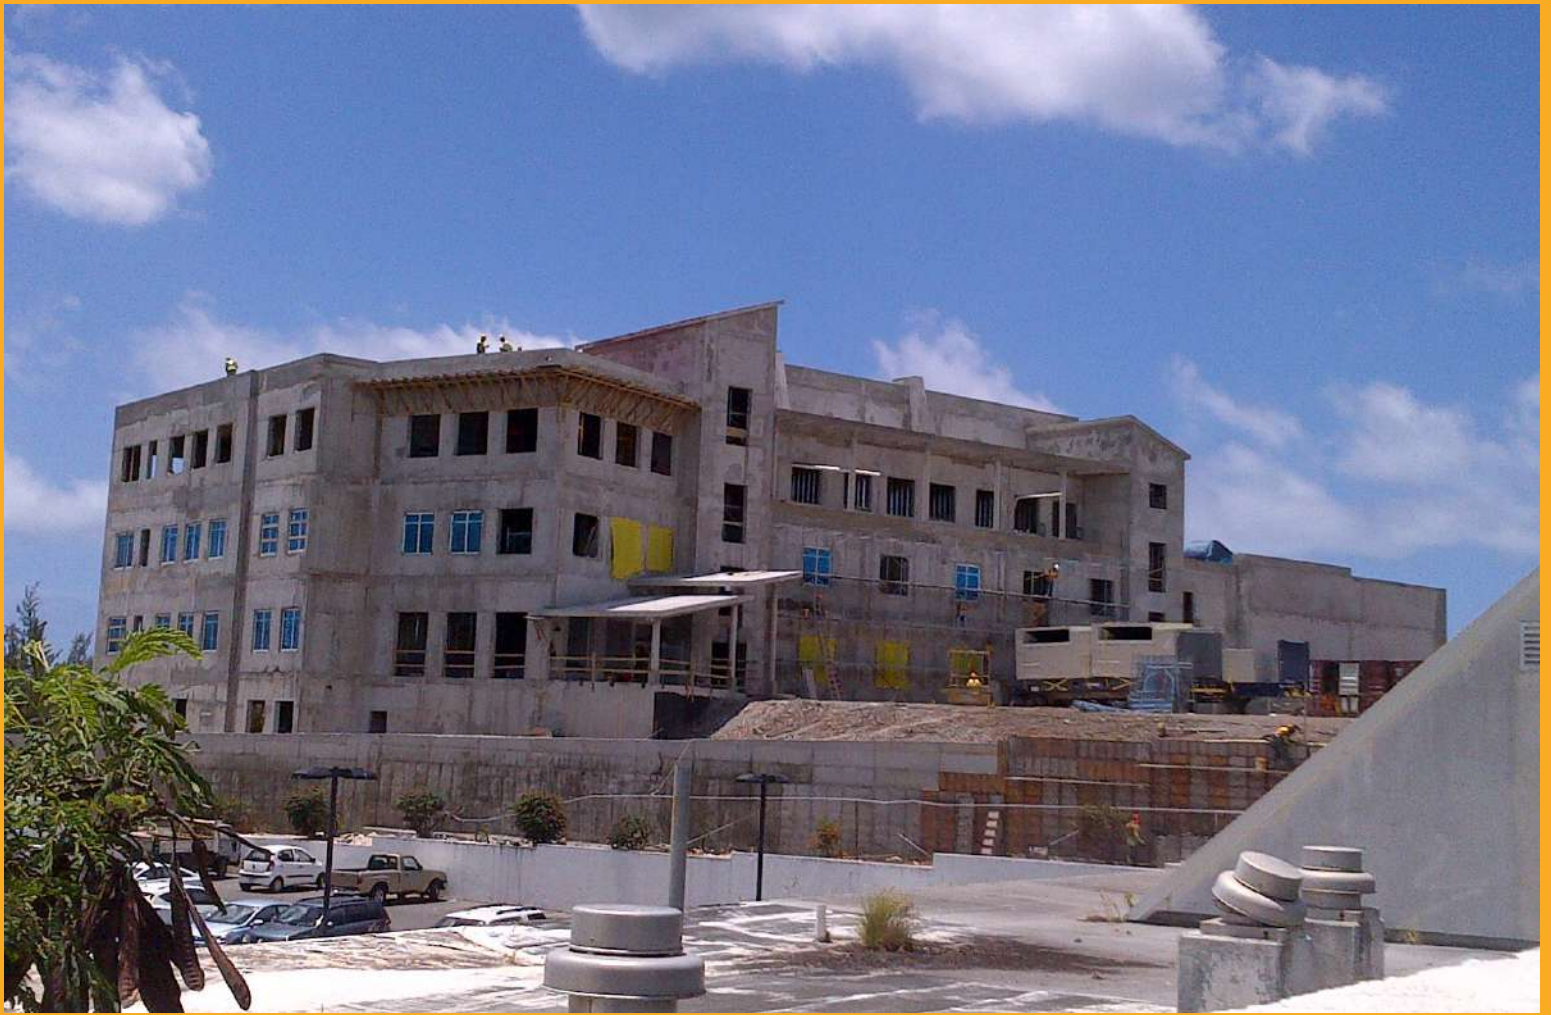
While metal roof panels on the adjacent building and metal flashing on the AUC building were blown away during Hurricane Irma, the RoofPro membrane in the foreground held fast.

Hurricane force winds produced no peeling or delamination of the RoofPro membrane - only some skid marks and scrapes in RoofPro membrane from airborne HVAC equipment which can be easily repaired. The RoofPro membrane is still well-bonded all around the tear preventing water from getting under the membrane and moving laterally to find a leakage pathway into the building.

On September 6, 2017 Hurricane Irma swept through St. Maarten and the surrounding islands. Category 5 winds of 185+ mph caused widespread damage to buildings throughout the area. Only minor damage occurred to the RoofPro membrane. The pictures below show 4 year old RoofPro membrane on the American University of the Caribbean medical building after Hurricane Irma devastated St. Maarten.
