# MARKET APPLICATION FOCUS

Strengthening Concrete Columns

**Project:** Ohio Stadium Horseshoe Renovation  
Columbus, Ohio  
**Owner:** Ohio State University  
**Specifier:** Osborn Engineering Company  
Carl Walker, Inc.  
**Contractor:** IC Construction  
**Year:** 2000

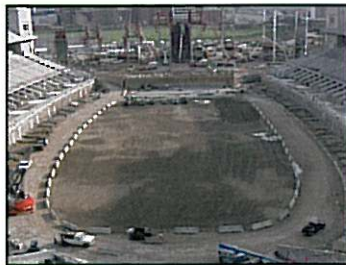
In the midst of renovating the 75-year-old landmark football stadium, it was noticed that the original concrete columns contained no hoop reinforcement. Current code requirements required the use of some form of stirrup in order to confine the vertical bars and provide shear and axial load strength. This necessitated the use of external reinforcement to stabilize the columns.

SikaWrap Carbon Fiber Fabrics were selected to strengthen the concrete columns and restore their structural integrity. The design was completed in one week using the engineering software provided by Sika and the contractor was able to mobilize almost immediately.

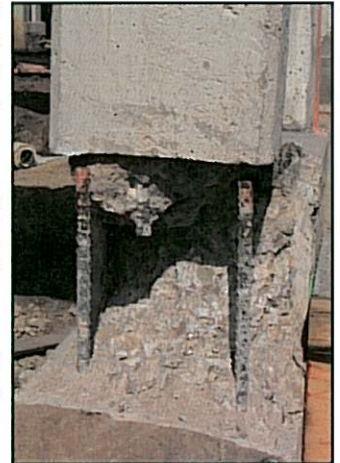
There was not enough time to start fabricating steel jackets to install on the columns, nor was there access in many of the areas for this traditional type of repair.

The concrete surface was sandblasted to provide a sound, level surface for the SikaWrap fabric to be applied on to. The material has an extremely high tensile strength (> 100,000 psi), yet is remarkably light and easy to work with. It is also non-corrosive and requires little to no maintenance once installed. A multiple layer system was installed to meet the structural requirements of the project, yet it remained unobtrusive and was able to be installed even in areas where two columns were only inches apart.
