Project Profile

Waterford High School
Waterford, Connecticut

Roofing System

Décor Roof System the Smart Choice for Waterford High School

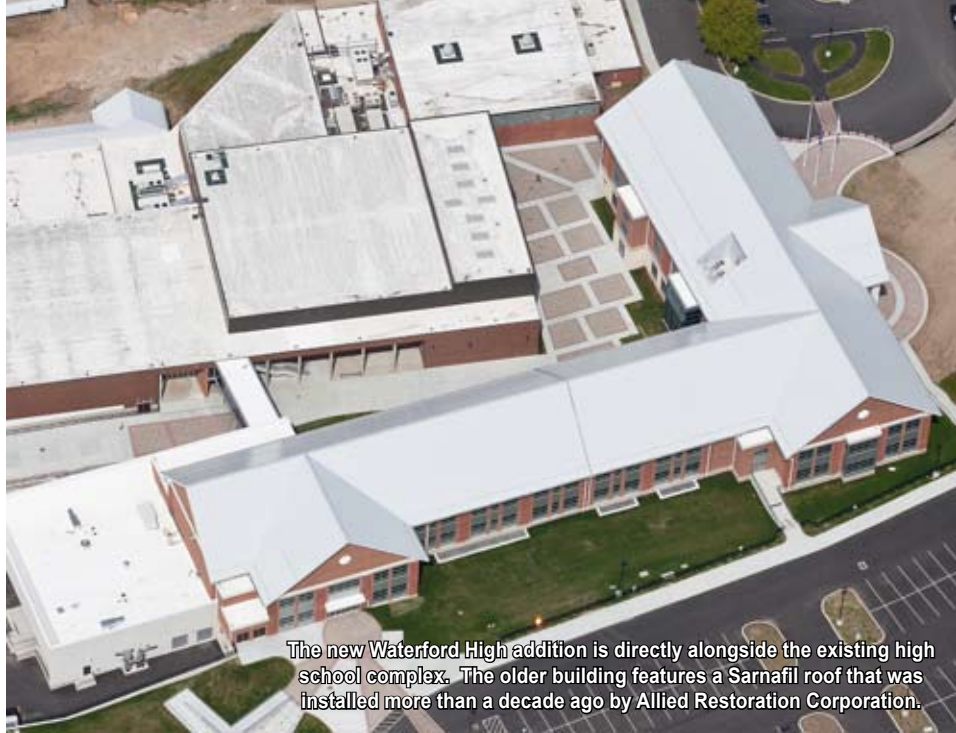
The new Waterford High addition is directly alongside the existing high school complex. The older building features a Sarnafil roof that was installed more than a decade ago by Allied Restoration Corporation.
