Sika® FerroGard® 903

Surface-applied, penetrating corrosion inhibitor for reinforced concrete

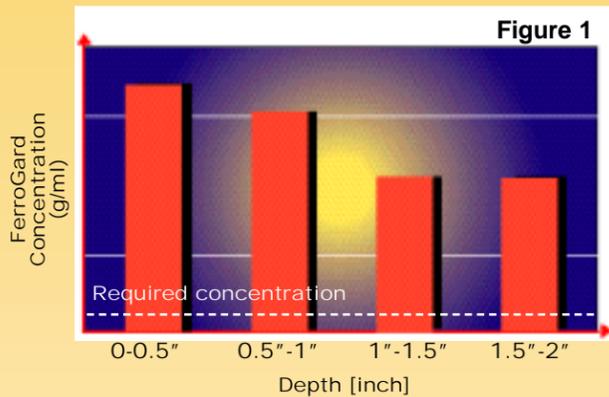
Typical penetration depth profile in 3500psi concrete

Tests to determine the actual penetration depth of Sika® FerroGard® 903 may be conducted on site. Color indicators show presence of the inhibitor at various depths (see Figures 1 and 2).

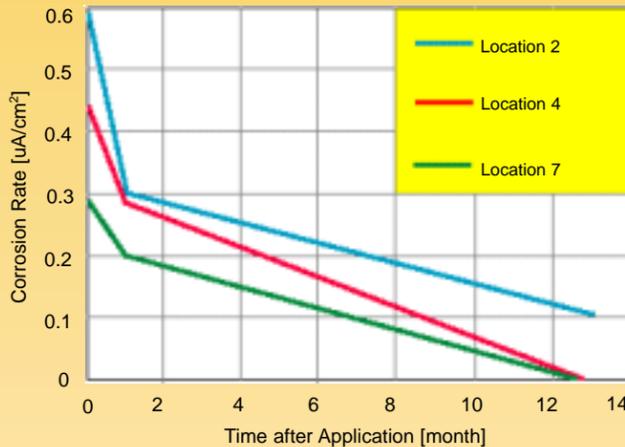
Example of monitoring the corrosion current after the application of Sika® FerroGard® 903 on the job site.

The effect of Sika® FerroGard® 903 can be monitored in the field by measurements of corrosion rate using linear polarization techniques:

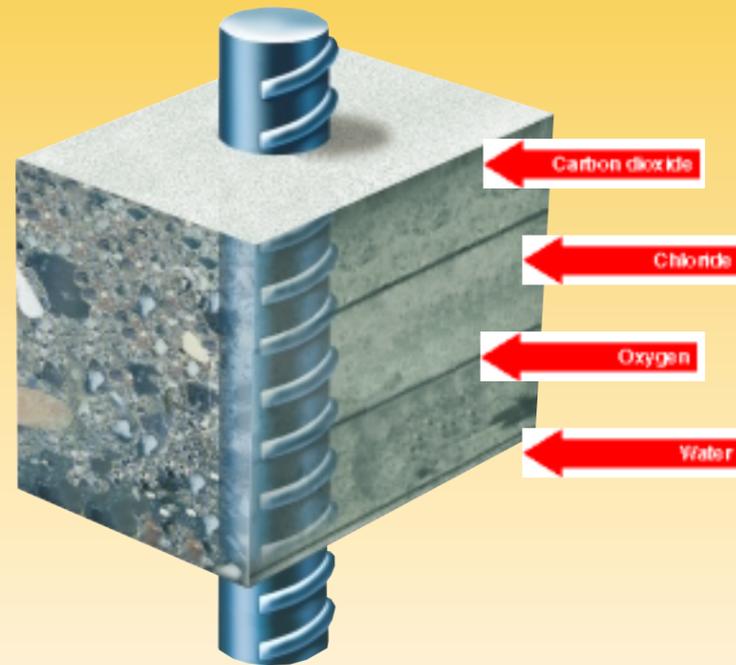
Aggressive influences on reinforced concrete

In reinforced concrete, due to the high alkalinity of the concrete (pH 12.5 to 13.5) a stable passivation layer protects the steel from corrosion. However the ingress of aggressive environmental influences can lead to steel corrosion.

Carbonation
Carbon dioxide ingress causes carbonation of the cement matrix, progressively reducing the pH-value of the concrete. The passivation layer of the steel is destroyed and corrosion of the reinforcing bars can occur.

Chlorides
Chloride ions from deicing salts or marine environments penetrate into the concrete. When the ions reach the steel surface they destroy, even in high alkaline concrete, the passivation layer locally, which leads to accelerated corrosion.

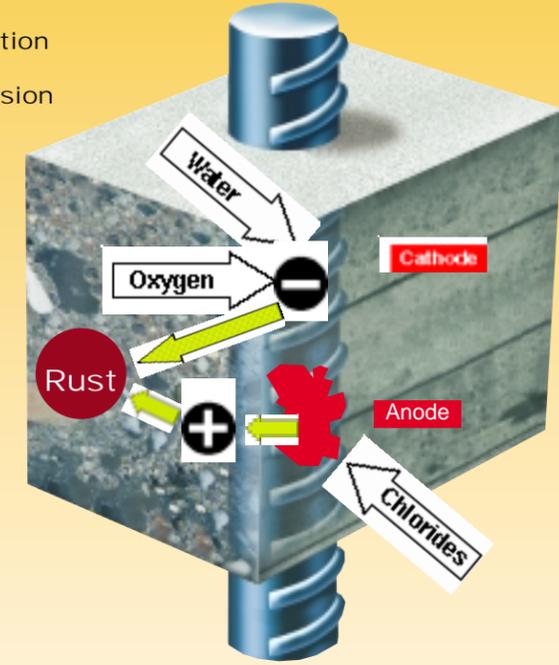
The effect of these aggressive influences

As soon as sufficient chloride ions (from deicing salts or marine environments) and/or the carbonation front have reached the surface of the reinforcing steel, the passivating layer is damaged and corrosion can start.

In presence of water and oxygen a corrosion cell is created on the reinforcing steel.

The corrosion of the steel involves iron changing into iron hydroxide, several times larger than the original iron. The reinforcing bars "expand" which leads to concrete damage (cracking, staining, spalling).

Conditions for corrosion of the reinforcing bars and damage of the concrete are established.

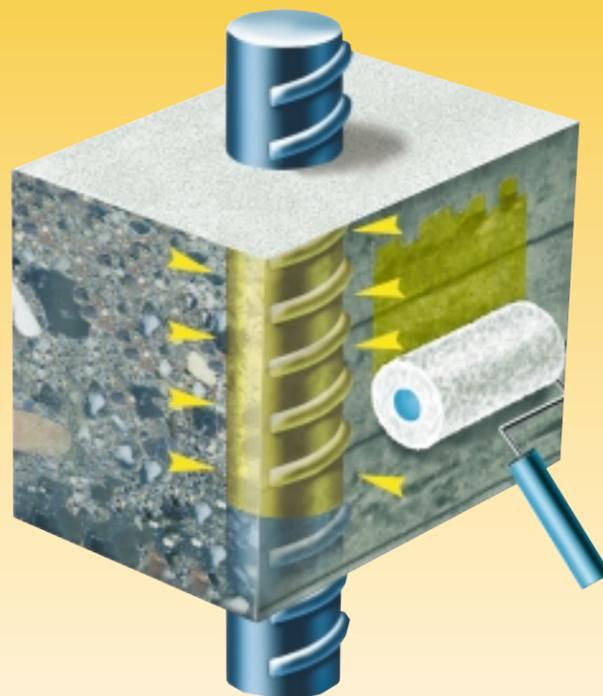
Application of Sika® FerroGard® 903

Sika® FerroGard® 903 is applied as an impregnation onto the surface of the concrete. The corrosion inhibitors penetrate into the concrete and protect the reinforcing bars by forming a protective layer on the steel surface.

Sika® FerroGard® 903 penetrates rapidly into the concrete and reaches the surface of the steel by three different transport mechanisms:

- 1 During application of Sika® FerroGard® 903 transportation is mainly by capillary suction (like water).
- 2 Sika® FerroGard® 903 is later carried in solution by the penetration of water and diffusion (like chlorides).
- 3 Sika® FerroGard® 903 with its high vapor pressure, also travels by gas diffusion (like carbon dioxide).

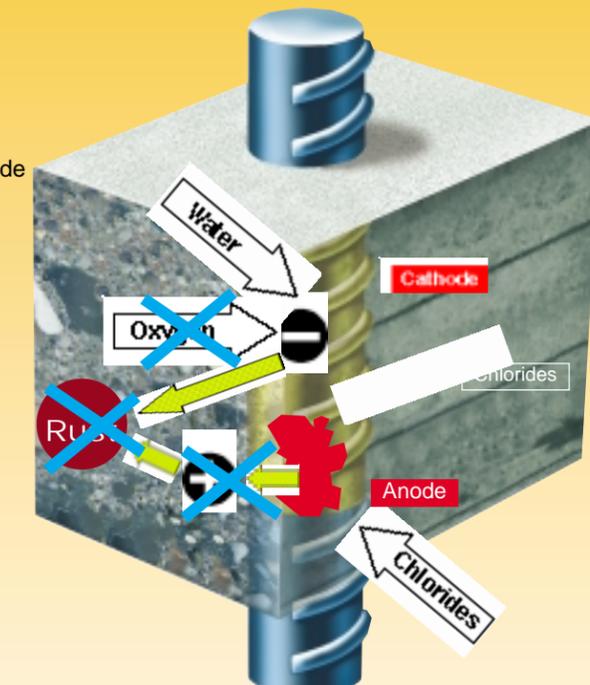
The performance of Sika® FerroGard® 903

Sika® FerroGard® 903 attaches to the reinforcing steel (by adsorption) and forms a protective layer on the surface, even in carbonated and/or chloride-contaminated concrete (up to 1% chlorides by weight of cement).

The dual inhibiting action of Sika® FerroGard® 903:

- ▲ The dissolution of the iron is reduced by the protective layer, which inhibits the anodic corrosion reaction.
- ▲ The protective layer reduces the access of oxygen to the steel surface, thus inhibiting the cathodic corrosion reaction.

Sika® FerroGard®-903 delays the beginning of the corrosion process and reduces, once started, the corrosion rate.

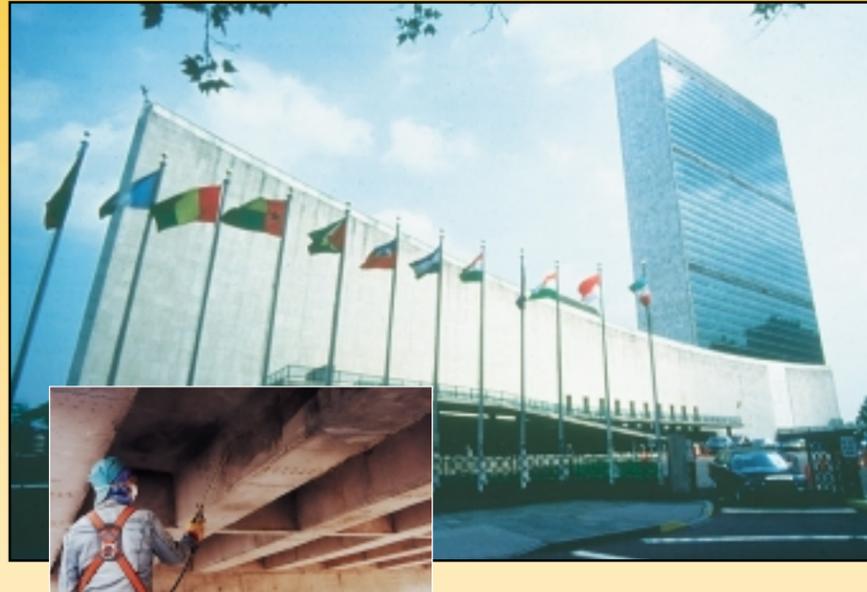
Repair & Protection – Parking Garage

- ▲ Parking garage with chloride contaminated concrete (max. 1% by weight of cement or 5-6lbs./yd³)
- ▲ Structural cracks in concrete slab
- ▲ Damaged concrete

- ▲ Crack injection with Sikadur® 31 and Sikadur® 35 epoxies
- ▲ Spray application of Sika® FerroGard® 903
- ▲ Full-depth repair of some concrete with Sika® FerroGard® 901 as an admixture

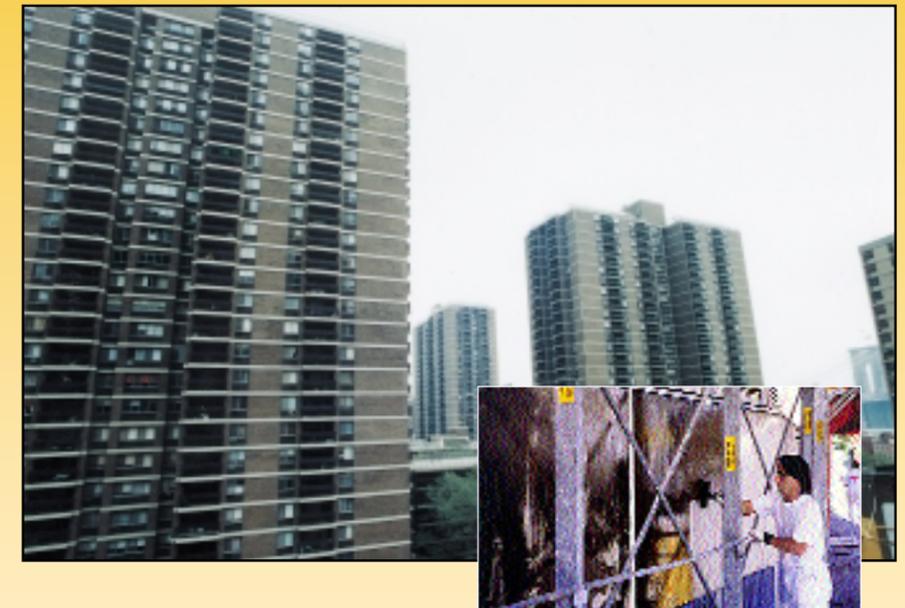
Repair and Protection – Hi-Rise Buildings Facade

- ▲ Reinforcing steel in carbonated concrete
- ▲ Spalling and cracking of the concrete

- ▲ Removal of the damaged concrete.
- ▲ Application of Sika® Armatec 110 EpoCem® as bonding layer
- ▲ Reprofiling with SikaTop® Plus repair mortars
- ▲ Joint sealing with Sikaflex® 1a sealant
- ▲ Application of Sika® FerroGard® 903
- ▲ Application of Sikagard® 550W Elastic and Sikagard® 670W anti-carbonation/protective coatings

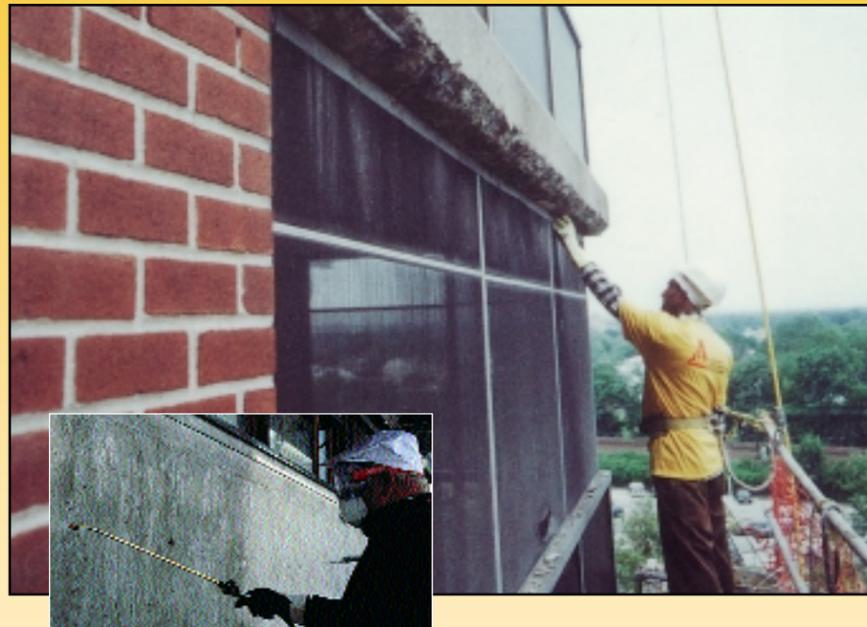
Repair and Protection – Building Facade and Balconies

- ▲ Insufficient concrete cover over reinforcing steel
- ▲ Reinforcing steel in carbonated concrete
- ▲ Cracking and spalling of the concrete

- ▲ Removal of the damaged concrete
- ▲ Application of Sika® Armatec 110 EpoCem® as bonding layer
- ▲ Reprofiling with Sika® MonoTop® repair mortar
- ▲ Application of Sika® FerroGard® 903 delays the onset of corrosion and reduces the risk of incipient anodes

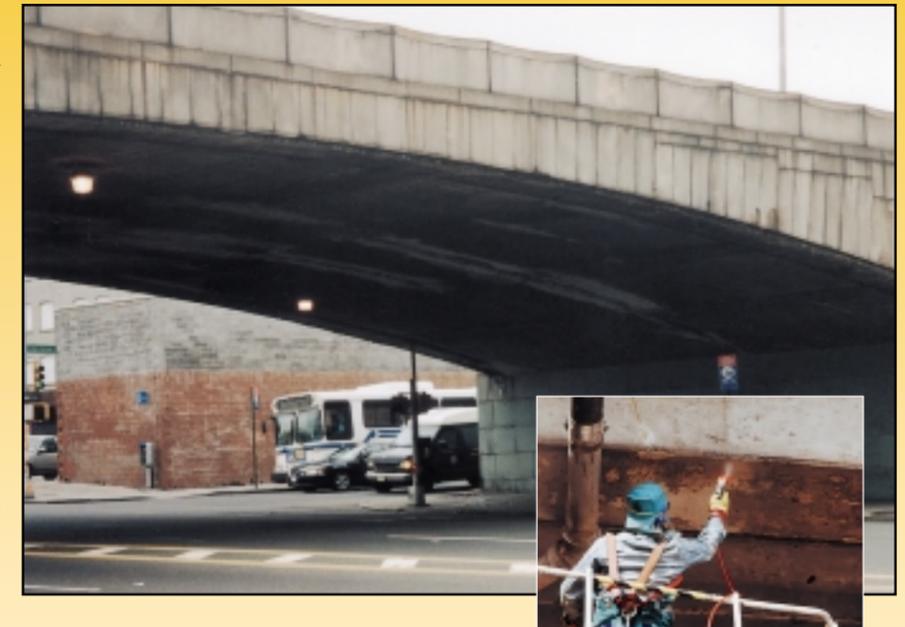
Repair and Protection - Bridge Overpass

- ▲ Leaking Cracks through the bridge deck
- ▲ Chloride contaminated concrete (max. 1% by weight of cement or 5-6lbs./yd³)
- ▲ Spalling and cracking of the concrete

- ▲ Removal of the damaged concrete
- ▲ Application of Sika® Armatec 110 EpoCem® as bonding layer
- ▲ Application of Sikacem® spray-applied repair mortars in the repair areas
- ▲ Application of Sika® FerroGard® 903 for the whole concrete structure
- ▲ Sealing of expansion joints with Sikaflex® 2C sealant
- ▲ Application of Sikagard® 670W protective coating
