Concrete Repair & Protection

Chloride Induced Corrosion-Spall Repairs

Project:	Mellville Towers
Owner:	Dep. of Housing and Development (HUD)
Specifier:	Wessling Architects
Contractor:	Heritage Restoration
Year:	2005

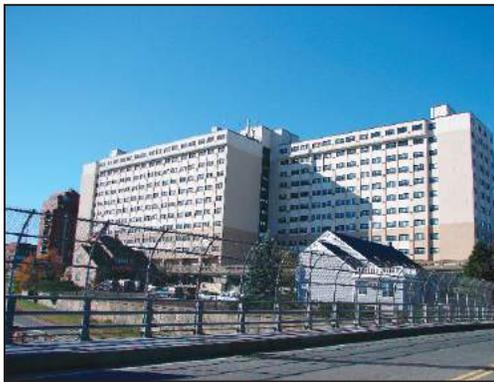
Mellville Towers is located in the center of the historic town of New Bedford, Massachusetts. This building is owned by the US Department of Housing and Development (HUD) and is used for elderly housing. The 12 story apartment building has 10 story's of apartments, a designated story for administration and one story of parking. This structure has a plaza at the ground level. The building built in the 1970's is a typical conventional cast in place concrete structure. Over the years the Plaza Deck suffered extensive deterioration due to the use of deicing salt during winter. This deck is used as the passage for elderly to move in and out of their apartment complex. Surface spalling, cracking, and failed joints were noticeable on the 40,000 sq. ft.

concrete deck. The plaza deck and the garage beams below were affected. The deterioration on the deck was to a point that it became hard for the handicapped and wheel-chaired residents to maneuver.

The repair strategy for the deck included fixing spalls and providing a positive drainage to the drains under the new slab. The versatility of thickness on the 40,000 sq. ft. slab was an integral part of the repair. The pitching of the slab from 1 ¼" down to ¼" was the key to remove the ponding of water, ice and salt on the deck by effectively directing the water to the drains.

SikaQuick 1000 was selected as the choice for the repair material for its low shrinkage and friendly placement characteristics. SikaQuick 1000 is a rapid setting material which achieves 1000 psi in 3 hours. SikaQuick 1000 was extended with ¾ pea-gravel for deeper than one inch repairs. SikaQuick 1000 was mixed with a mortar mixer in some locations and was pumped in others. Due to the fast setting property of the material, pumping of SikaQuick 1000 over a distance of 100 ft. was a challenge. Sika Plastiment, a retarder was added to SikaQuick 1000 in appropriate quantity to gain some additional working time for the pumping operation. The entire placement was done in --- days without having any problems. The contractor and his concrete crew were extremely happy with the placement and performance of the repair material.

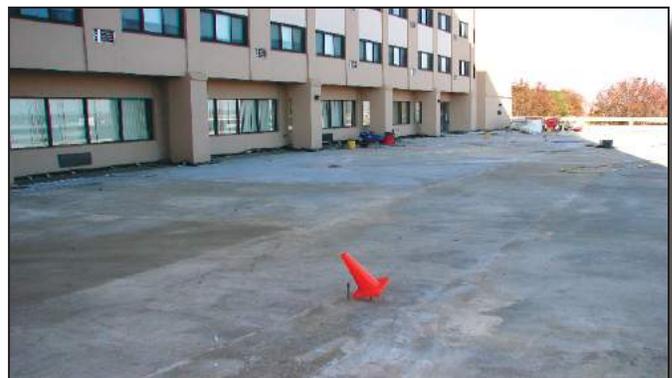
The new repaired slab was then top coated with a flexible membrane system for additional waterproofing. Prior to installing the waterproofing membrane, SikaQuick 1000 was inspected after three months of its placement. There were no signs of any cracking on the slab.
