Structural Strengthening/ Concrete Repair and Protection

Reinforcing Steel Corrosion

Project: Harmon Hall, United States Air Force Academy
Owner: United States Air Force
Contractor: Weston Solutions
Engineer: S.A. Miro Engineering
Year: 2006

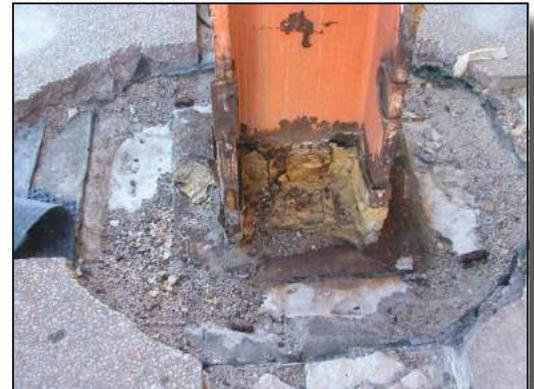
The fireproofing materials that had been applied to the columns before they were originally encased in the 1950's were wicking moisture up from under the plaza deck. This was causing anywhere from mild to severe corrosion approximately 4-5 feet up on all 40 of the columns.

Some of the columns had significant section loss and were of great concern to the engineer; therefore a solution to repair the columns was needed immediately. All other renovations to the building, interior and exterior, were halted until the engineer felt the support columns could be strengthened. Several different approaches of repair were investigated.

The engineer reviewed several options and decided on applying Sika CarboDur strips to the surface of the columns. This would provide the safety factor required in the columns and would not change the dimensions of the columns significantly. This would allow for the re-use of the existing stainless steel sleeves that were removed from the columns and save over \$200,000 in the total cost of the project, while maintaining the original look of this historic building.

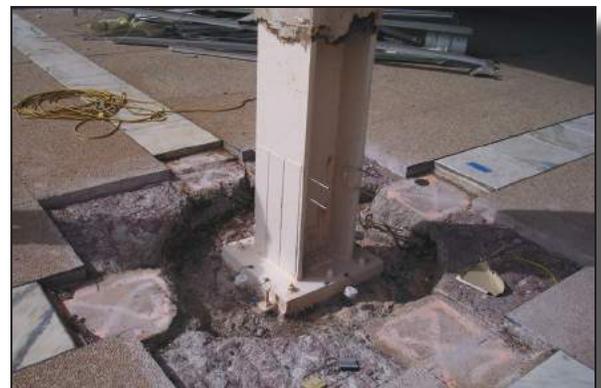
After the CarboDur was applied, the columns were then coated Sikagard 62 epoxy coating to protect them from future corrosion.

Sika Galvashield sacrificial galvanic anodes, which utilize a zinc core which should corrode preferentially to the adjacent steel, were placed at the base of the columns to prevent corrosion of the embedded portion of the steel columns. The columns were then embedded with a total of 315 cubic feet of SikaQuick 2500 repair mortar that was extended with aggregate. The fast setting repair mortar was chosen over traditional concrete for its fast cure capability, which was critical in this cold weather application.
