# MARKET APPLICATION FOCUS

*Clean Water Treatment Structures*  
*Concrete Repair/Protection/Waterproofing*  
*Leaking Cracks & Surface Erosion*

**The Project:** Trenton Water Works  
Trenton, NJ  
**The Owner:** City of Trenton, NJ  
**The Specifier:** Buck, Seifert, & Jost  
**The Year:** 1996

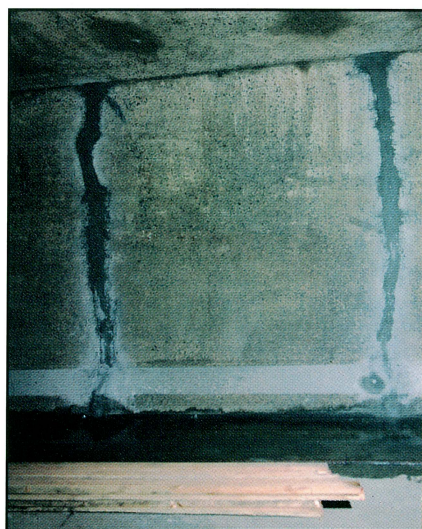
Condition surveys of the concrete flocculation/sedimentation tanks revealed considerable erosion and spalling of the concrete surface and cracking of the tank walls. The roof slab had also suffered cracking and wear after exposure to many harsh winters. After documenting all necessary repairs and mapping all existing cracks, a comprehensive repair and protection system from Sika was selected.

Leaking water through moving cracks presented a formidable challenge. Sikadur® Combiflex® was selected - a unique "strip and seal" system which offers excellent movement capability even on large, irregular cracks or joints. Combiflex provides an absolutely watertight seal where conventional sealants or caulks cannot.

The spalling and erosion of the tank walls was addressed using a "repair and protect" approach. SikaTop® Plus repair mortars were used to restore the profile of the concrete. These polymer-modified repair mortars offer excellent strengths and adhesion, and contain a corrosion-inhibiting admixture to help protect reinforcing steel from corrosion.

Finally, the surface of the tank walls was protected using Sikagard® 62, a high-build epoxy protective coating. All repairs were made using NSF/ANSI standard 61 approved products for drinking water contact.
