SIKA® AT WORK INTERSTATE 85 BRIDGE COLLAPSE

AFTER A MASSIVE FIRE A SECTION OF I-85 REQUIRED A MAJOR REFURBISHMENT

INTERSTATE 85 BRIDGE COLLAPSE

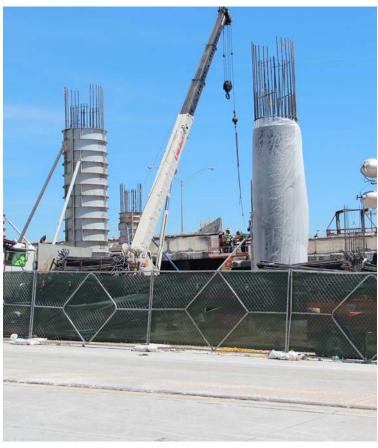
C.W. Matthews Contracting Company was chosen as the contractor for the repair

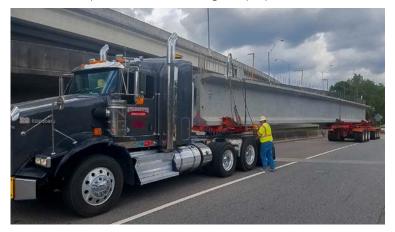
Thomas Concrete provided the concrete during the repair process

Prestressed concrete girders were brought in for the repair
