## MARKET APPLICATION FOCUS

*Concrete Repair & Protection*

**The Project:** Union Carbide World Headquarters  
Danbury, CT  
**The Owner:** Union Carbide Chemical Company  
**The Specifier:** Hoffman Architects  
**The Year:** 1996

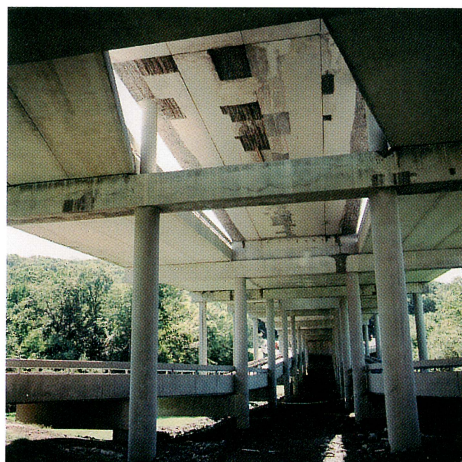
Reinforced concrete access ramps, approximately 20 years old, were suffering from water and deicing salt penetration causing corrosion of reinforcing steel. The chlorides had penetrated by diffusion to reach the steel and caused spalling and delamination in the topping slab. In other areas, cracks allowed the chlorides through the slab leading to corrosion of the steel closest to the underside of the ramps, as well as in the beams and columns.

While the spalling was clearly visible in many areas, there was also concern about underlying (latent) corrosion ongoing in other areas not yet visible. For this reason, a diagnostic condition survey of the structure was recommended first before selection of the rehabilitation strategy.

The condition survey confirmed that the chloride levels exceeded the corrosion threshold - identifying them as the root cause of the problem. Carbonation (pH loss) was also identified in some areas.

**Repair** - the visibly spalled/delaminated areas were repaired and restored using Sika MonoTop® 611, a polymer-modified, silica fume enhanced repair mortar, extended with coarse aggregate for deep repairs (greater than 1 1/2 inches). On the underside and columns, forms were erected and the material was pumped into place. A total of 3,000 cubic feet of repairs were made.

**Protect** - to address latent corrosion in surrounding areas, a spray-applied, corrosion inhibiting impregnation was applied to all areas after repairs were completed. This water-based material is able to penetrate to the reinforcing steel by liquid and vapor diffusion. It then forms a protective layer on the steel which dramatically slows the corrosion process. Over 100,000 square feet of surface area was treated.
