Project Profile

Carver-Hawkeye Arena
Iowa City, IA

Sika Sarnafil Roofing System on Carver-Hawkeye Arena Wins Big – Twice!

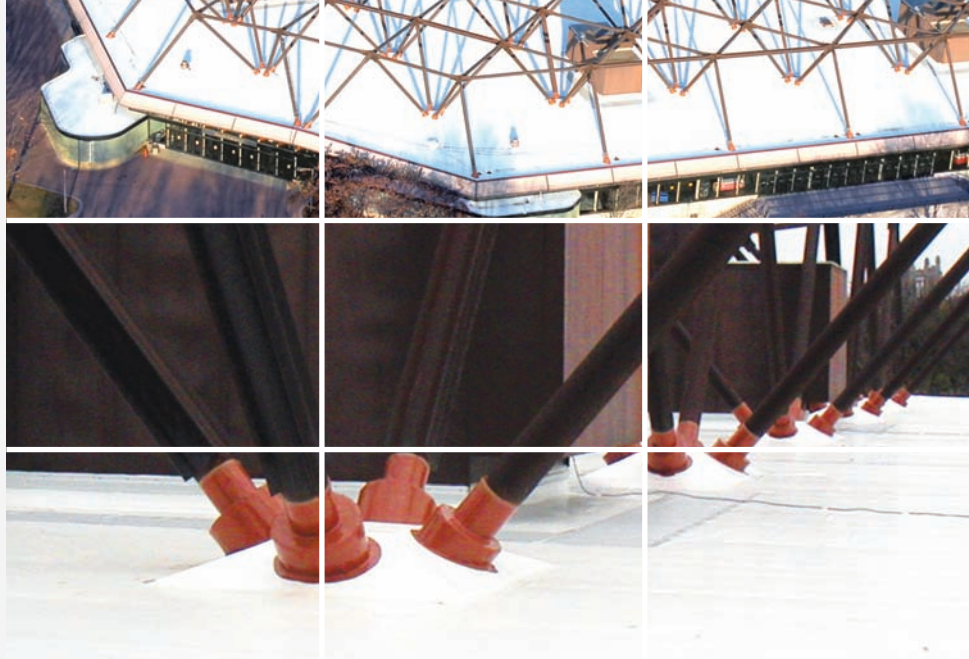
The arena roof is supported by exposed Cor-Ten steel trusses, so CEI used copper brown colored Sika Sarnafil flashing membrane on truss column bases.
