Project Profile

The Toro Company
Irrigation Business Headquarters
Riverside, California

Mechanically-attached
EnergySmart Roof® using Sarnafil®
S327 membrane in white

Sika Sarnafil and Toro “Bullish” on Recycling

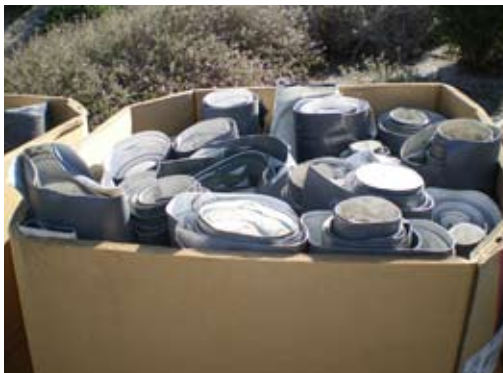
Older vinyl roofing in Sika Sarnafil-supplied Gaylords for shipment to a recycling center.

“Toro’s goal was zero impact to the landfill, and they accomplished that,” Ouellette remarked. “Not only was the membrane recycled, but the old gypsum board, the obsolete equipment on the roof, the sheet metal, fasteners and plates — all were either reused or recycled.” He added, “With 102,000 square feet of roof, it was the largest Sarnafil recycling project in the West.”

Males explained that recycling wasn’t any more expensive than a regular reroofing project. “Any additional costs were cancelled out by the savings on the fees that we would normally pay to haul materials to the landfill,” he said. “Plus, it really wasn’t much more labor-intensive to recycle the roofing membrane. We simply cut the material into strips, rolled them up and put them in the boxes provided. The other materials, such as sheet metal, fasteners, etc. were sorted into separate containers and shipped to the specific recycling center. We even found a facility that recycled used lumber. Overall, it was similar in cost and labor to a normal tear-off.”
