Sika® FerroGard® 903

Assessing Performance on the Jobsite:

Surface-applied, penetrating corrosion inhibitor for reinforced concrete

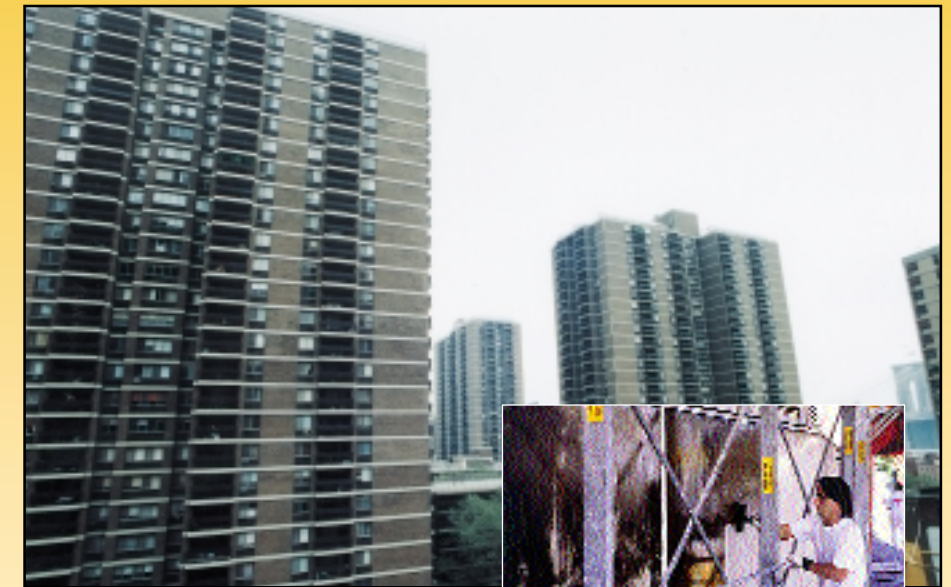
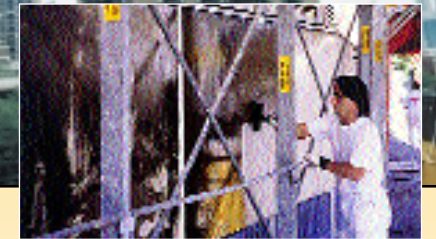
Repair and Protection – Hi-Rise Buildings Facade

- ▲ Reinforcing steel in carbonated concrete
- ▲ Spalling and cracking of the concrete

- ▲ Removal of the damaged concrete.
- ▲ Application of Sika® Armatec 110 EpoCem® as bonding layer
- ▲ Reprofiling with SikaTop® Plus repair mortars
- ▲ Joint sealing with Sikaflex® 1a sealant
- ▲ Application of Sika® FerroGard® 903
- ▲ Application of Sikagard® 550W Elastic and Sikagard® 670W anti-carbonation/protective coatings

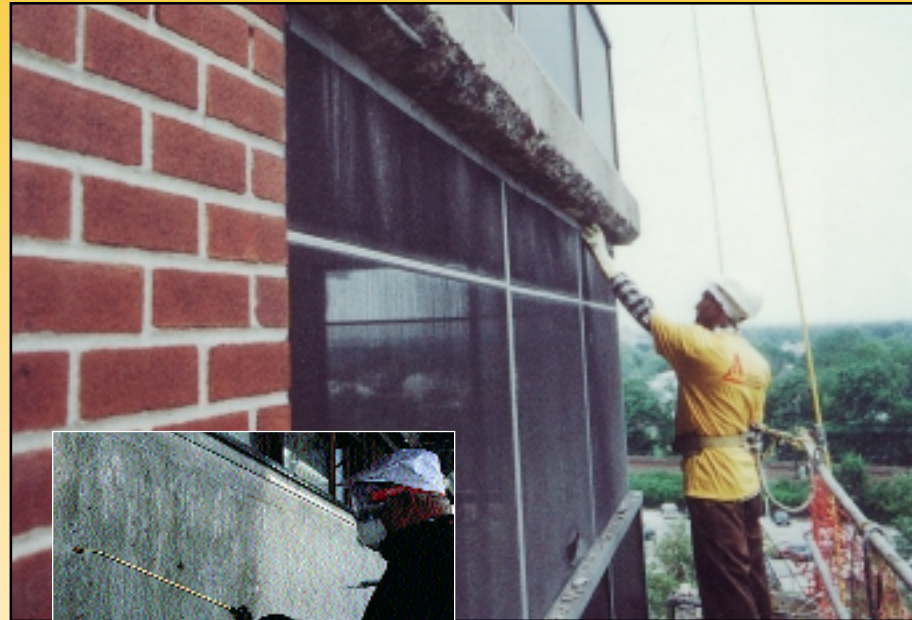
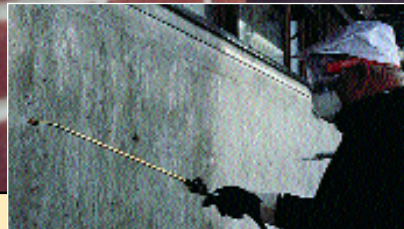
Repair and Protection – Building Facade and Balconies

- ▲ Insufficient concrete cover over reinforcing steel
- ▲ Reinforcing steel in carbonated concrete
- ▲ Cracking and spalling of the concrete

- ▲ Removal of the damaged concrete
- ▲ Application of Sika® Armatec 110 EpoCem® as bonding layer
- ▲ Reprofiling with Sika® MonoTop® repair mortar
- ▲ Application of Sika® FerroGard® 903 delays the onset of corrosion and reduces the risk of incipient anodes

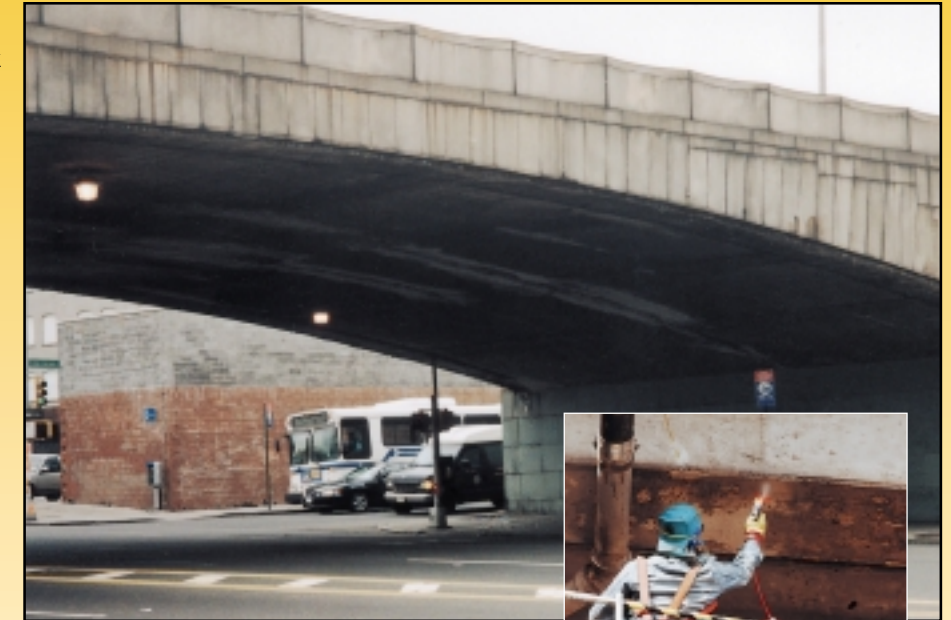
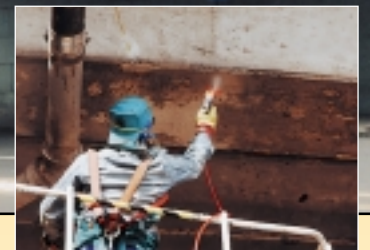
Repair and Protection - Bridge Overpass

- ▲ Leaking Cracks through the bridge deck
- ▲ Chloride contaminated concrete (max. 1% by weight of cement or 5-6lbs./yd³)
- ▲ Spalling and cracking of the concrete

- ▲ Removal of the damaged concrete
- ▲ Application of Sika® Armatec 110 EpoCem® as bonding layer
- ▲ Application of Sikacem® spray-applied repair mortars in the repair areas
- ▲ Application of Sika® FerroGard® 903 for the whole concrete structure
- ▲ Sealing of expansion joints with Sikaflex® 2C sealant
- ▲ Application of Sikagard® 670W protective coating
