CASE STUDY

Sika at Work

San Vicente Dam

San Diego, California

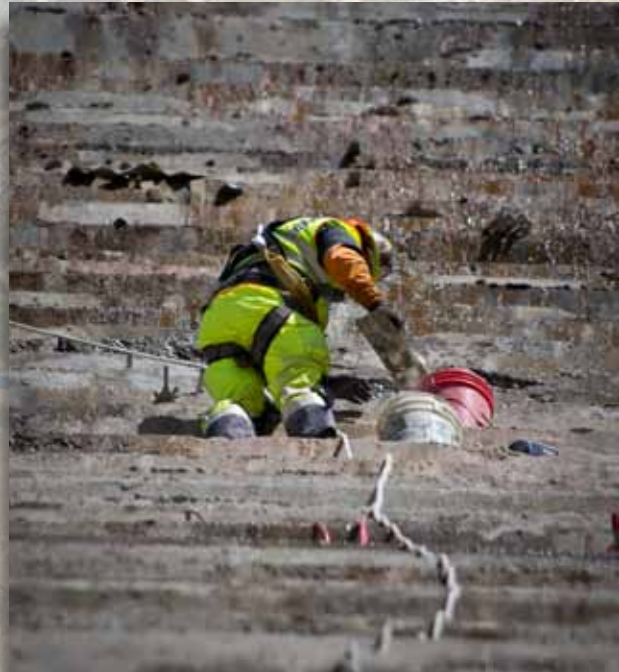
San Vicente Dam, which is owned and operated by the city of San Diego, currently stands at 220 feet. The Water Authority will raise the dam an additional 117 feet – the tallest dam raise in the United States and the tallest of its type in the world. The raised dam will store an additional 152,000 acre-feet of water, more than doubling the reservoir's water storage.

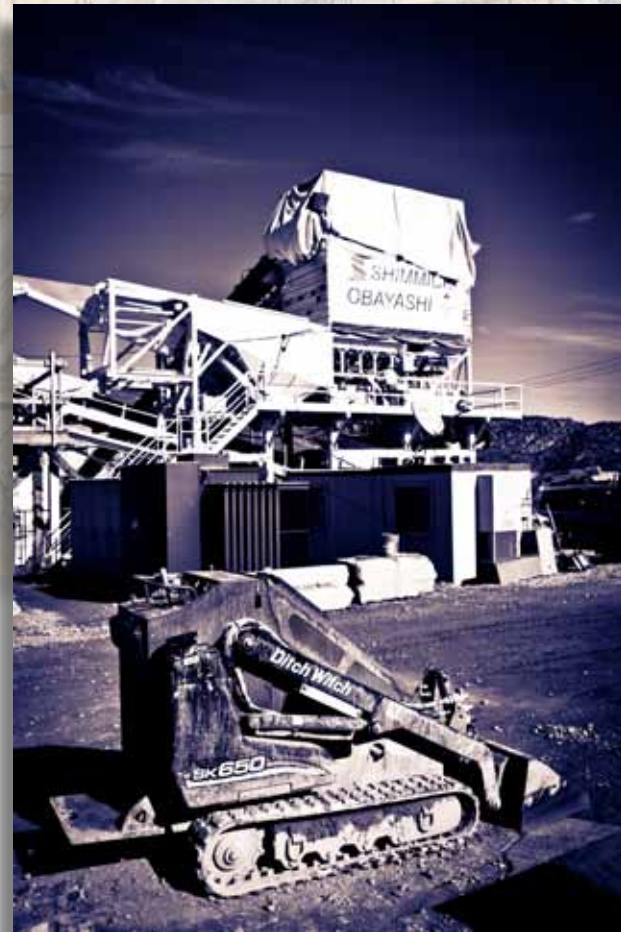
The San Vicente Dam Raise project is being constructed in several phases from 2009 to 2014. The first task was to prepare the dam to receive concrete that will raise it 117 feet. The contractor excavated down to the existing dam's foundation, filled crevices with concrete, and installed a new pipeline through the existing dam. To create a good bonding surface for the new concrete, the contractor also removed about two inches of the downstream, or dry, surface of the dam.

The second construction stage focuses on manufacturing and placing massive quantities of roller-compacted concrete to raise the dam. This phase began in Summer 2010 and was been completed in Fall 2013. The raised dam is built to remain operational in the event of a major earthquake. Roller-compacted concrete takes less time and water than conventional concrete, but is just as strong. Concrete was transported by system of telescopic high speed conveyors from the plant directly to the final placement point, thus eliminating transportation by trucks and reducing project carbon footprint. This system also allows placement of concrete layers, one on top of another without any interruption and permits fast track construction 24 hours a day, seven days a week. The dam is built from the bottom up, starting at the newly excavated foundation on the downstream side of the dam.

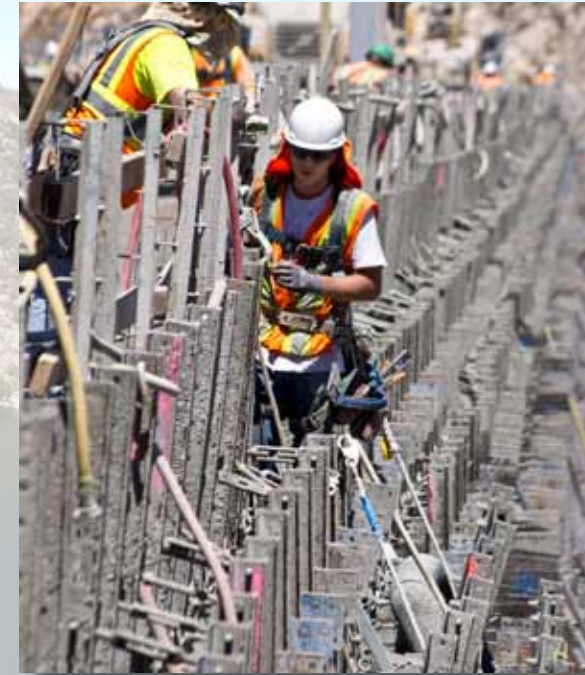
Layers of roller-compacted concrete 24 inches thick completely cover the downstream side, producing a stairstepped surface. The new concrete is nearly equal in volume to the original dam.
