Projects

RhinoBond[®] Roof System using 60 mil Sikaplan[®] membrane in white

Aldi Stores in New York State Get Great Coverage with RhinoBond Roof System

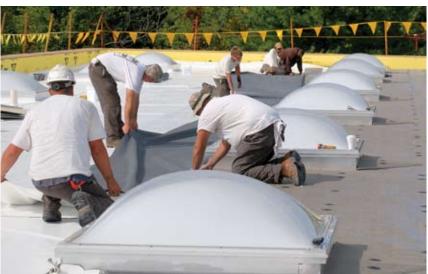
The roofing crew found the RhinoBond tool easy to use and operate. After going through a brief learning curve, the crew achieved good productivity on the Springville store and even better productivity on the second Aldi store installation in Farmington. The RhinoBond tool is used to weld the underside of the membrane to the specially coated plates affixed to the insulation or cover board.
