TECHNICAL BULLETIN

Procedures for Repairing EIFS

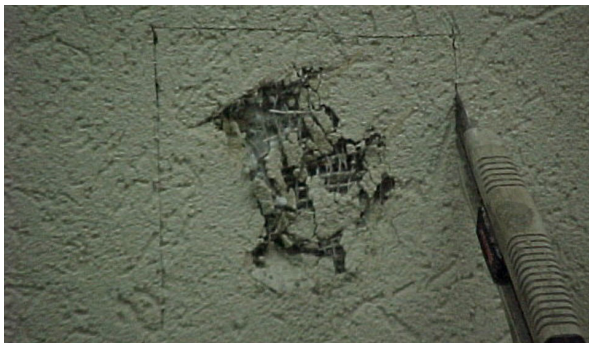
1. Cut around the damaged area with a razor knife, cutting through all layers, to the substrate or the water-resistive barrier (if the system is an EIFS with Drainage). Make sure the patch area is large enough to easily work within, even if the damaged area is small.

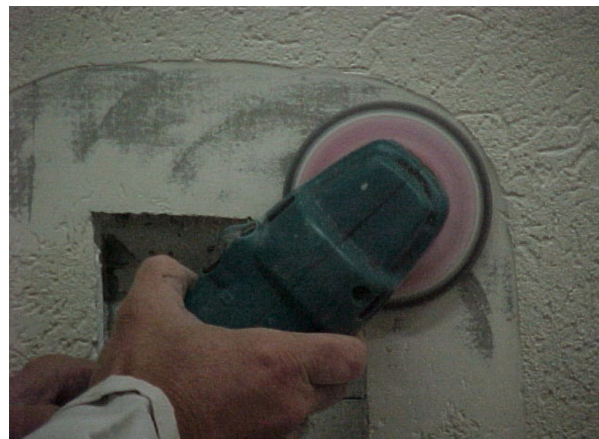
2. Carefully remove the EIFS lamina.
3. Remove the damaged EPS. Inspect the water-resistive barrier and repair as necessary if damaged during EIFS removal.

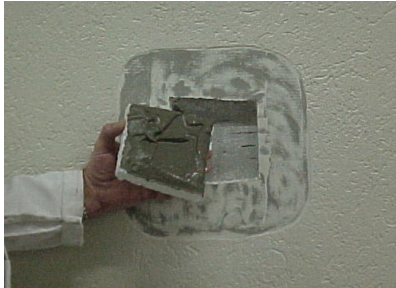
- Cut new EPS to the shape of the EPS void, creating a tightly fitting repair. Apply Senergy Alpha or Alpha Dry Base Coat to the new EPS and press it into place. Allow the adhesive to dry. Insert EPS slivers into any gap greater than 1/16-inch wide. Do not fill gaps between insulation board with base coat. Sand or rasp the surface flush with adjacent EPS.

Note: For mechanically fastened EIFS, small areas of EPS can be friction fit. Larger areas of damage will require stud to stud removal to fasten new EPS.

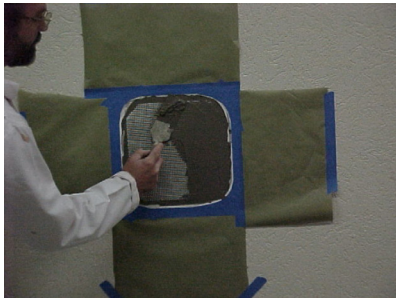
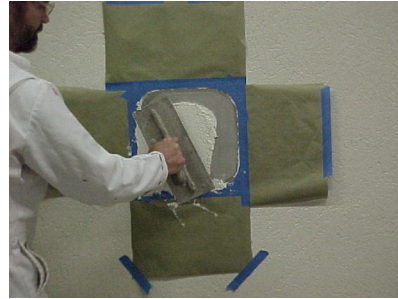
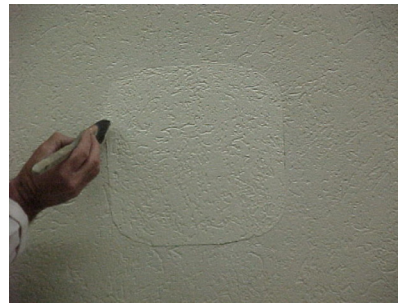
- Mask the existing finish around the repair area.
- Cut Senergy Flexguard 4 Reinforcing Mesh so that it overlaps at least 1" onto existing base coat and mesh. Embed Senergy Flexguard 4 Reinforcing Mesh into Alpha or Alpha Dry Base Coat, ensuring that fresh base coat and mesh is level with the existing lamina. Use a double layer of Flexguard 4 when repairing damaged corners. Allow to dry and scrape any trowel marks prior to finish application.
- Apply color and texture matched Senergy finish. Float the finish to match existing finish. Remove the masking tape before the finish dries and use a brush to blend the wet edge of the finish into existing finish and allow to dry.
