Smoky Row Elementary School Carmel, Indiana

Décor Roof System, using 60 mil Sarnafil® G410 feltback membrane in custom pewter grey color

# Décor Roof System a Star Performer at Smoky Row Elementary School

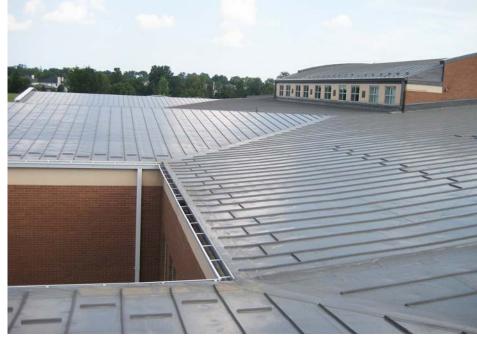
The flexibility inherent in the Décor Roof System made the job of Midland Engineering, the roofing contractor, easier when faced with the many flashing details, elevation changes, valleys and roof configurations at the Smoky Row School.

Installation included removal of the metal roof and purlins, followed by installation of two layers of Sarnatherm isocyanurate insulation, which was topped with ¼ inch of gypsum roof board. The Décor system was then installed.

The height difference at the gutters was addressed by changing the slope at the bottom eight feet of the rafter length with a layer of tapered insulation between the two other layers of insulation. A sheet of the custom-color Sika Sarnafil membrane was also installed on two leaking Dryvit-covered knee walls, thus making them watertight.
