# Market Application Focus

Timber Pile Repair

**Project:** NYC Passenger Ship Terminal Rehabilitation  
**Owner:** City of New York  
**Engineer:** DMJM and Harris  
**Contractor:** Trevcon/Phoenix Marine  
**Year:** 2002

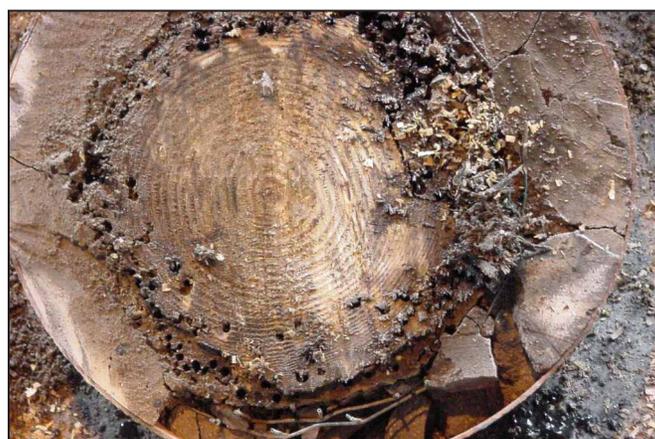
The wood timber piles of the original construction were of green untreated wood which at that time was in vast supply. With the cleanup of the river came the return of the marine life. One such organism were the marine worms that made their home in the piles and also used them as a food supply. They bored holes throughout these piles, deteriorating and weakening them. Also noticeable was the fact that the piles were sinking into the mud line on the bottom of the river.

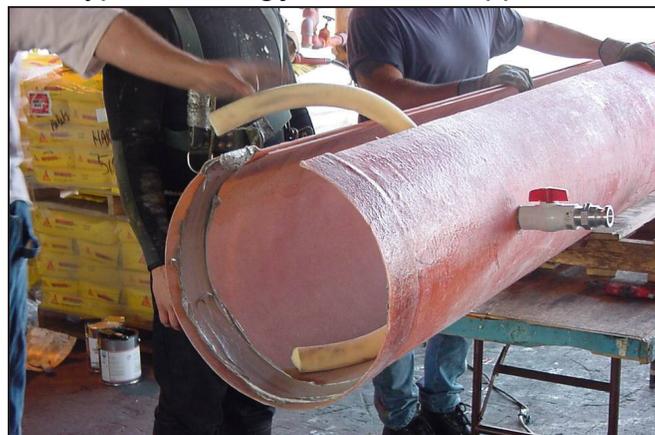
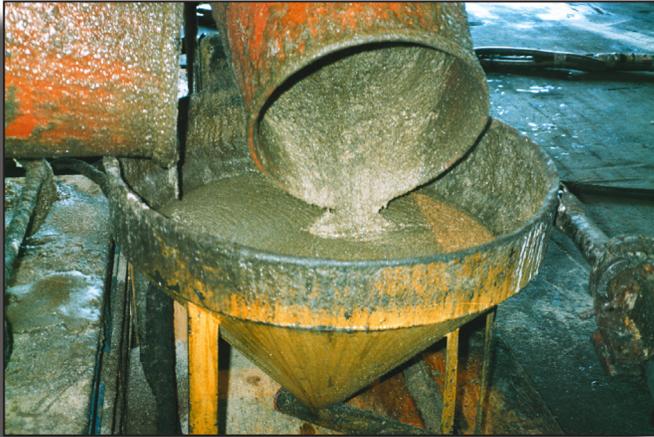
Several methods of restoration were tried. First, a type of floating jacket was wrapped around the pile to create an isolation barrier. With the stretching of the cloth-like fiber of the jacket, a void was created in between the jacket and the pile. Unfortunately, this allowed the surging of the tides to aerate the void creating an even friendlier environment for the marine worms to thrive. Secondly, replacement and encapsulation of the pile was tried with conventional concrete. This was an economically sound solution, however with the added

Replacement with newly cut timber was not an environmentally or politically popular solution. The engineers decided that a fiberglass jacket with an epoxy grout was the answer. The reduction of added weight to decrease settling and control costs were the major deciding factors. This system could maintain a smaller annular space between pile and jacket. Sikadur 35 Hi- Mod LV LPL (Long Pot Life), a two

component 100% solids epoxy was mixed with a well-graded oven dried sand to make an epoxy mortar. A three gallon pail of the epoxy was mixed with 100 pounds of C 404 sand resulting in a epoxy mortar that was flowable in consistency and could be pumped with a peristaltic pump. Sikadur 35 Hi Mod LPL mixed with sand was pumped through the connections at the bottoms of the jackets. The mixed epoxy mortar was able to displace the standing water and harden to the necessary requirements of the job. The ability of this material to push the water without compromising its ability to chemically react and harden was the reason it was selected by engineers.

The result was a watertight pile jacket with no void between the pile, and a strong protective layer against debris and ice flow. The impermeable nature of the fiberglass jackets coupled with a dense thick section will ensure protection to the wood timber piers for many years to come.
