# SIKA AT WORK

Norman W. Paschall Company Plant and Offices  
Peachtree City, Georgia

Sikacoat® FC3400 Roof Coating with  
Sikacoat AE400 asphalt emulsion and  
Sikacoat RF400F reinforcing fabric

## NORMAN W. PASCHALL COMPANY COTTONS UP TO Sikacoat® SYSTEM

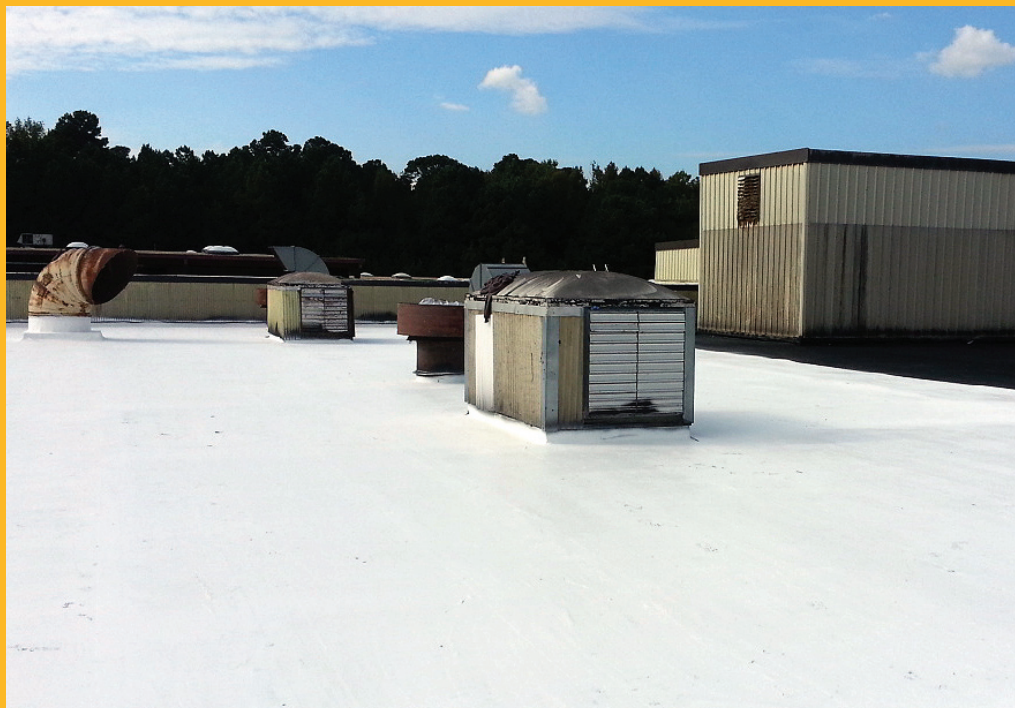
Werner General Contracting began the installation by cleaning up the existing roof. "Due to the nature of their business there was about two inches of lint on the roof, which we removed," Werner stated.

Werner General Contracting then power-washed the roof, and reinforced and repaired areas where needed.

After the roof was washed the contractors applied six gallons per 100 square feet of the asphalt emulsion and then broomed the fabric reinforcement into the emulsion. The acrylic coating was then sprayed on. "With the emulsion we only needed to use three gallons of acrylic instead of four," Werner said.
