Concrete Repair & Protection

Project: Miami Beach City Hall
Owner: City of Miami Beach
Engineer: BEA International
Contractor: National Concrete Preservation
Year: 2008

Case Study

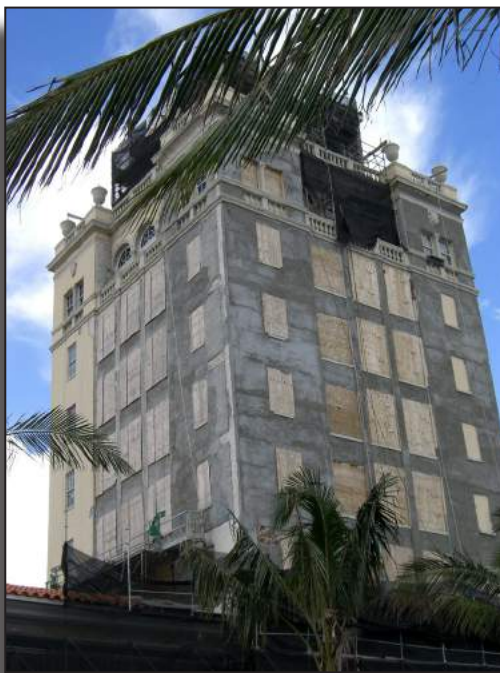
The 80 year old Miami Beach City Hall Building stands out as a strong architectural landmark and a classic example of the diverse history of Miami Beach. The old City Hall Building is one of the largest and youngest listings on the National Register of Historic Places. The structure, displaying a Mediterranean Revival style, was designed by Martin Luther Hampton and erected in 1927. The building is composed of a central nine - story tower standing 125 feet and 3 inches tall with two two-story wings. The Miami Beach police 911 communication equipment office at one time was located on the 9th floor of the building. After approximately half a century of serving the community, the old City Hall building started to show signs of aging. Structural cracks that started to appear in the exterior of the building. Water intrusion through the exterior façade and windows was slowly deteriorating the structural integrity of the historic building. In 1996, there was a fire on the roof of the South Wing. During the restoration of the fire damage, the first piece of the decorative cornice began to fall.

A total of 36,300 sq.ft of surface area was replaced with the fiber reinforced stucco. Columns on each floor of the building were found in an extremely deteriorated state. There was spalled concrete with damaged steel in these members. Concrete was chipped using chipping hammer to get to sound concrete. Sikacrete 211, a pre-bagged concrete, was used to restore these existing columns.

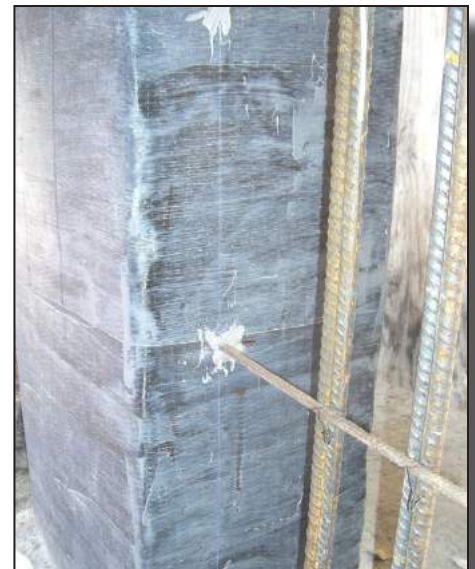
These columns were strengthened with carbon fiber reinforced fabric using SikaWrap 230 C. Columns were strengthened to allow installation of the new window system in the building. Once exposed, the Structural steel I-Beams were found in a precarious condition. Armatec 110 was applied to the steel beams for corrosion prevention and

encased in concrete. The reinforced concrete beam located on the 1st and the 2nd floor was corroding and spalling. These beams were repaired by form and pour and form and pump methods. A total of 1052 cubic feet of concrete, including Sikacrete 211 and cast in place concrete, was used to restore the beams. A total of 1000 linear feet of cornices were recreated and installed to maintain the original architectural look of the building façade. Lack of cover on the rebar, aided by the waterborne chlorides had resulted in active corrosion on the concrete joist and the underside of the concrete slab. Once
