Project Mount Carmel Christian School and Sanctuary Stone Mountain, Georgia

Décor Roof System using 60 mil Sarnafil[®] G410 feltback membranes in copper brown and patina green colors

Décor Roof System Gives Christian Church Peace of Mind

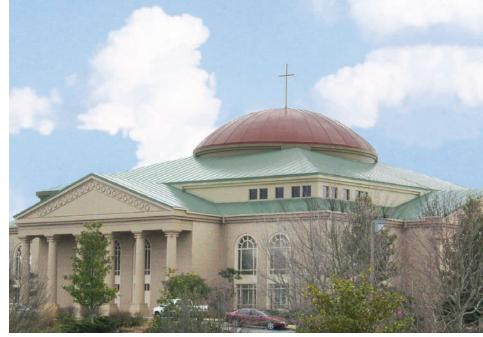
The Mount Carmel Christian School is finally watertight, thanks to the Décor Roof System. In addition to performance, the Décor system delivered style, with the roof having the appearance of a metal roof with standing-seam profiles.
