Project Profile

Century Hill Condos
Century Hill, California

Mechanically attached 60 mil
Sarnafil® S327 membrane in tan

Sika Sarnafil's High Performance Roofs a Comfortable Fit at Luxury Condo

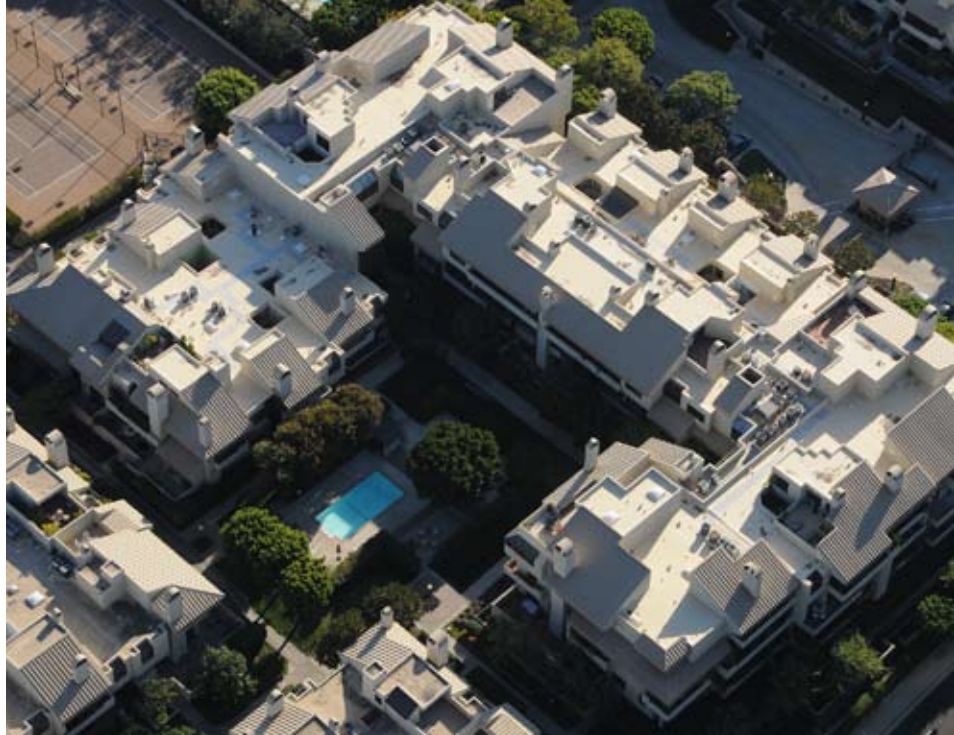
HVAC units – which typically numbered about 40 to 50 per building, also posed a challenge. Scholten had to lift the units off their platforms, install clad metal around all the base flashings, install the 60 mil roofing membrane and weld all around the platforms, install sheet metal caps and seismic straps, and then put the HVAC units back in place. "Some of these units were almost touching the walls, making it very difficult to weld seams in those areas," McDaniels stated.
