SIKA AT WORK

NE 20TH COURT

FORT LAUDERDALE, FLORIDA

FORT LAUDERDALE: WHERE STRENGTH MEETS STYLE

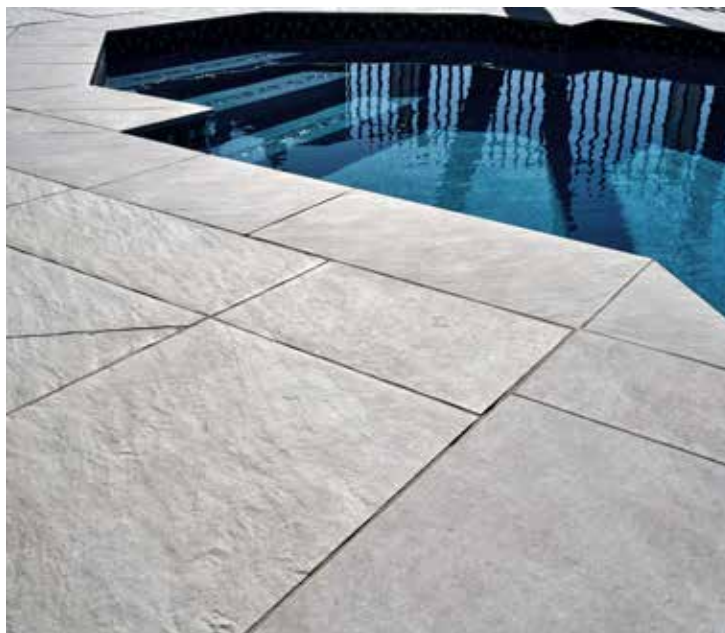
SikaTile®-100 Moisture Guard helps fight efflorescence on the porcelain paver deck.

The team used Merkrete Underlay C to correct the property's slope deficiency. On top of this, SikaTile®-100 Moisture Guard was applied for waterproofing and to combat efflorescence. Johnson explained the choice of product and technique, "This is TCNA F101, which is the standard that we followed for exterior installations. Not everybody follows the TCNA standard. Typically, what would have been done in this situation, and what we see a lot of in Florida, is that this would be a 'Miami sandwich,' which is an incorrect, false mudset done externally. With this, slope is not followed correctly. And one of the biggest challenges we see in Florida is efflorescence based. There's a lot of big projects down here that have efflorescence cascading over the side of it because they use the 'Miami sandwich' to set it."

Johnson continued, "Even take the system that we put together: Underlay C has the Portland-cement material in it, so it has the potential to effloresce. So, we put the Moisture Guard 100 on top of it, which keeps water from getting down and emulsifying the soluble materials, allowing them to dry and come to the surface. So, we are mitigating the effects with that layer."

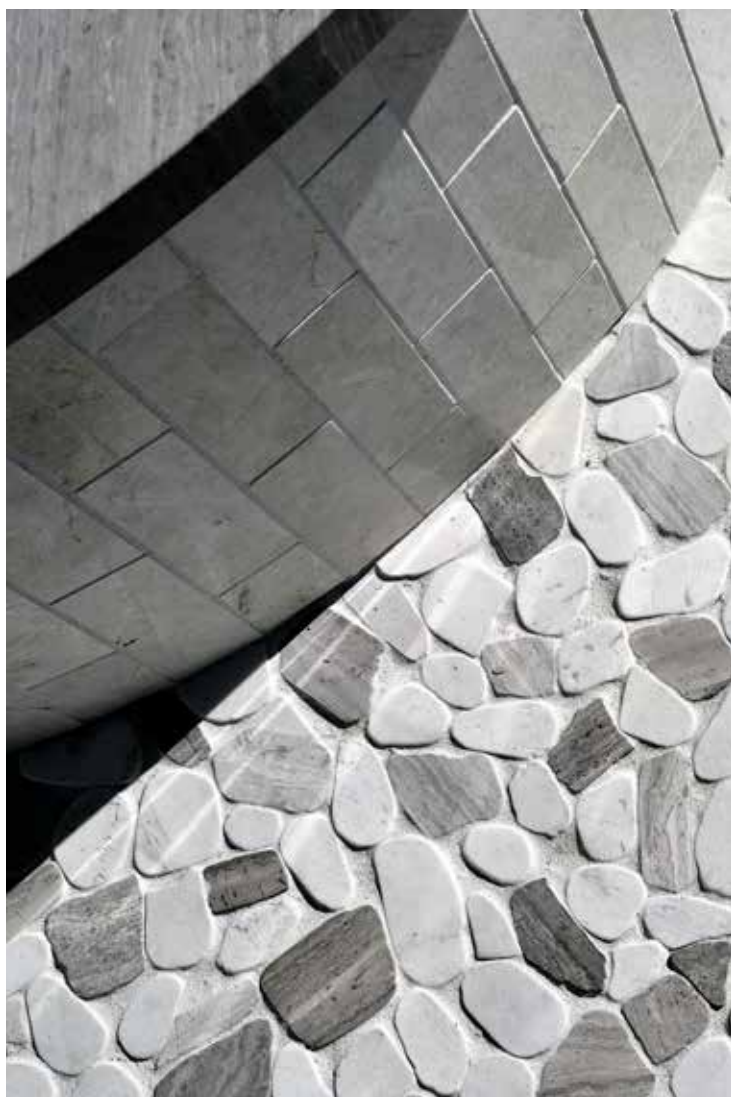
SikaTile®-815 Secure Grout fills the space between the pebbles surrounding the firepit.

SikaTile®-475 LHT Premium Set was used to bond all horizontal and vertical stone and ceramic tile surfaces. The team chose high-performance SikaTile®-815 Secure Grout for bright white color around the tiled fire pit and for the compass rose mosaic at the southwest corner of the property. All the elements of the Sika system restored the form and functionality of the outdoor space.

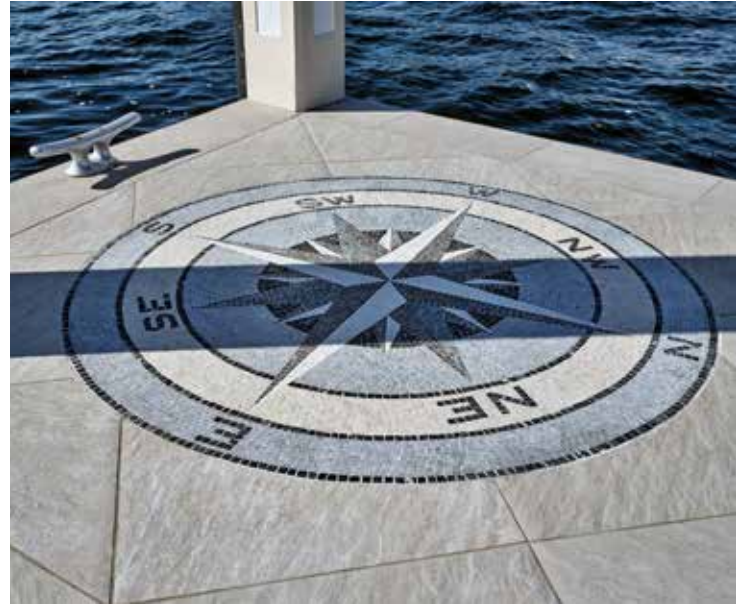
The new mosaic compass rose will withstand decades of Florida’s aggressive weather.

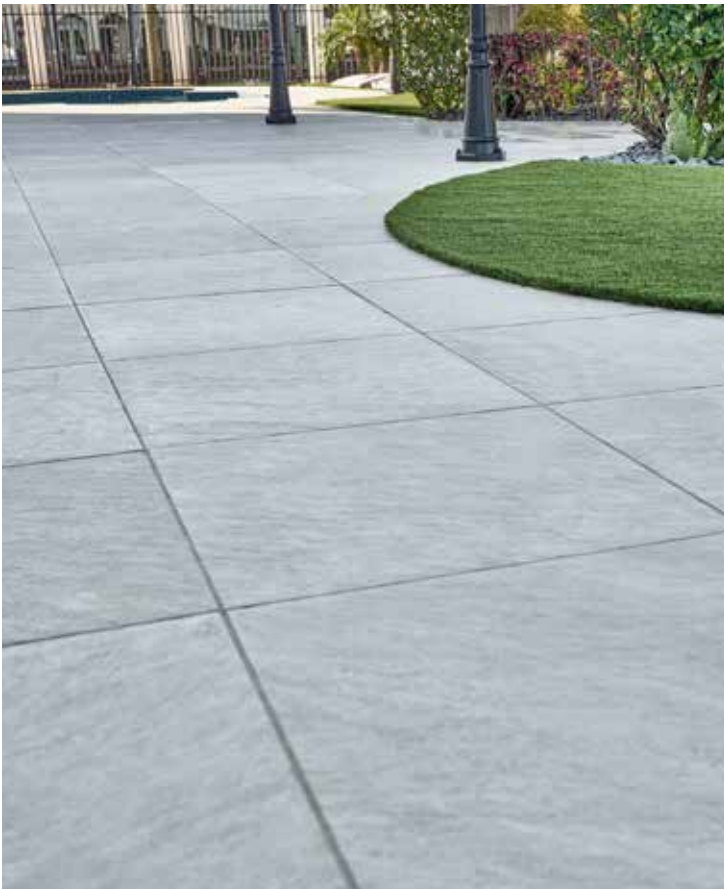
Merkrete Underlay C flattened surface irregularities and established proper slope for drainage.

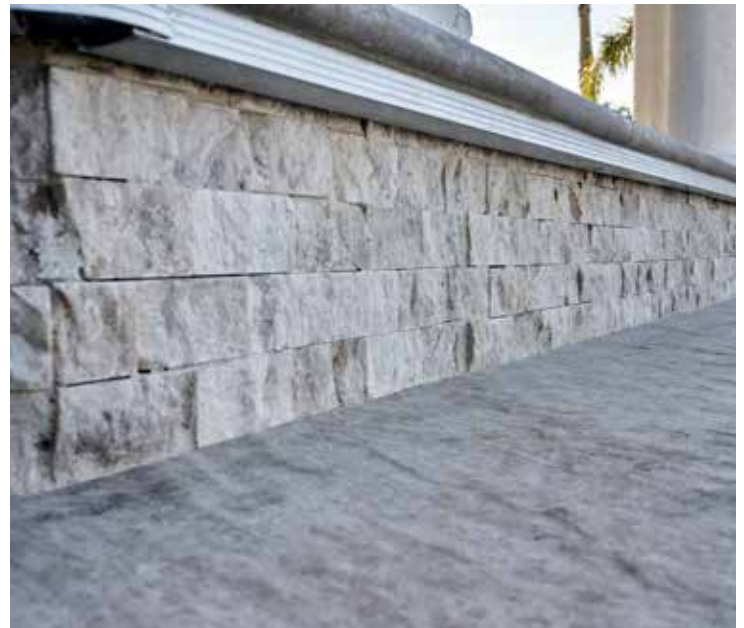
SikaTile®-475 LHT Premium Set was used to set all tile at the Fort Lauderdale property.

With the waterproofing membrane applied, LS Tile Design then used SikaTile®-475 LHT Premium Set for the 2-cm porcelain pavers. SikaTile®-825 Epoxy Grout was worked between the pavers to further combat efflorescence, while SikaSil® N Plus provided the needed expansion joints.
