Pile Restoration

Timber/Concrete Pile Repair

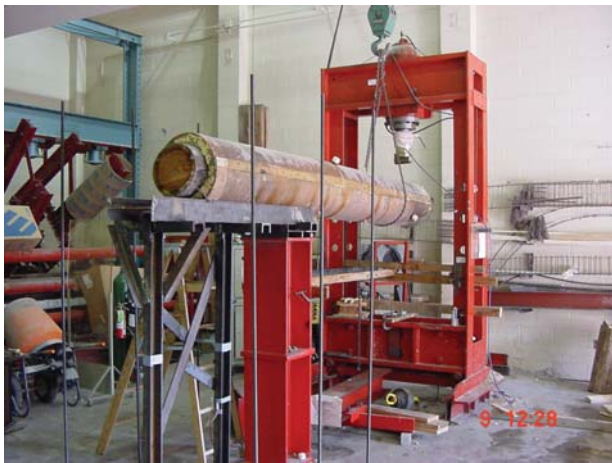
Scenario 1 Dry (Over Land)

Symptoms – Decayed Core, Fungal Attack (Outer Layer Intact)

Preparation of Timber Substrate Base Material – Drill holes (3" diam.) through outer layer to penetrate damaged core. Mechanical removal of loose core material by way of vacuuming, flushing, sawing or other approved means. Allow sound timber to drain and dry. Treat core with anti-fungal solution and/or rods (e.g. Borate). Depending on size of cavities and voids in core, place appropriate sized aggregate as filler material. Plug holes with treated timber dowels. Mechanical removal of all surface contamination such as grease, oil, tar, etc. by way of sand blasting, hydro-blasting, wire brushing or other approved means until a clean sound substrate is achieved.

Sikagard 670W
Protective Acrylic Coating
(Pigmented)

SikaWrap 100G
Structural
Strengthening Fabric

Sikadur 300

Timber Pile

Sikadur Injection Gel
(Optional for Pile Surface Repair)

Drilled Hole
For Filler Aggregate Placement
(Later Plugged with Timber Dowel)

Sikadur 35, HI-MOD LV
Injected Into Filler Aggregate

Timber Pile

Drilled Hole
For Filler Aggregate
Placement (Later Plugged
with Timber Dowel)

Injection Port

Sikadur Injection Gel
(Optional for Pile
Surface Repair)

Removed Port
(After Epoxy Injection)

Drilled Hole
(For Epoxy Injection)

Sikadur 300

SikaWrap 100G
Structural
Strengthening Fabric

Sikagard 670W
Protective Acrylic Coating
(Pigmented)

Sikadur 35, HI-MOD LV
Injected Into Filler Aggregate

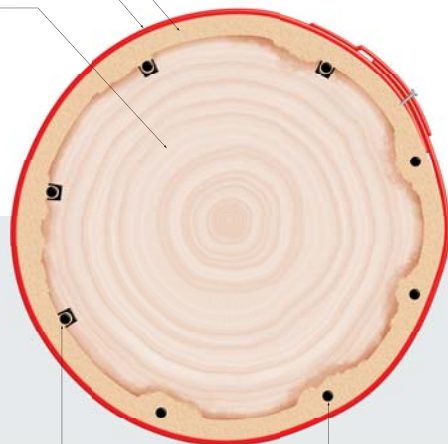
Decayed Timber Pile

Repaired Pile with Epoxy Mortar

Sikadur 35, Hi-Mod LV LPL
Epoxy Mortar

FRP Pile Repair Sleeve

Timber Pile

CarboDur Rod
(Optional - Slotted
into Pile Surface)

CarboDur Rod
(Optional - Within
Epoxy Mortar)

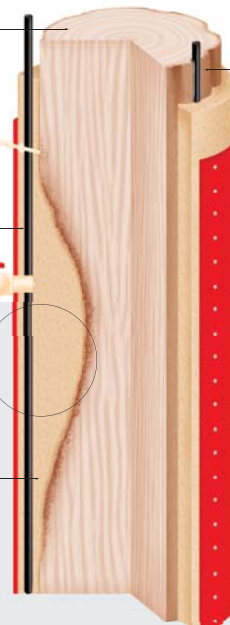
Timber Pile

Adjustable Stand-off
To Provide Annulus

Sika CarboDur Rod
(Optional - within
Epoxy Mortar)

Injection Port

Hour-Glass Effect
Epoxy Mortar Flows
Into Damaged Portion.

Removed Port
(After Epoxy Injection)

Sika CarboDur Rod
(Optional - Slotted
into Pile Surface)

Sikadur 35, Hi-Mod LV LPL
Epoxy Mortar

FRP Pile
Repair Sleeve

Scenario 2 Wet (Submerged Marine Environment)

Symptoms – Marine Borer Infestation, Rot Decay in Tidal Zones, “Hour-Glass” Deterioration

Preparation of Timber Substrate Base Material – Mechanical removal of loose material and all surface contamination such as grease, oil, tar, marine organisms, etc. by way of hydro-blasting, sawing, wire brushing and other approved means until a clean, sound timber substrate is achieved.

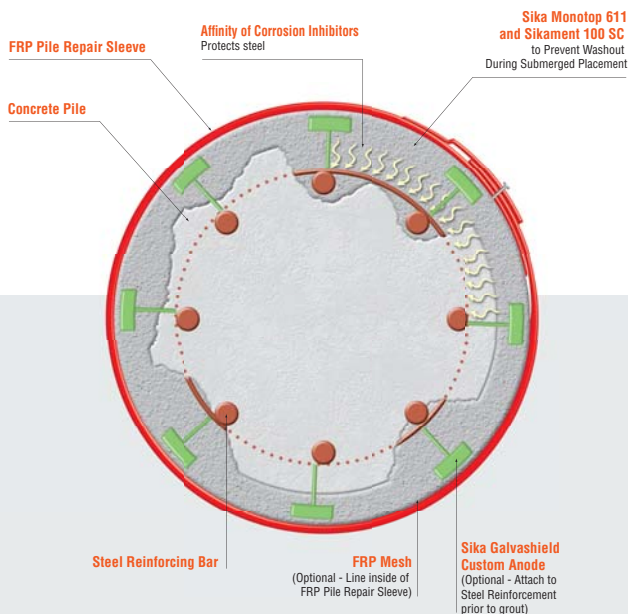
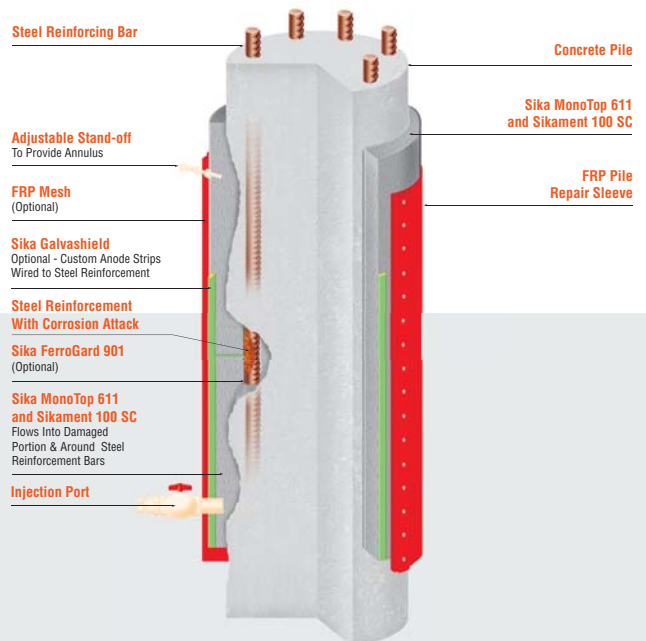
Repair Mortar with Anti-Wash-Out Admixture

Hardened repair material, underwater.
Cross Section of Repaired Pile.
Repair Material Thickness = 1.5" - 2"

Scenario 3 Wet (Marine Environment) Symptoms – Spalling, Corrosion of Reinforcement

Preparation of Concrete Substrate Base Material – Mechanical removal of loose material and all surface contamination such as laitance, grease, oil, tar, etc. by way of shot blasting, scarifying, sand blasting, hydro-blasting, grinding, wire brushing or other approved means until a clean, sound concrete substrate is achieved.
