**Bridge Hwy/Ramps/Aviation/Airport**

**Repair and Waterproofing**

<b>Project:</b>	ITTS 3rd Level Roadway Strengthening at Honolulu International Airport
<b>Owner:</b>	State of Hawaii, Department of Transportation
<b>Specifier:</b>	Wilson Okamoto Corporation
<b>Contractor:</b>	Kiewit Pacific
<b>Year:</b>	2002

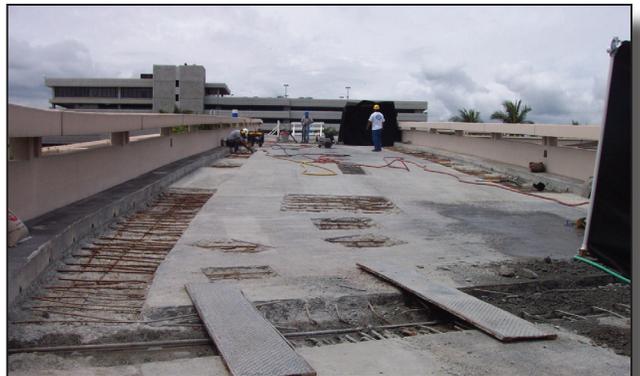
After approximately 35 years of service, the elevated roadway decks and ramps showed signs of deterioration with a significant amount of cracking, spalling and delamination. The reasons for this deterioration include: corrosion of the embedded reinforcement due to chloride attack from the salt air environment, water intrusion, and lack of concrete cover. Concrete cover over the rebar was further reduced over the years by the repeated number of groves that had been tined in the steep ramps. The groves that were tined at the time of construction wore out and repeated saw cuts were made to maintain the groves. This was necessary to provide skid resistance on a 15% slope for the buses operating during Hawaii's tropical rain showers.

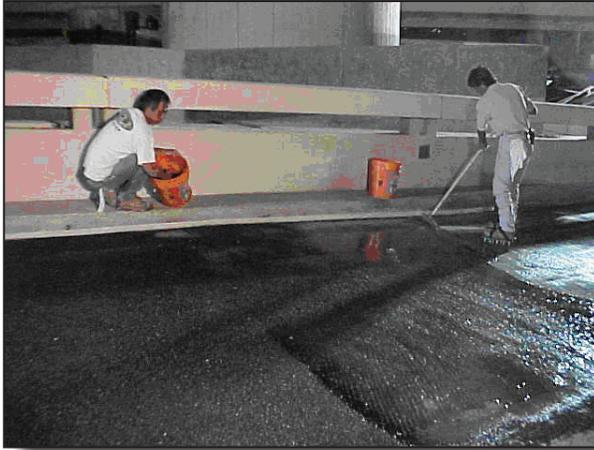
Sika Armatec 110 was chosen as the anti-corrosion coating for exposed steel reinforcement. A total of 8 cu.yds of small to medium sized spalls were repaired with Sika Roadway Patch 2000. Larger spalls amounting to almost 200 cu.yds were repaired with ready mix concrete fortified with Sika Rapid-1 for rapid strength gain. A two inch overlay was considered for adding concrete cover. However, the 1970's vintage structure did not have capacity for the additional dead load. Structural upgrades were considered but ruled out due to financial constraints.

The Sikadur 22 Lo-Mod Epoxy Broadcast Overlay System was chosen for its ability to add effective cover, waterproof the deck and provide a robust skid resistant surface. These benefits were achieved without adding significant dead load to the ramp areas over the 23,000 sq.ft area. A double broadcast system was employed using a locally sourced reflective #8 copper slag aggregate that provided excellent abrasion and skid resistant. This local aggregate was instrumental in enhancing the appearance of the old ramps by masking typical oils stains and tire marks. Its color and texture remind arriving passengers of the lava flows that created the islands.
