Taholah Education Center
Taholah, Washington

Adhered Sarnafil® Roof System,
using lead grey, 60 mil
G410 membrane

With Sarnafil® Adhered System, Taholah School Is "Dressed For Success"

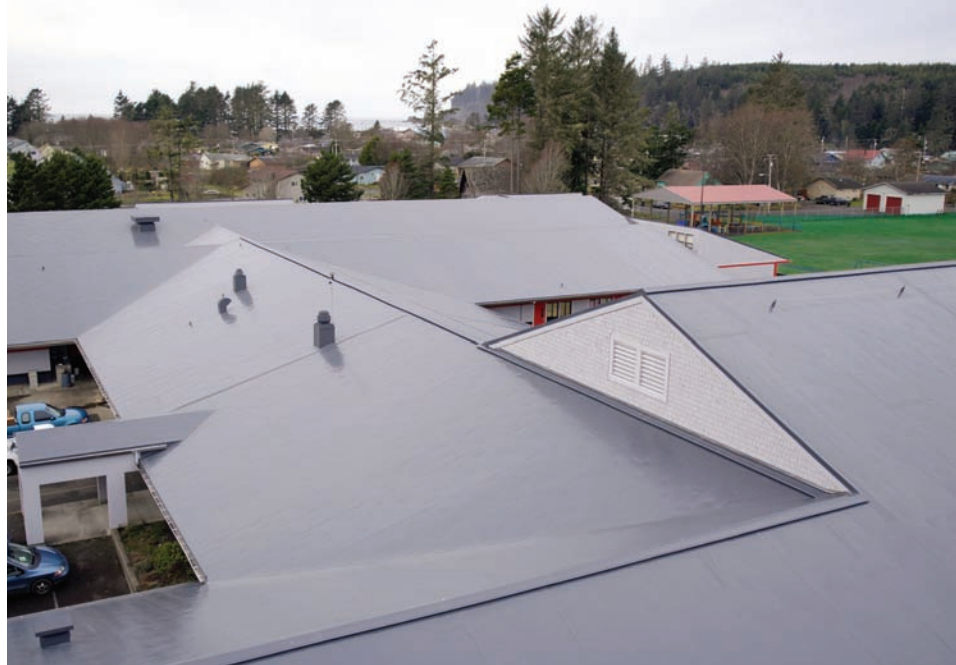
The Taholah School of Taholah, Washington is situated right on the ocean and experiences very high winds and driving rains. The area also gets about 100 inches of rain per year — all factors which prompted the need for a watertight roofing system.
