CONCRETE PROTECTION

RANDALL KRATZ – DISTRICT MANAGER MD/DC/VA
SIKA CORPORATION – REFURBISHMENT, SEALING & BONDING
WITH SIKA SINCE 1991
GRADUATE DREXEL UNIVERSITY - COMMERCE & ENGINEERING
410-336-3757

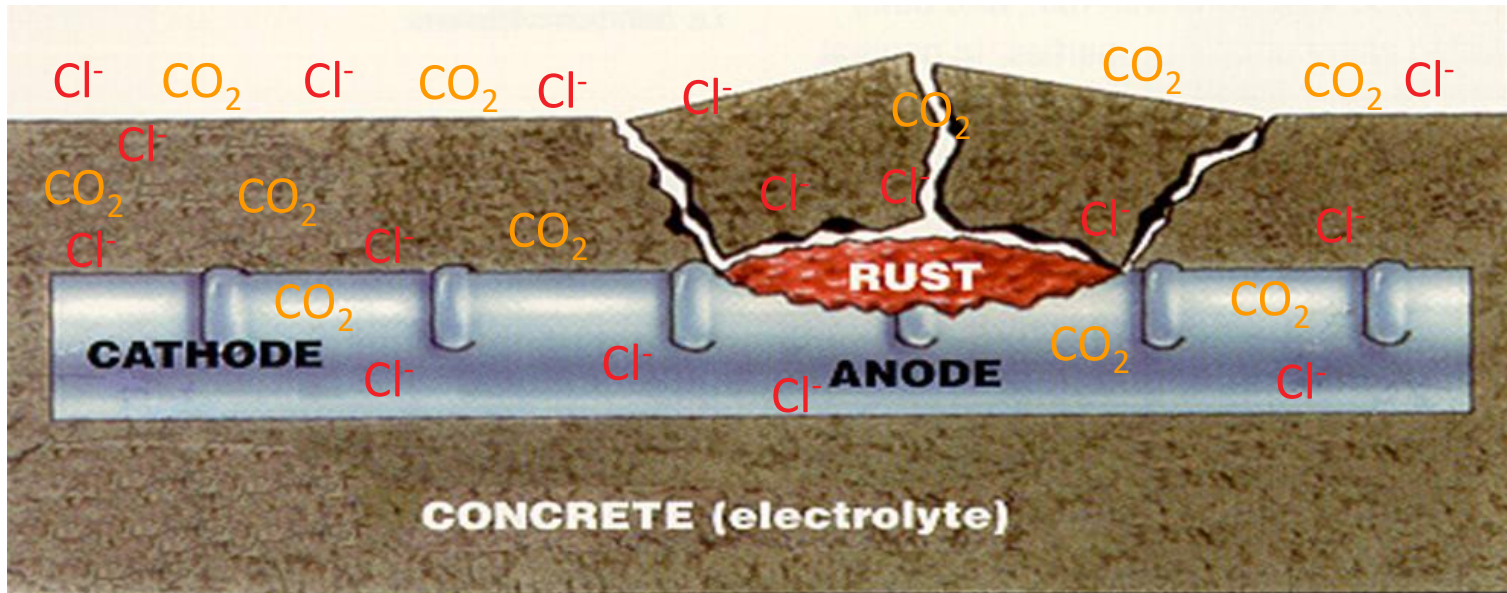
ROOT CAUSES OF REINFORCEMENT CORROSION

- Chlorides and carbonation destroy the passivating layer
- Available moisture and oxygen corrode steel
- As steel corrodes it expands causing cracking and spalling of the concrete

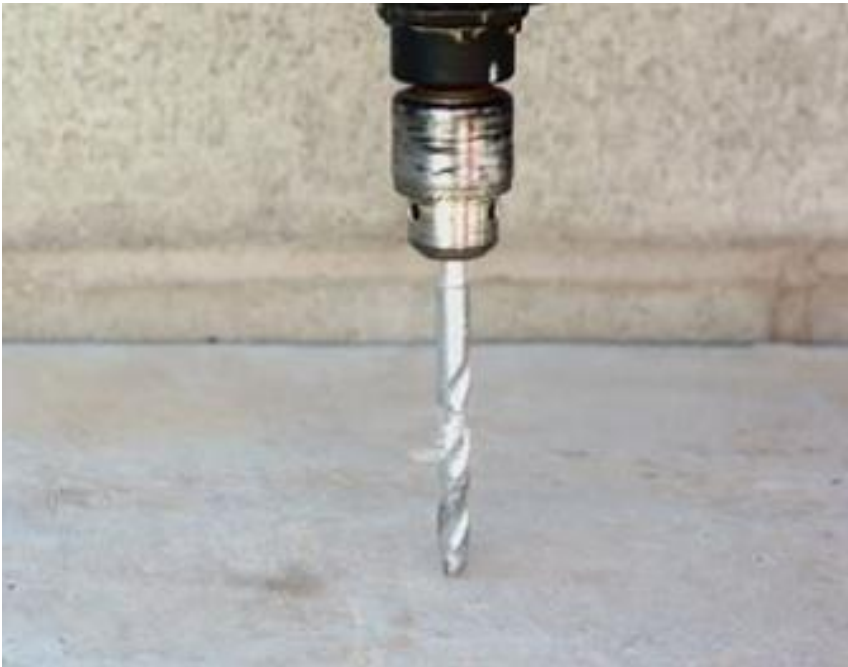
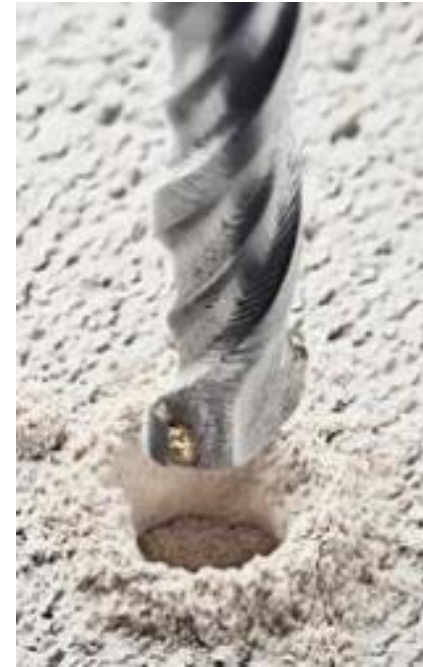
- ✓ Tested using AASHTO T260 (total-acid soluble, free-water soluble)

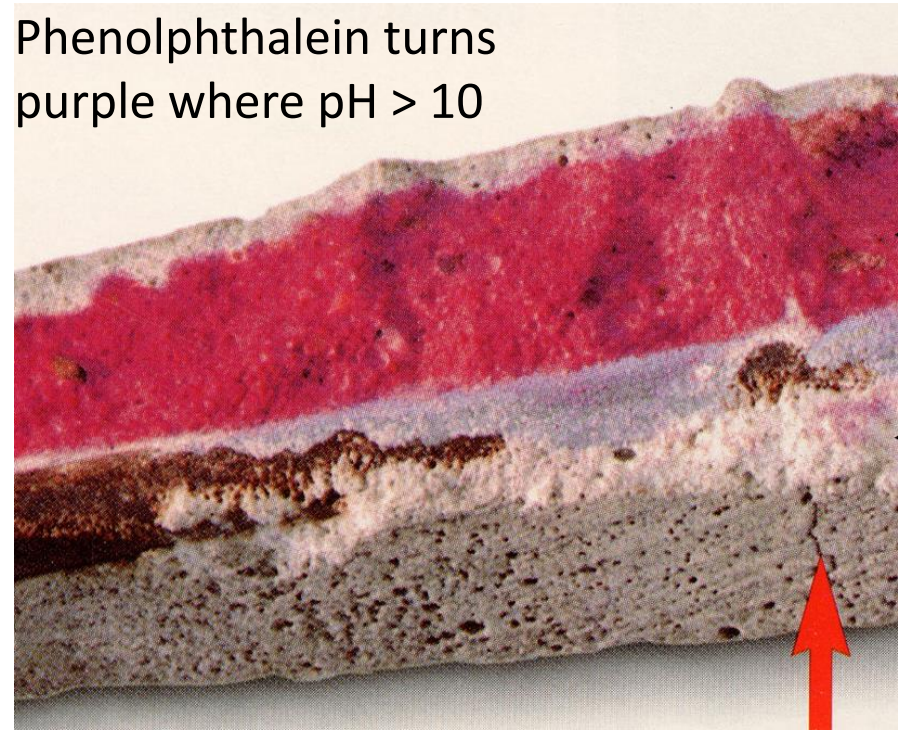
CARBONATION-INDUCED CORROSION

Phenolphthalein turns
purple where pH > 10

- $\text{Ca(OH)}_2 + \text{CO}_2 \rightarrow \text{CaCO}_3 + \text{H}_2\text{O}$
- RH 50-70 is optimal for carbonation
- Concrete 'carbonated' when pH < 10

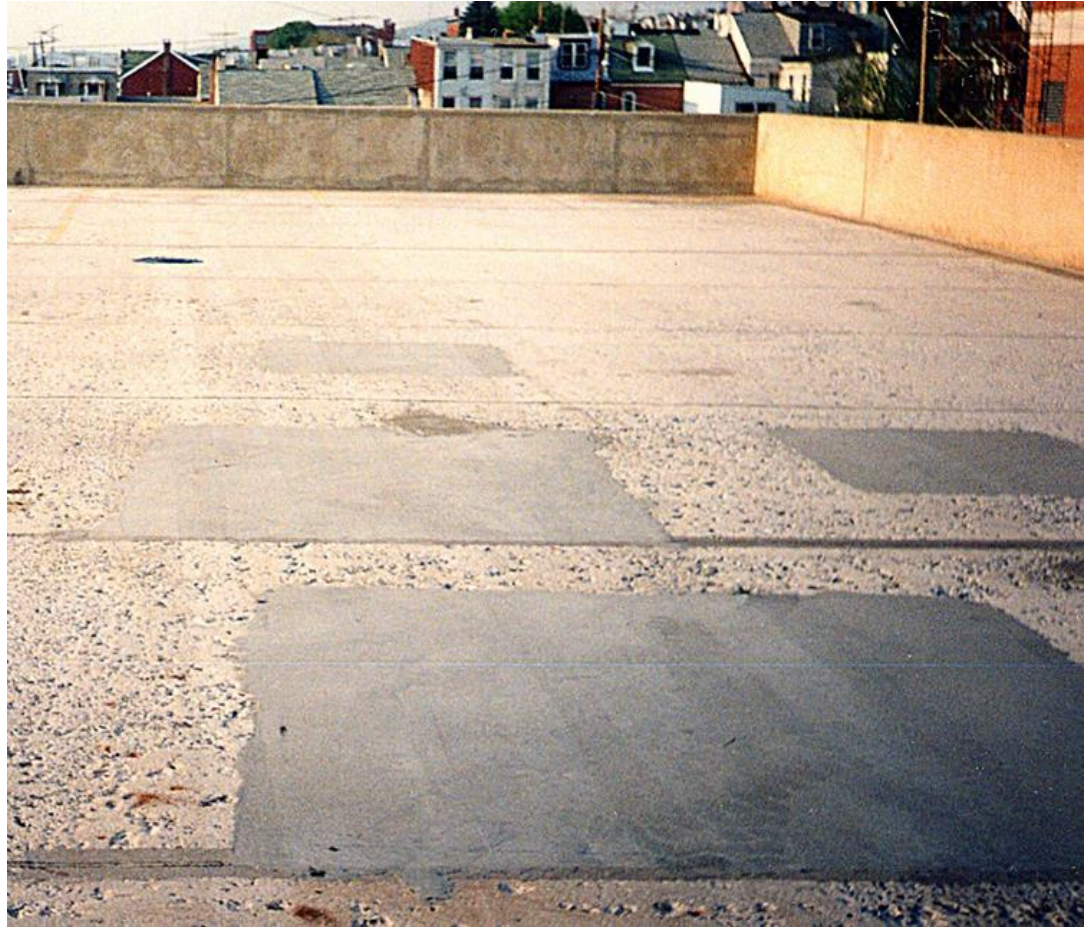
- Reinforcement is existing in contaminated concrete
- Repairs create anodic ring or halo effect driving more corrosion activity around the repairs
- Matter of time until corrosion generates forces to crack and spall the concrete
- Often 3–5-year cycles of significant spalling
- Treat the latent (unseen) corrosion now to prevent/reduce future damage

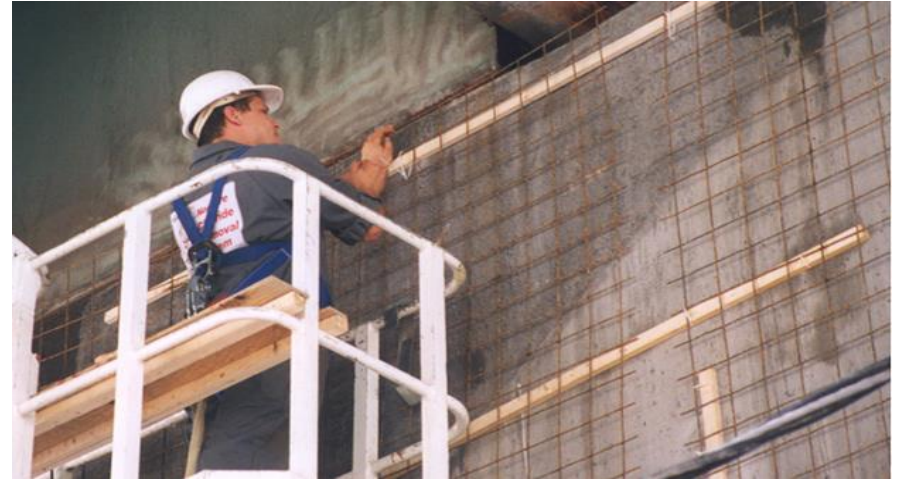
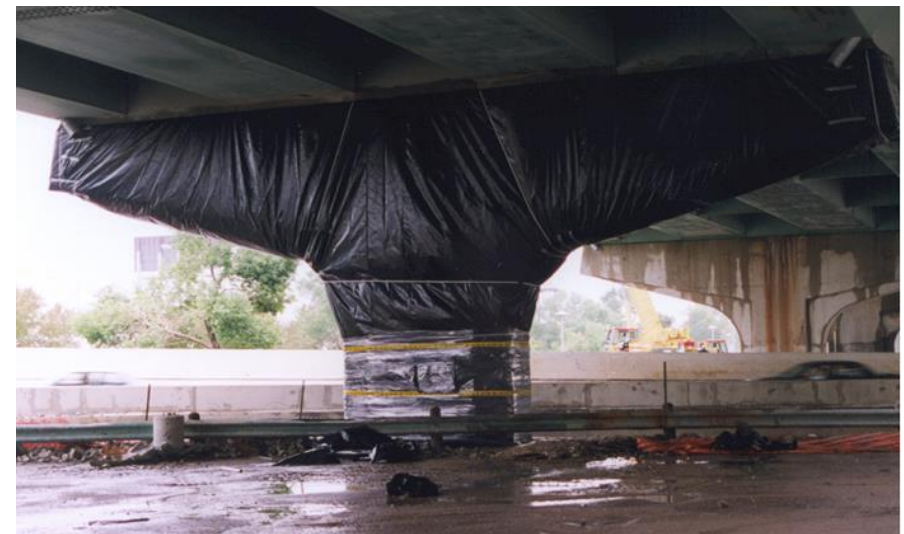
- Current flows between cathode and anode through steel and concrete
- Electrical current flow is governed by Ohm's Law
- $V = IR$ Potential Difference (V) = Current (I) x Resistance (R)
- $V = IR$ Current (I) is the concern
- $I = V/R$ Current (I) = Potential Difference (V) / Resistance (R)
- To lower Current (I), increase Resistance (R)

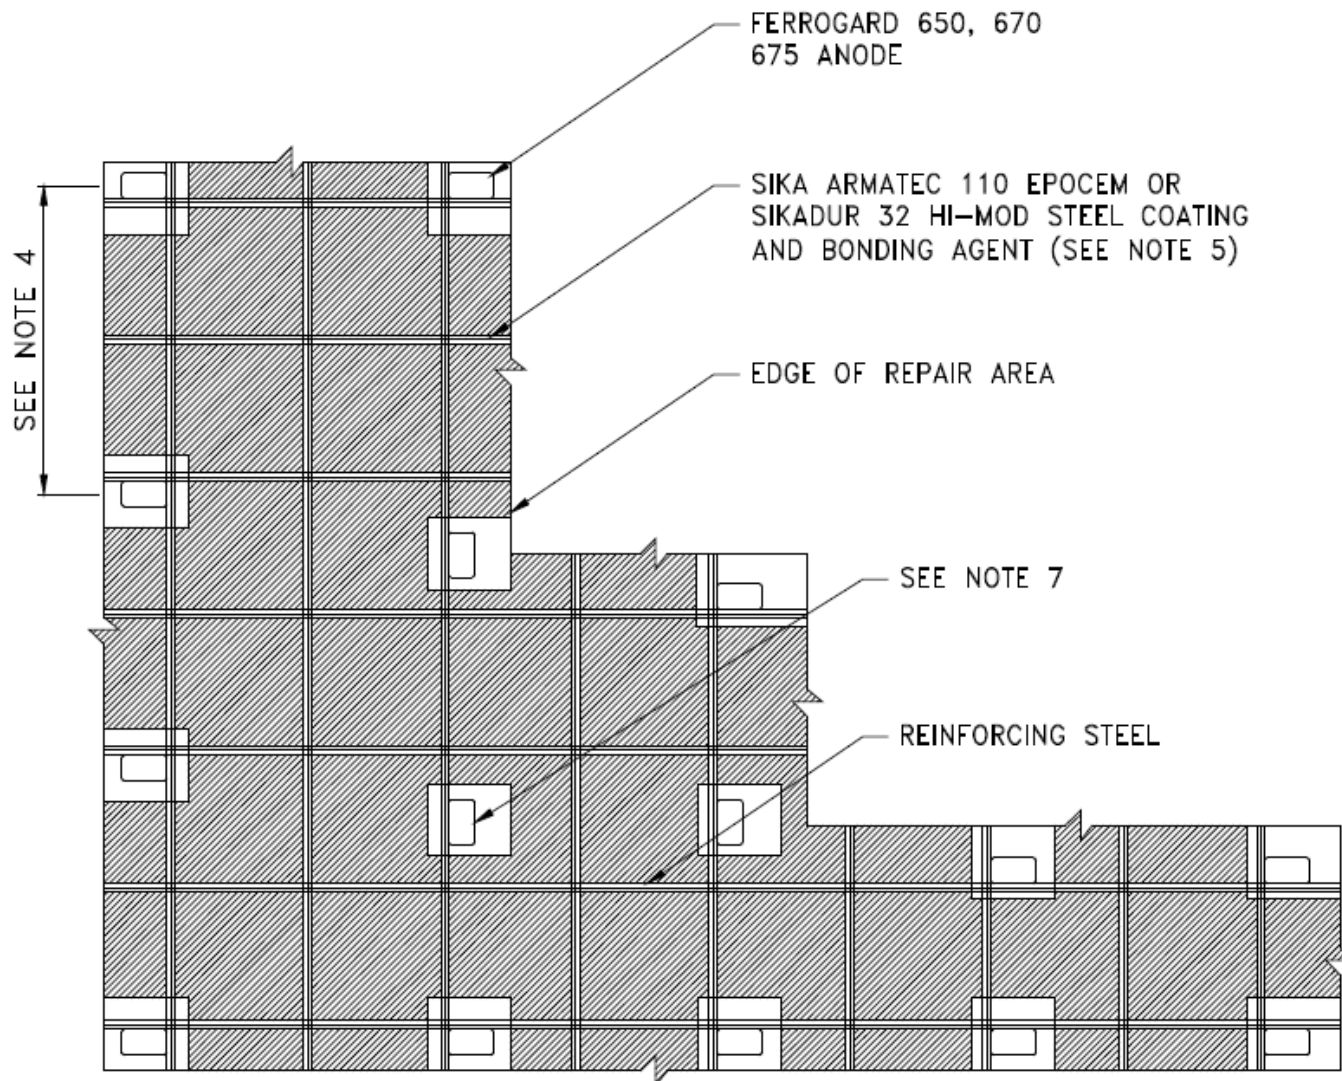
TYPICAL LAYOUT FOR SLAB REPAIR

1. Remove unsound concrete
2. Clean/replace corroded steel
3. Ensure continuity of steel with tie wires
4. Attach anodes to clean steel and verify connection with ohmmeter
5. Do not apply steel coating or bonding agent within 1" of anodes
6. Install repair material
7. Anodes typically installed around perimeter (interior if steel in contamination)

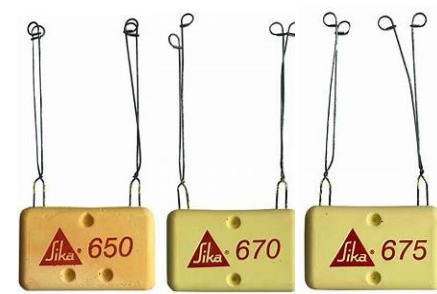
- Zinc core corrodes rather than rebar
- Protects reinforcement just outside the repair area
- Treats the halo/anodic ring/incipient anode effect
- Could also be spaced throughout a large area

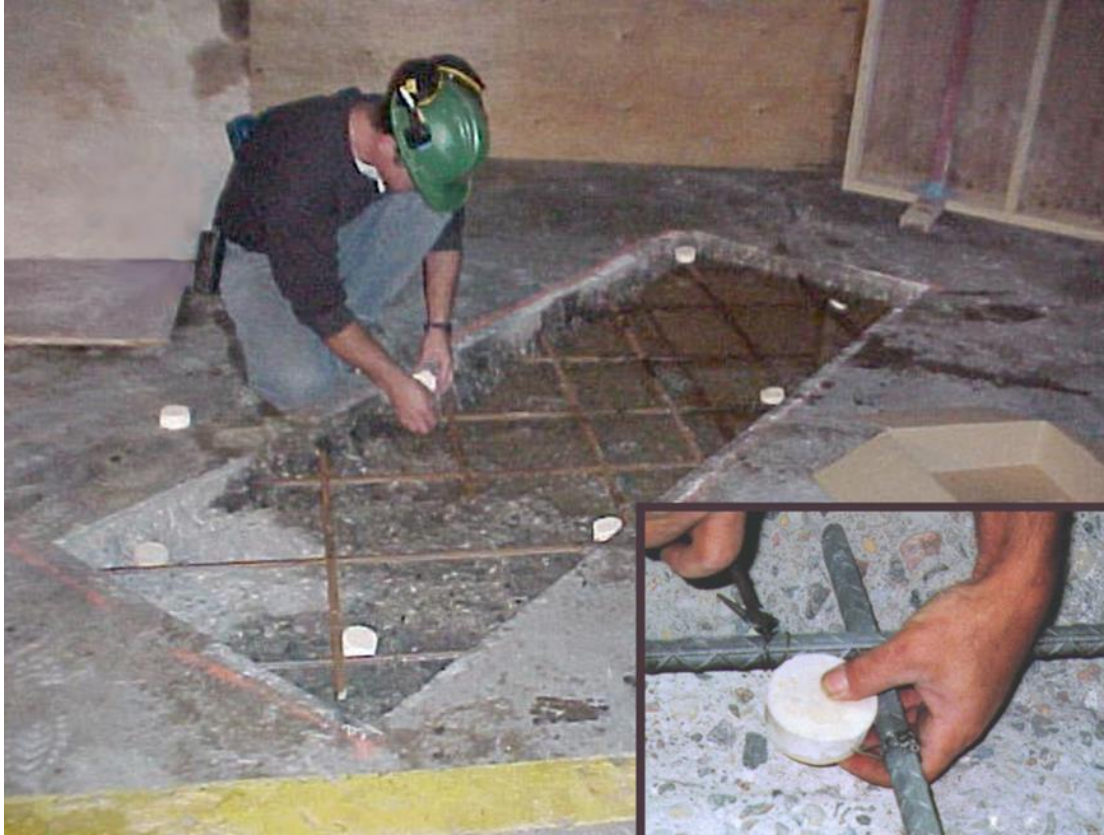
SIKA FERROGARD 650/670/675

- Spacing based on steel density ratio and service environment (see PDS)
- Spacing usually 18-30" around perimeter
- Use on interior area of repair if reinforcement in contaminated concrete
- Verify continuity of repair area steel with DC resistance $\leq 1\Omega$

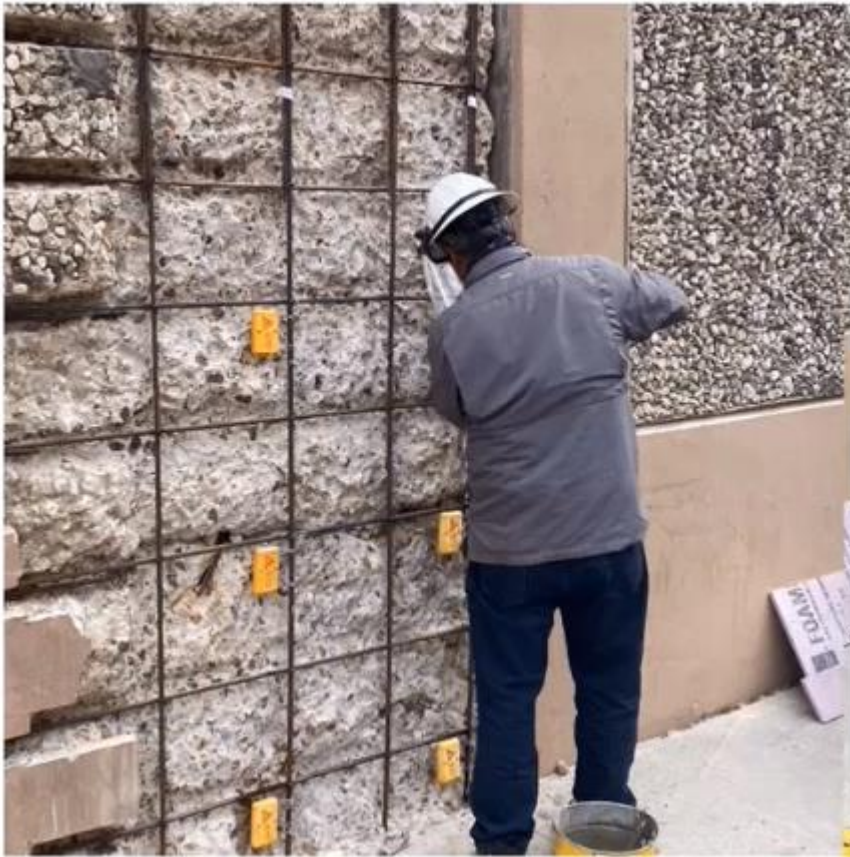
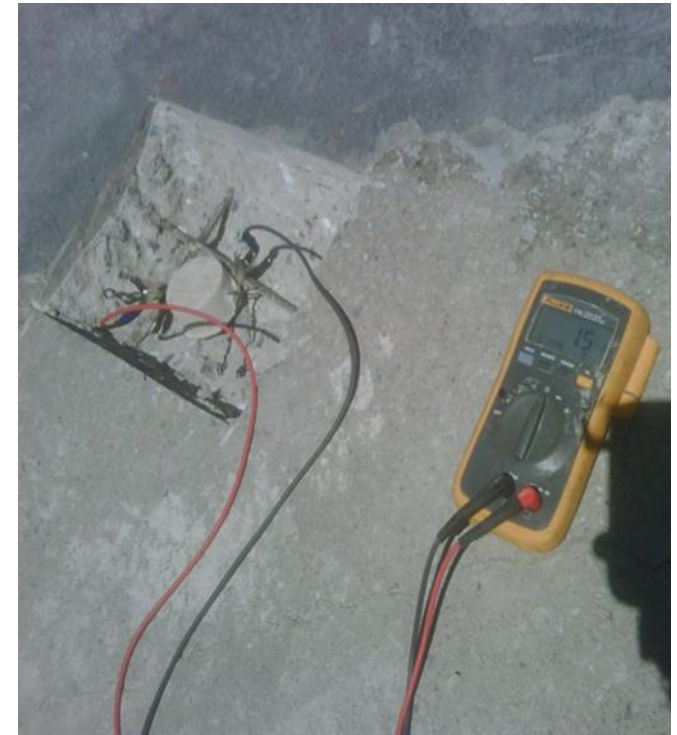
SIKA FERROGARD 650/670/675

- Spacing based on steel density ratio and service environment (see PDS)
- Spacing usually 18-30" around perimeter
- Use on interior area of repair if reinforcement in contaminated concrete
- Verify continuity of repair area steel with DC resistance $\leq 1\Omega$

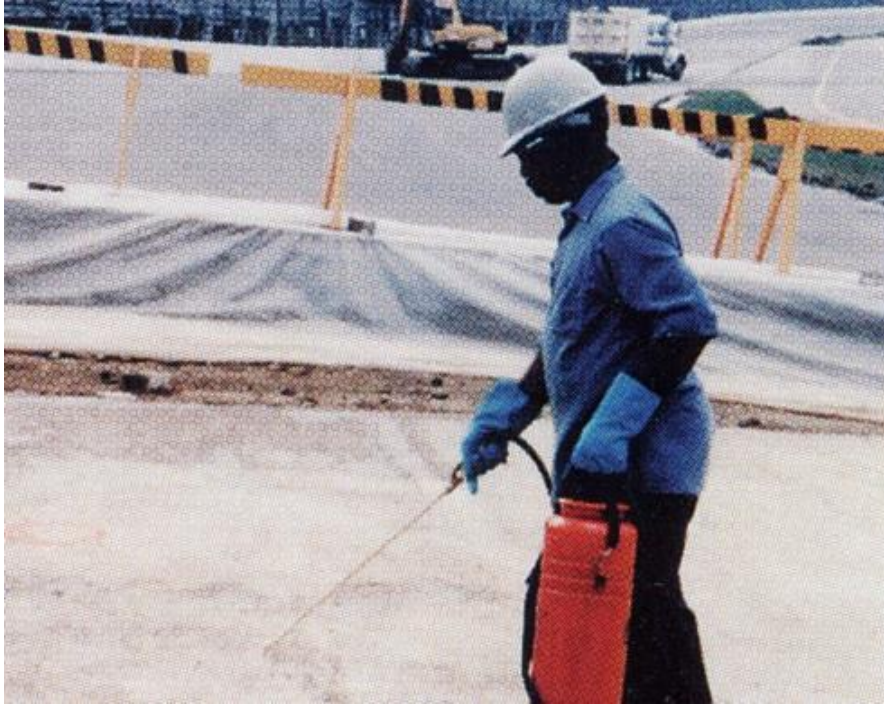
Indianapolis Motor Speedway

- Spray corrosion inhibitor on surface
- Migrates to coat embedded reinforcement within 3" of surface
- Treats latent corrosion activity mitigating cracking and spalling
- Economical treatment to avoid expensive repairs

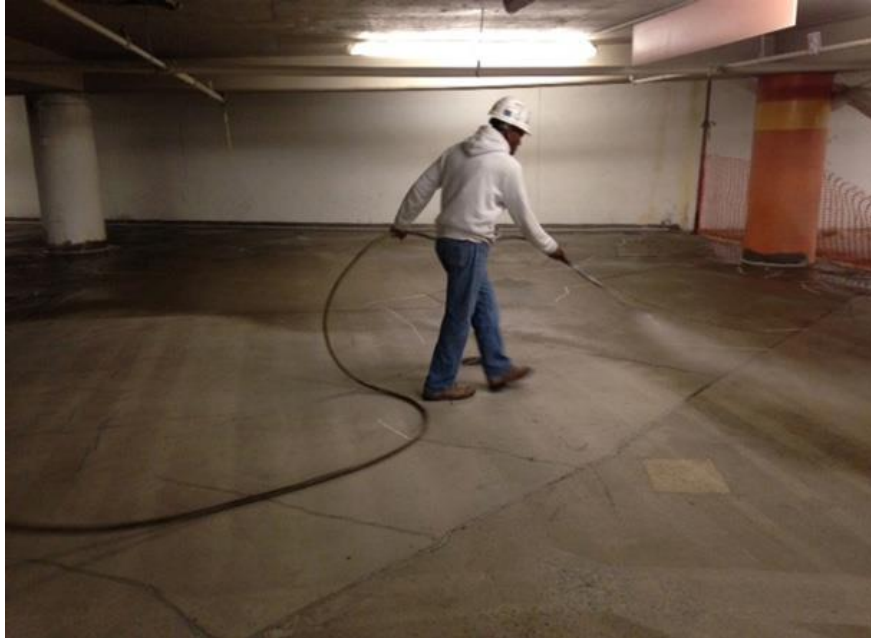
SIKA FERROGARD 903 MIGRATING CORROSION INHIBITOR

- Clean, dry, open-pore substrate
- 100 sf/gal coverage rate
- Decks best at (2) 200 sf/gal coats
- Walls/OH best at (3) 300 sf/gal coats
- Next coat as soon as previous is dry

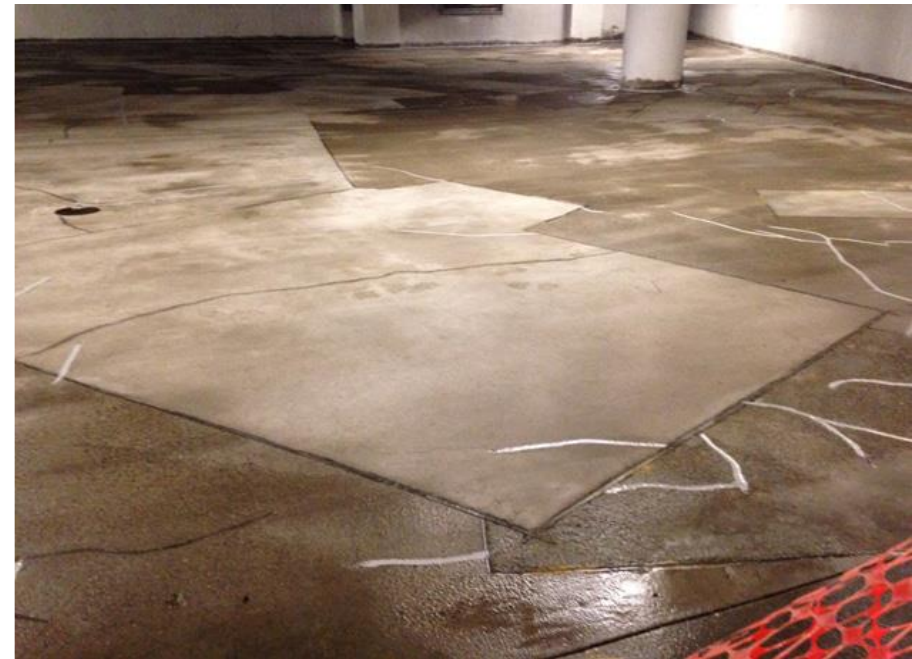
Mazza Gallerie, DC 2014

- Prepare concrete for the coating
- Let inhibitor migrate for 24 hours
- Remove surface residue with water
- Allow concrete to dry for coating

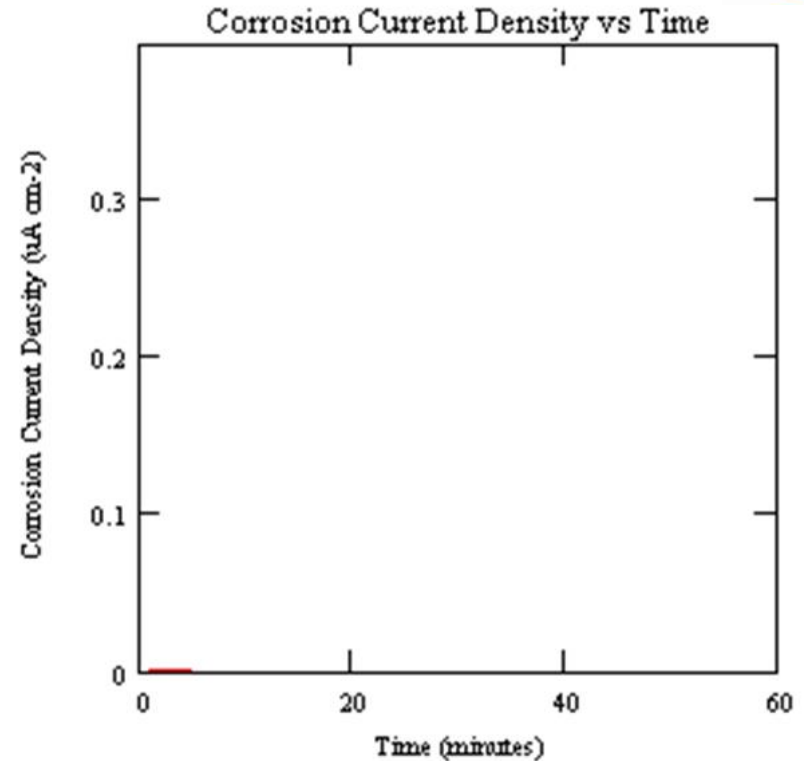
- Steel plate to have chloride solution applied to it
- Corrosion current to be measured

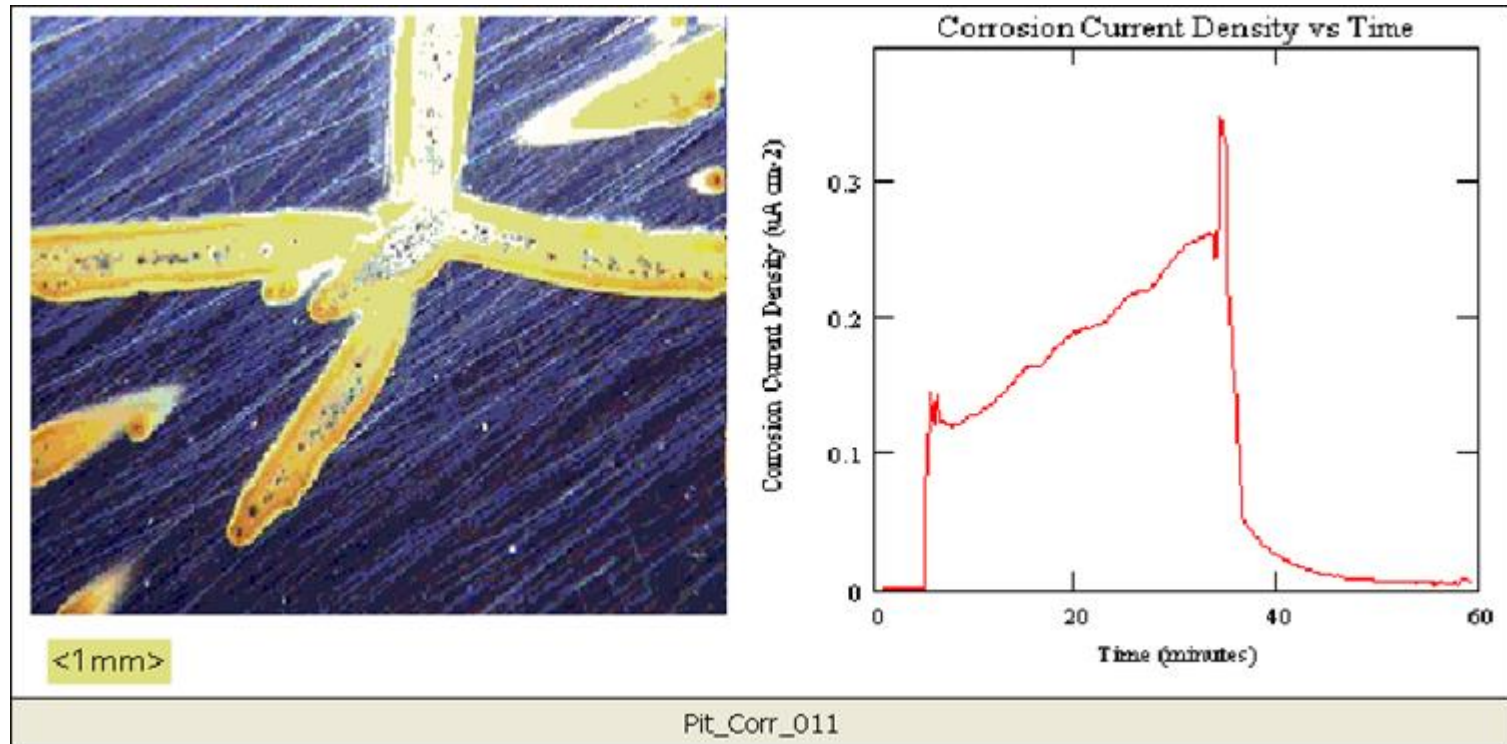
SIKA FERROGARD 903

- Corrosion begins on plate and current increases
- Inhibitor is introduced, sudden spike
- Inhibitor displaces chlorides and attaches to steel
- The barrier coating protects steel and current is mitigated

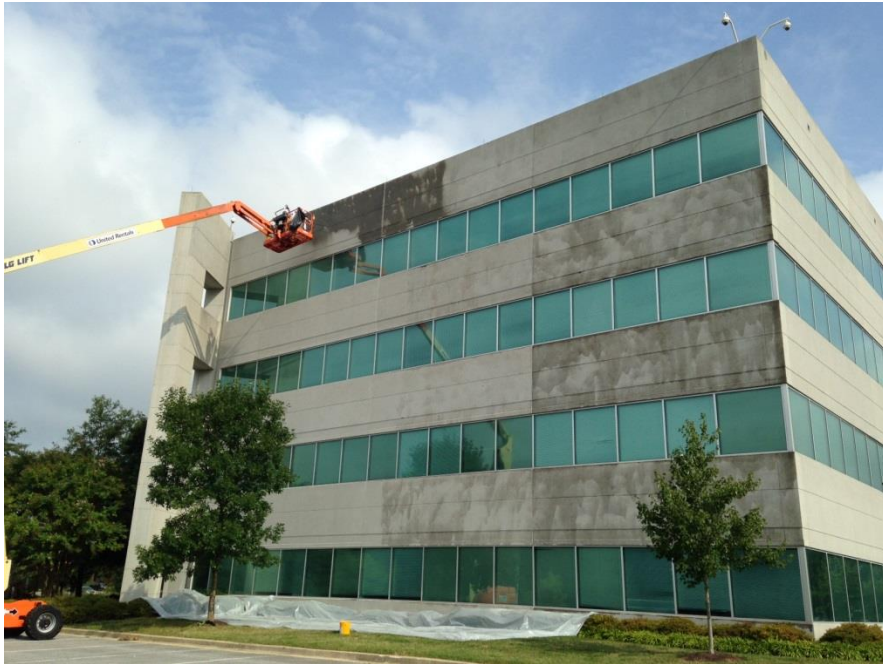
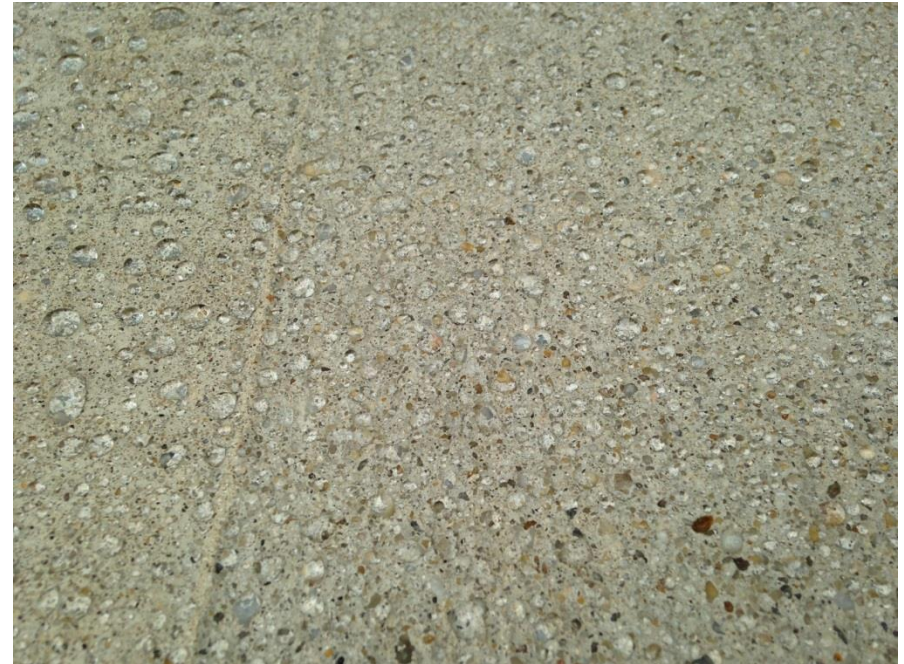
Corporate Blvd, Linthicum Heights MD 2014

- Repel water and chlorides (screens out about 85%)
- Improve freeze/thaw resistance
- Do not alter appearance (keep cleaner)

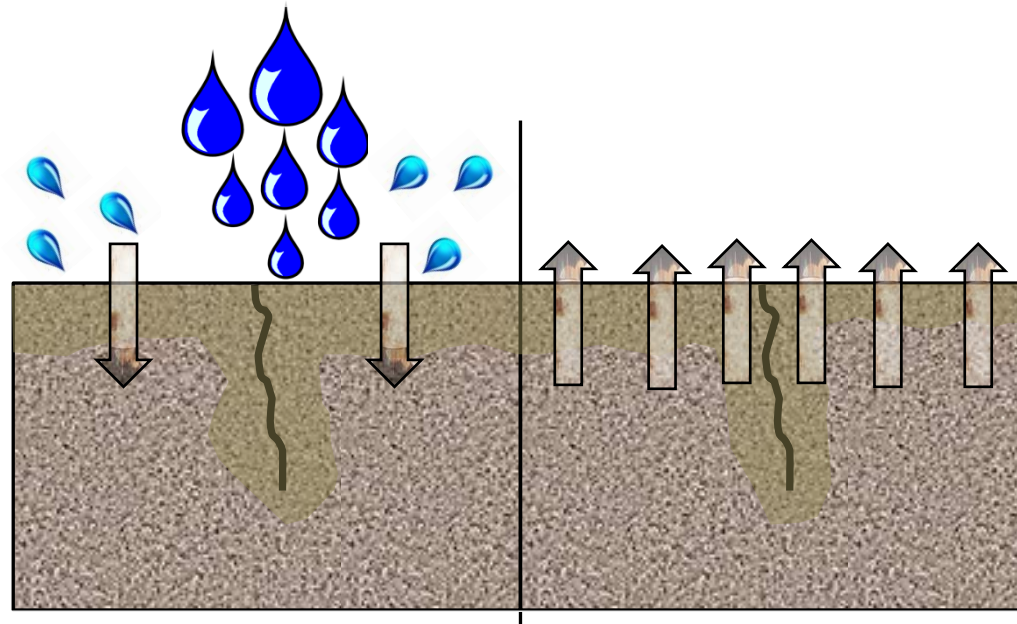
SIKAGARD SEALERS – DRYING EFFECT

Silane penetrates for several millimetres in the concrete and along cracks

Net effect: Relative humidity of the concrete decreases

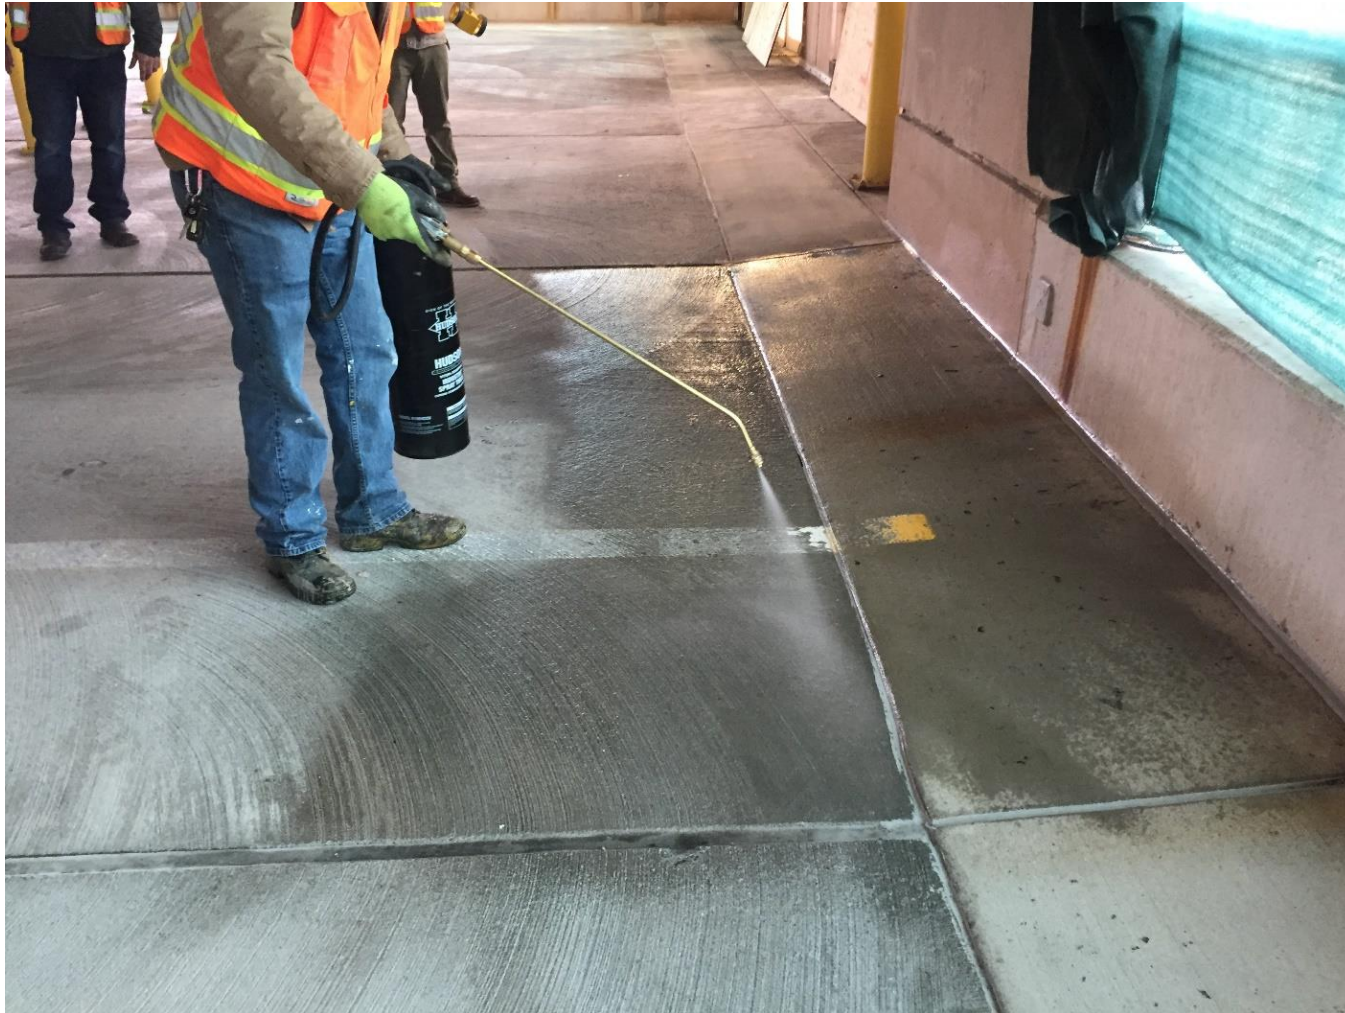
SIKAGARD SILANE SEALERS

- 40% ~ ¼" penetration
- 100% ~ ½" penetration
- 100% silane best for traffic decks to resist hydrostatic pressure
- Simple pump sprayer application

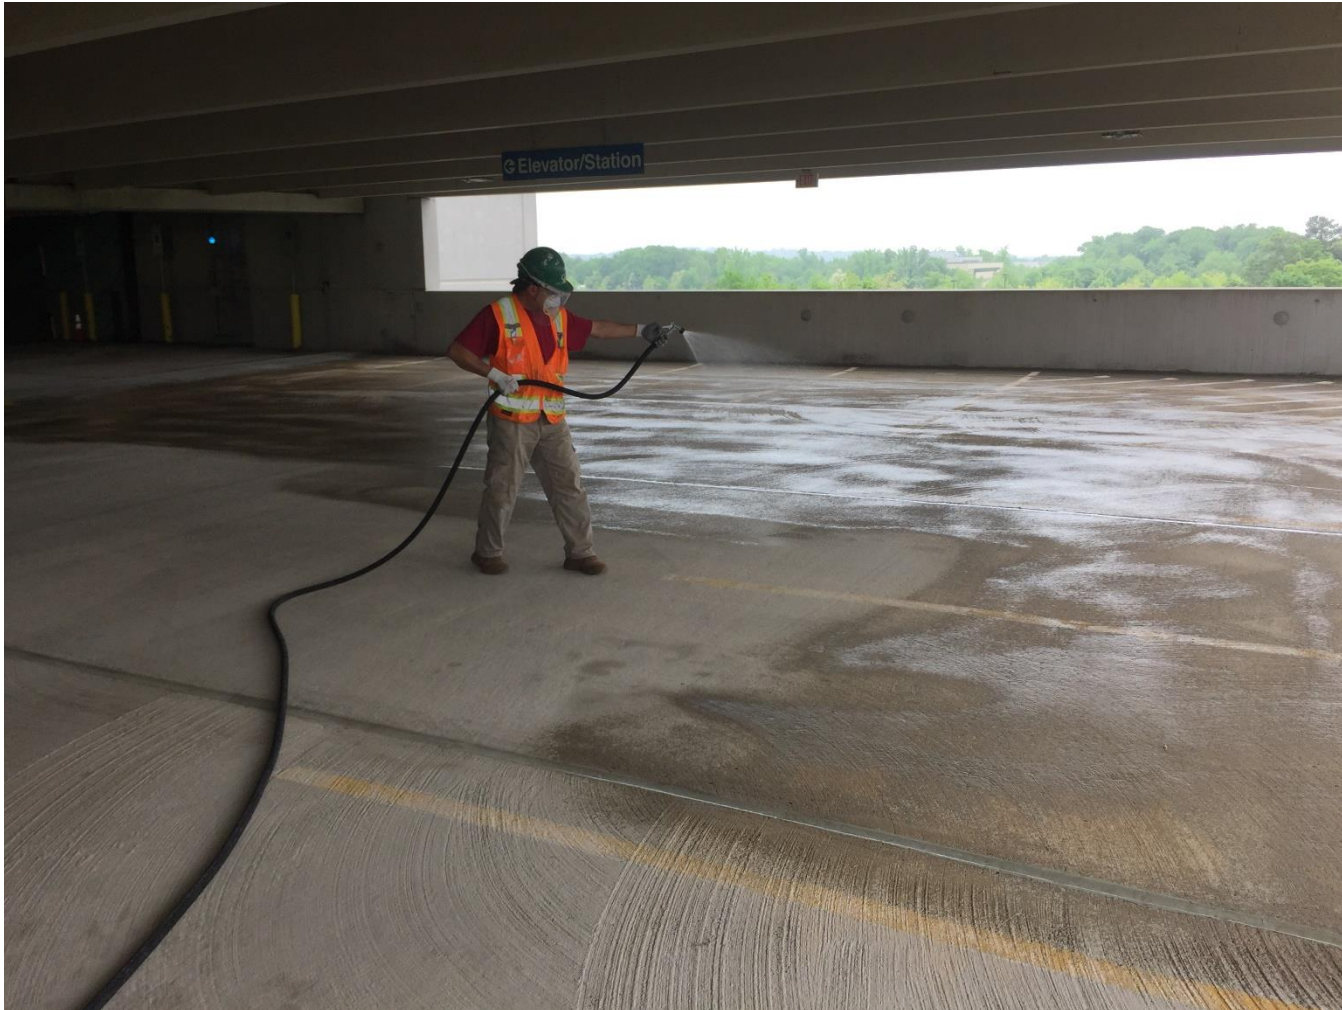
SIKAGARD SILANE SEALERS

- Drum pump sprayer for higher production
- Coat evenly and avoid puddling
- NCHP 244 testing done at 125 sf/gal total consumption
- Decks done best with 2 coats
- Walls/OH best with 3 coats

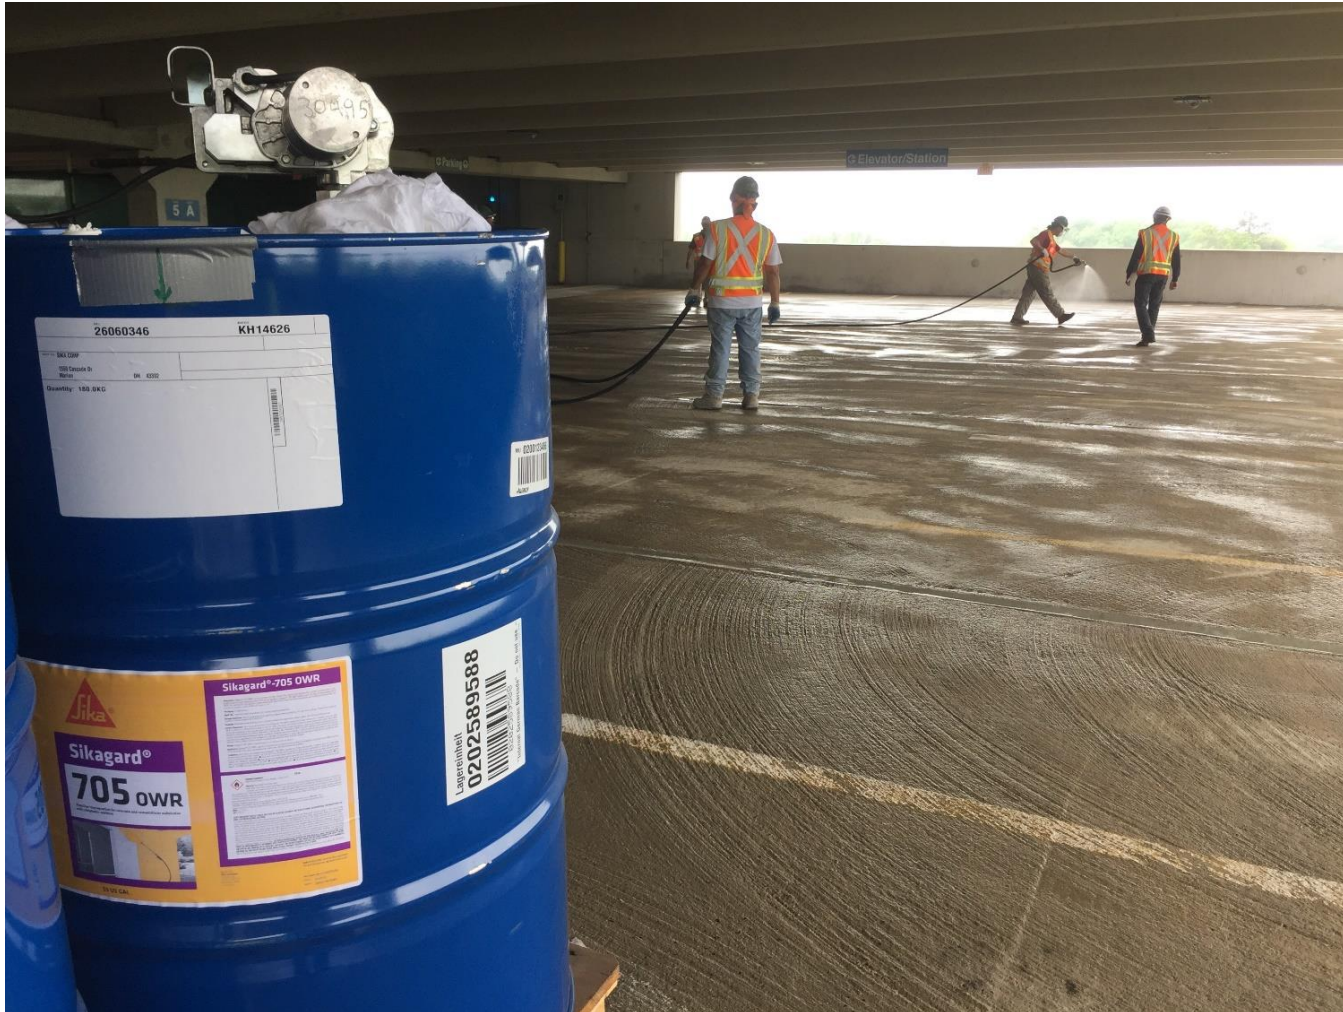
- Can apply next coat as soon as surface is dry (not glistening)
- Blow or broom out any puddles
- Completely dry in ~ 6 hours and ready for service

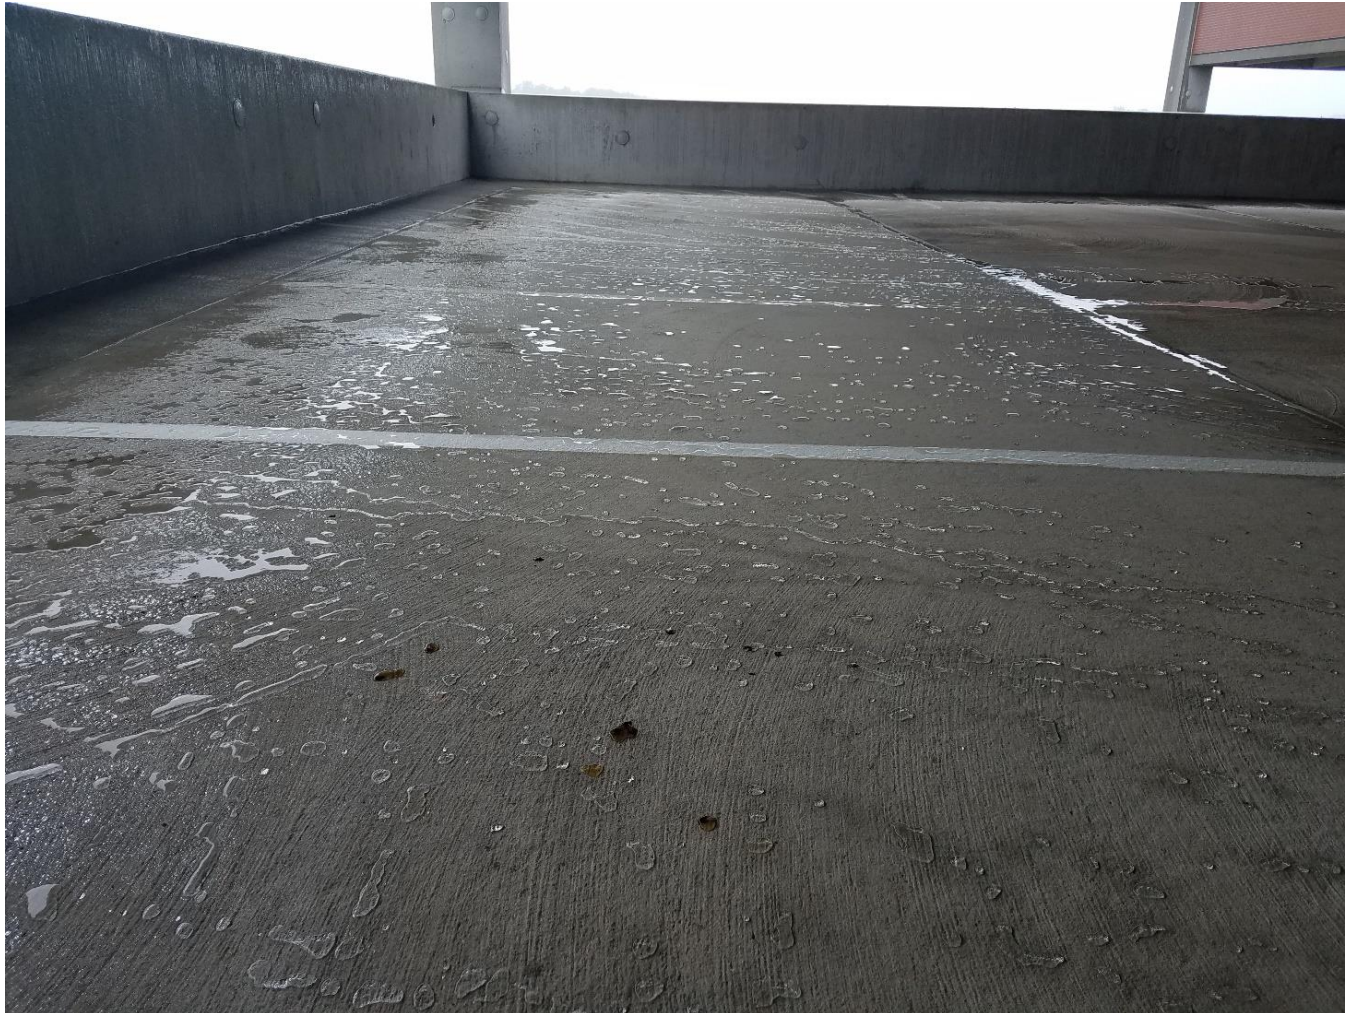
WMATA North Largo Metro Garage, 2018

- Excellent repellency of both water and oil with Sikagard H 1001

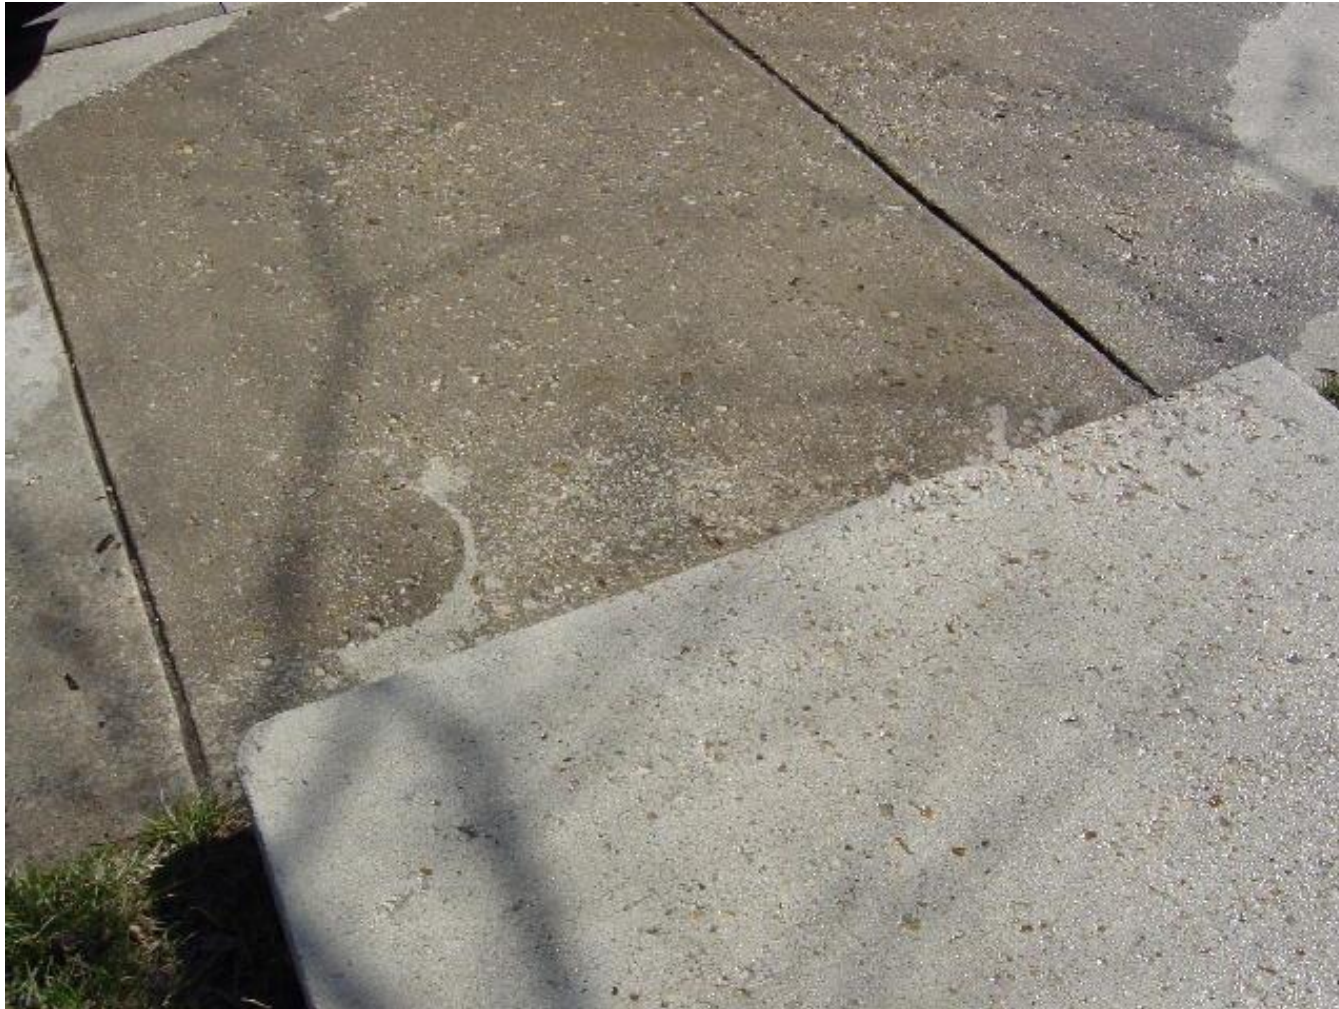
- 5 years after application
- Treated area still not absorbing
- Can even see where bucket rundown protected
- 20% silane & siloxane last 5+ years
- 40% silane last 10+ years
- 100% silane last 15+ years

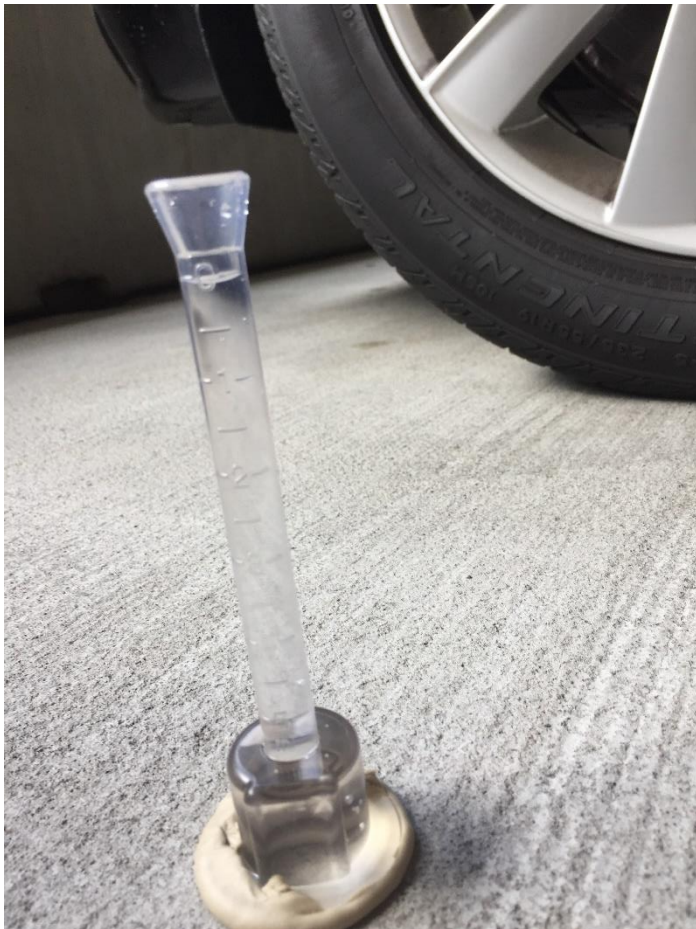
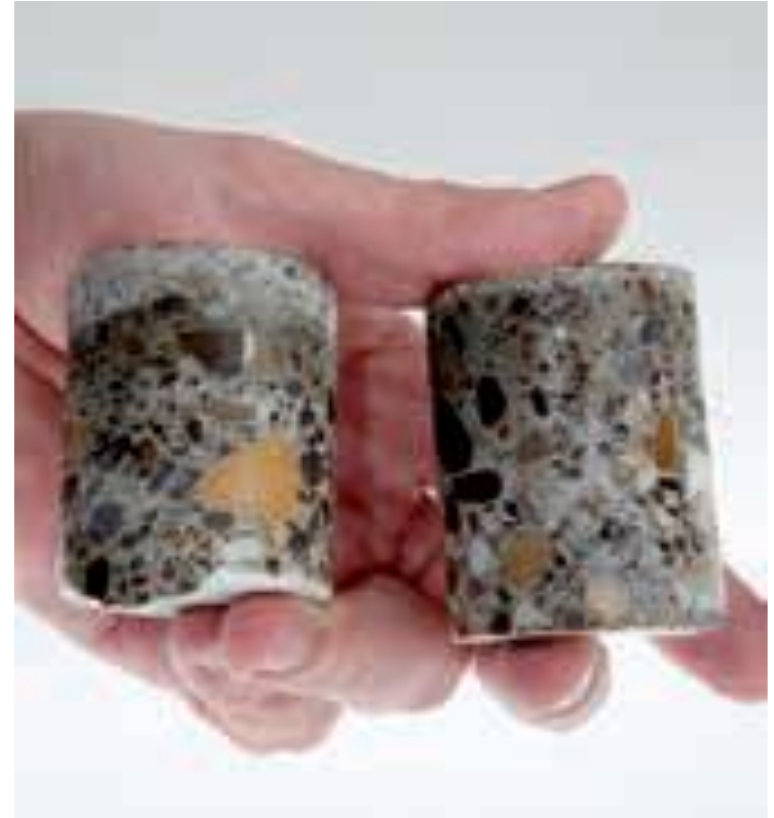
- Verify repellency with RILEM tube testing (before and after application)
- Verify penetration with cores
