CONCRETE PROTECTION

RANDALL KRATZ – DISTRICT MANAGER MD/DC/VA
SIKA CORPORATION – REFURBISHMENT, SEALING & BONDING
WITH SIKA SINCE 1991
GRADUATE DREXEL UNIVERSITY - COMMERCE & ENGINEERING
410-336-3757

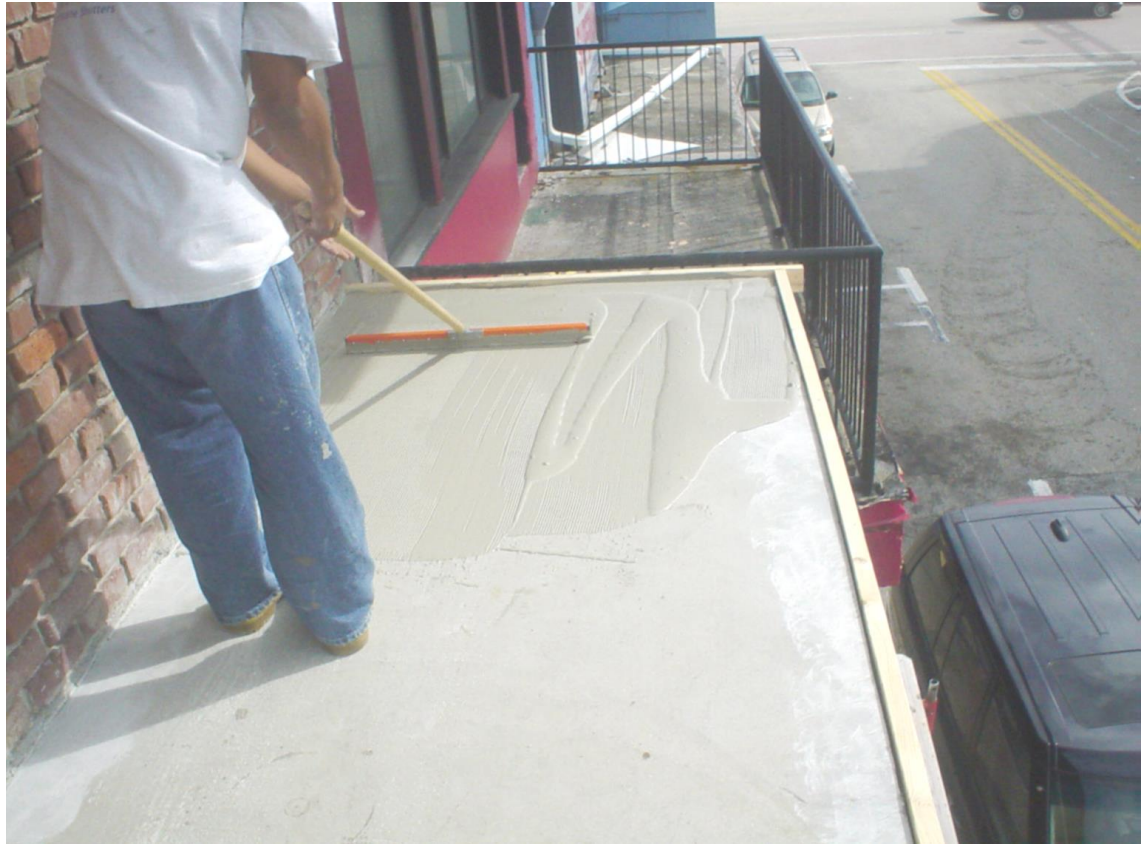
- Polymer-modified, cement-based coating
- Waterproofing
- Breathable
- Conceals fine cracks
~ 15 mils (1/64" wide)

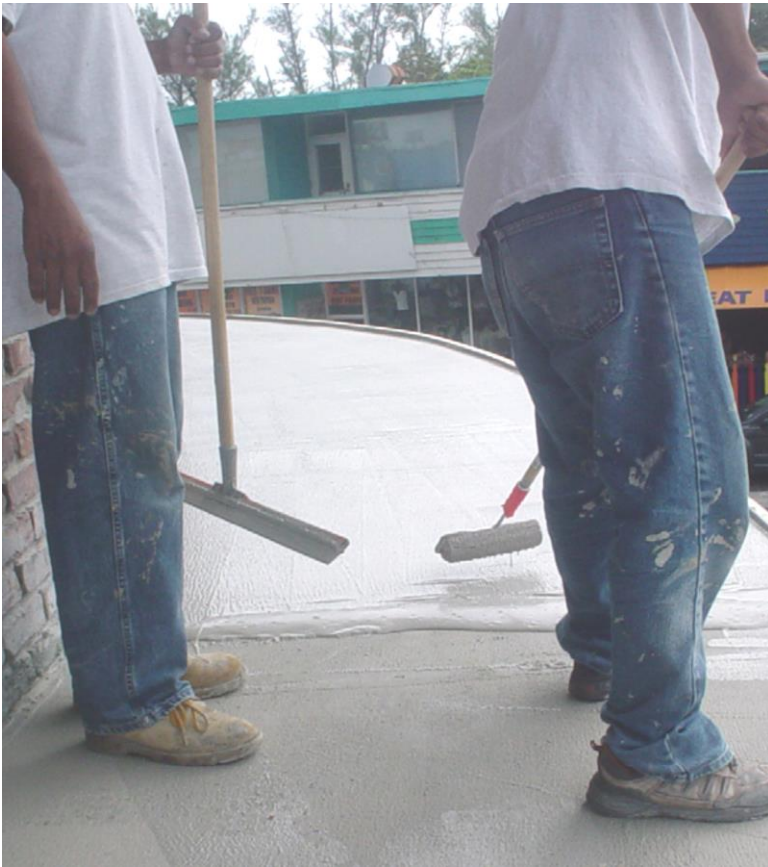
- Best installed in 2 coats by squeegee or roller

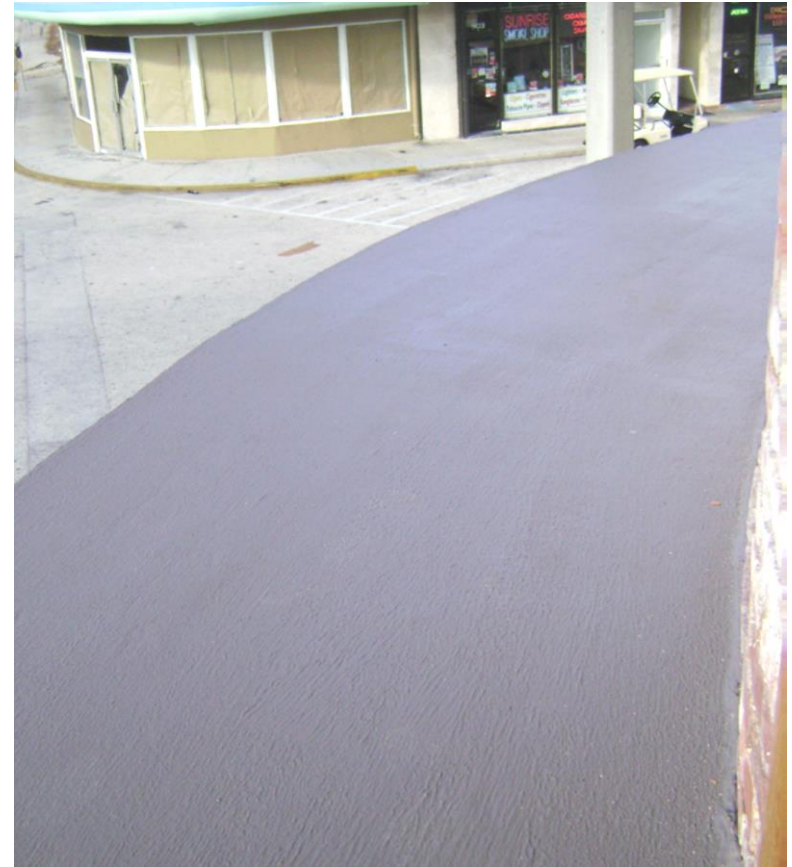
- 120 mils (~1/8") total thickness

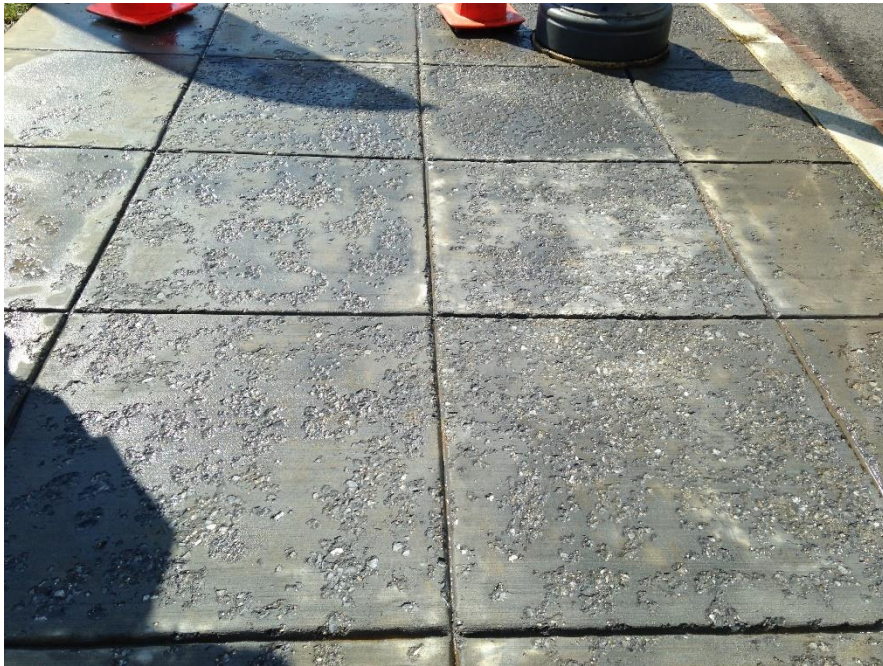
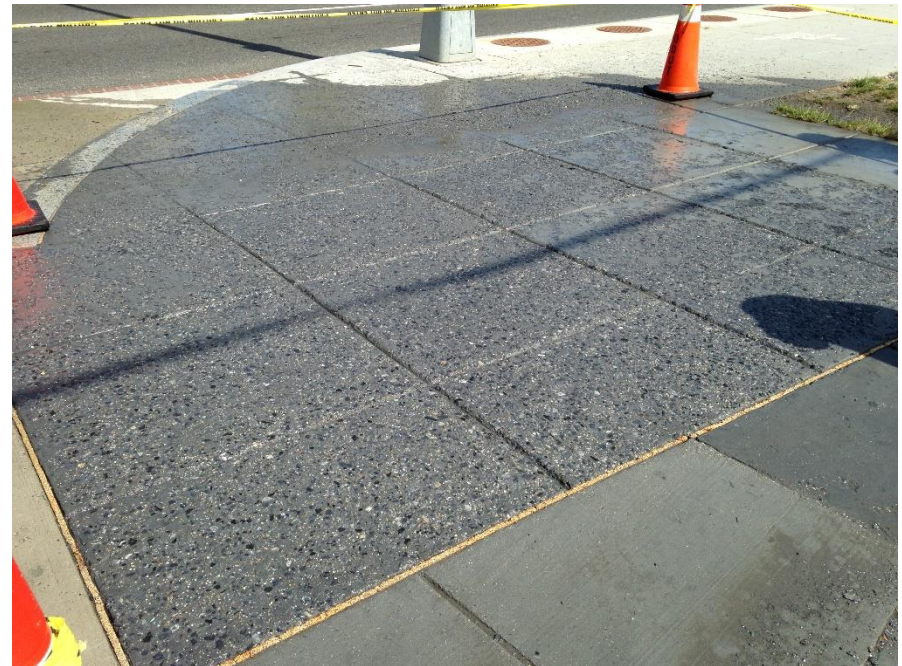
- Resurface scaled/pitted concrete
- Apply 1st coat by squeegee to level

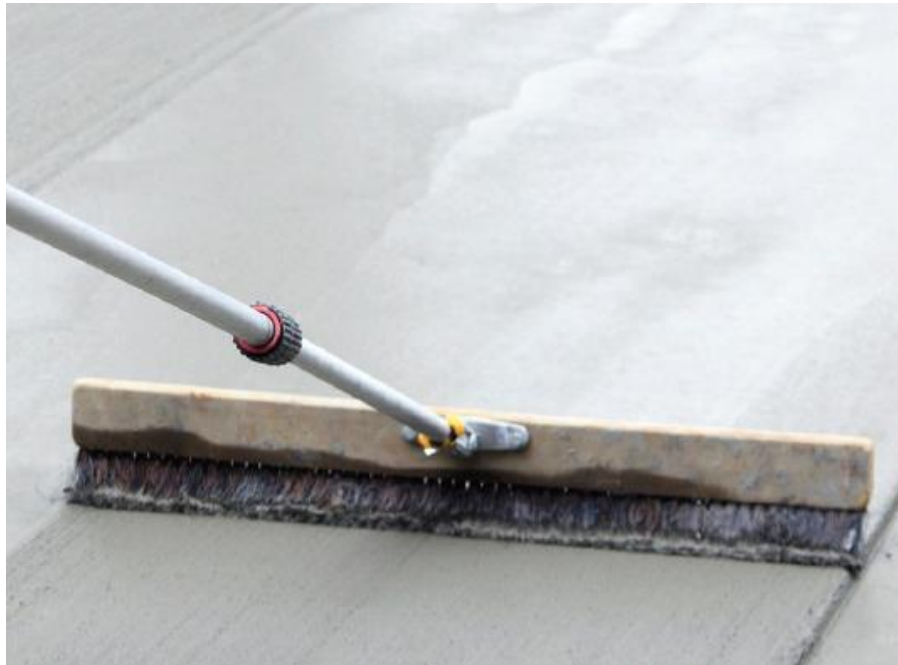
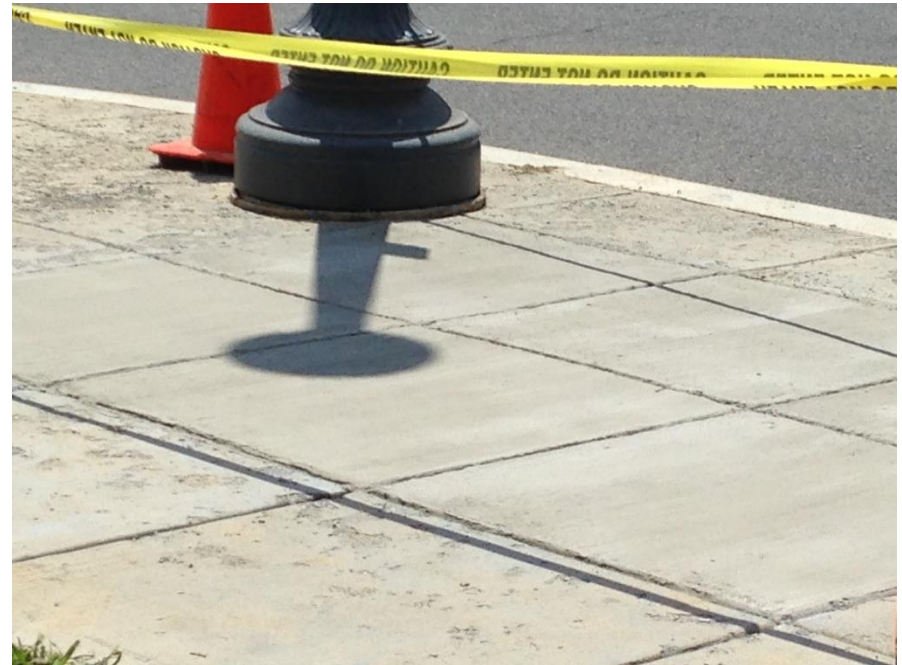
- 2nd coat receives preferred finish
- Typical concrete appearance

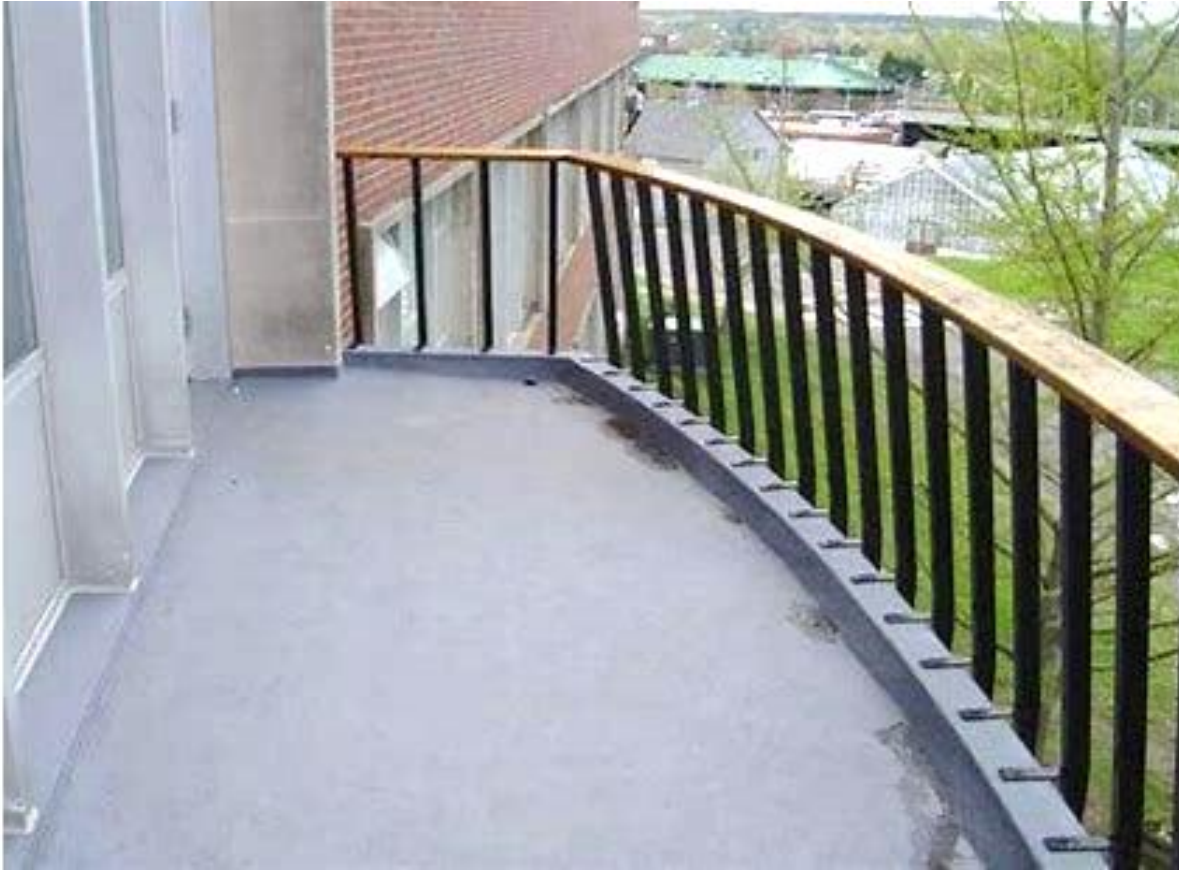
- Roller, broom, or knockdown finish
- Protection completed

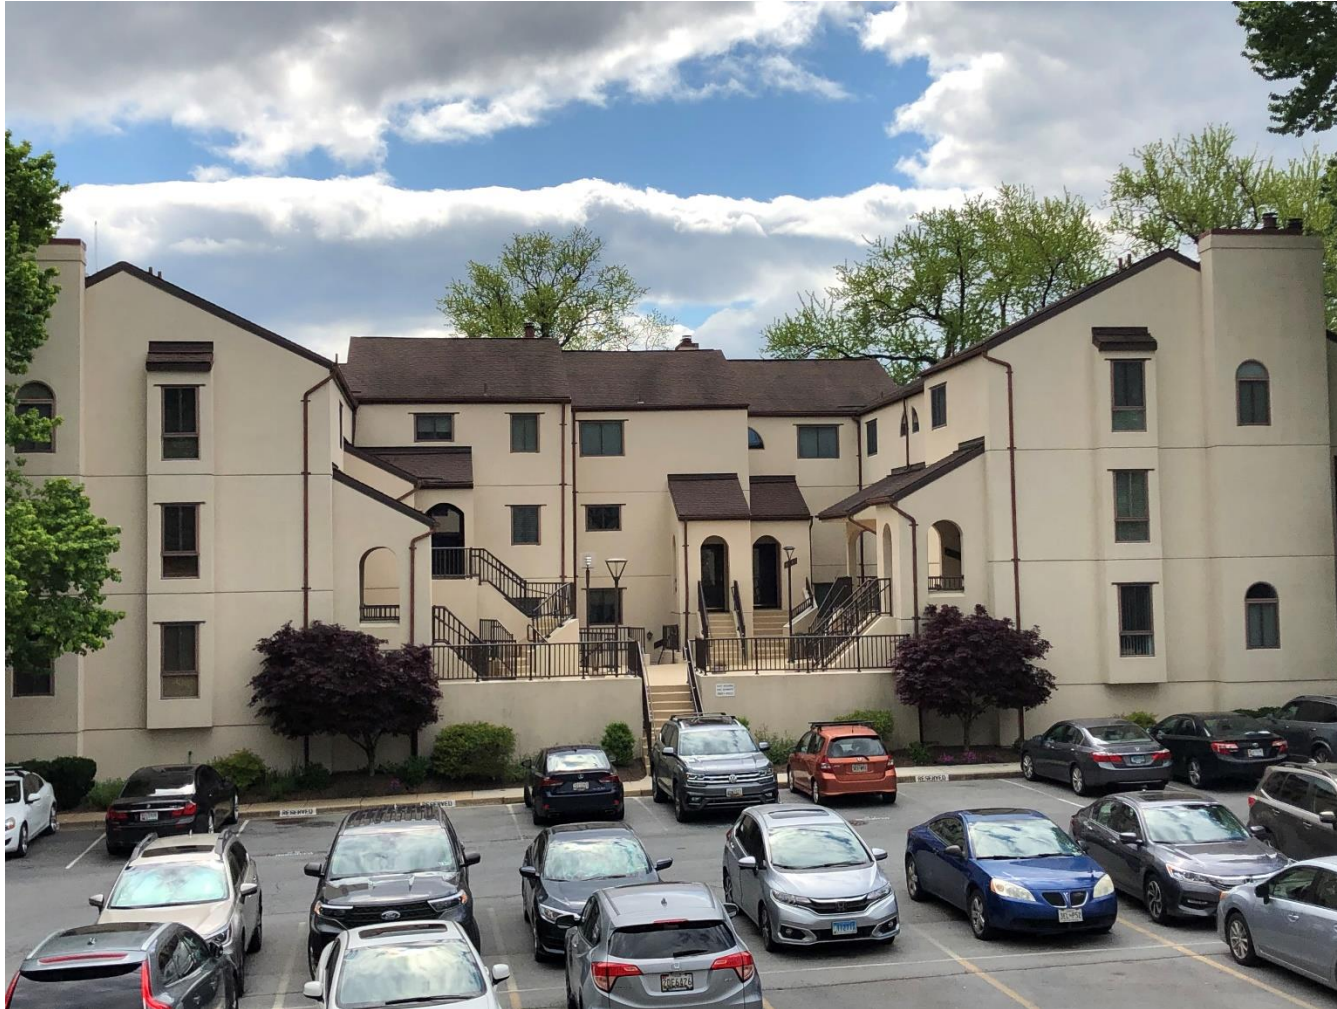
- Add color with Sikagard FlexCoat ATC

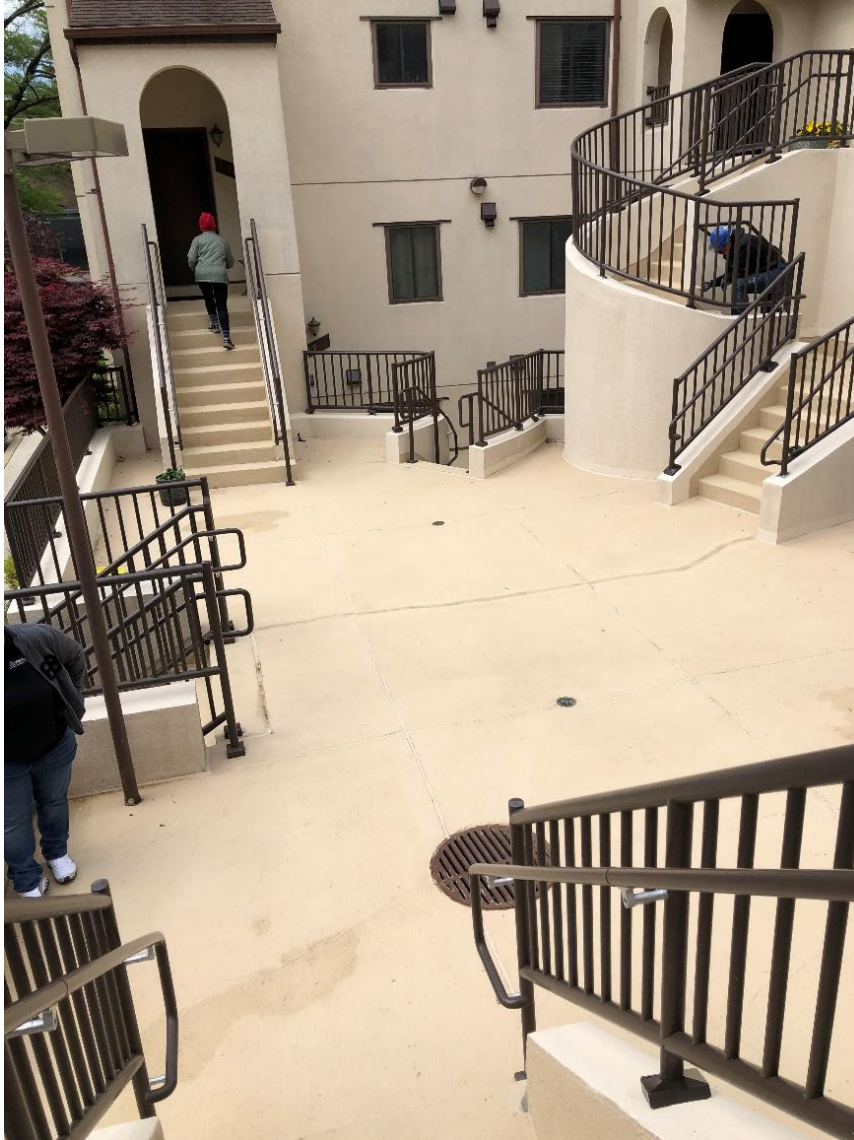
- **Waterproofing over occupied space**
(FlexCoat not recommended over occupied space)
(stairs going up to landings)
- Hide concrete repairs
- Level rough surfaces
- Suitable for on-grade service
- Conceal wider treated cracks
- Conceal fine cracks
- Perform in seldom dry walk-down areas
- Install in sections to allow use of sole entries and common areas
- Final total uniform appearance
- Easy maintenance

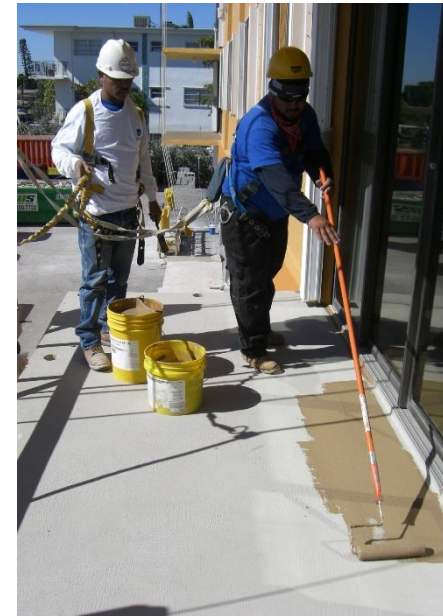
- Sikagard FlexCoat ATC applied in 2 coats for a total of 5 mils
- Color will last, but it will wear
- Very easy to touchup
- Sikagard 620 FlexCoat CC can be applied for additional clear coat protection

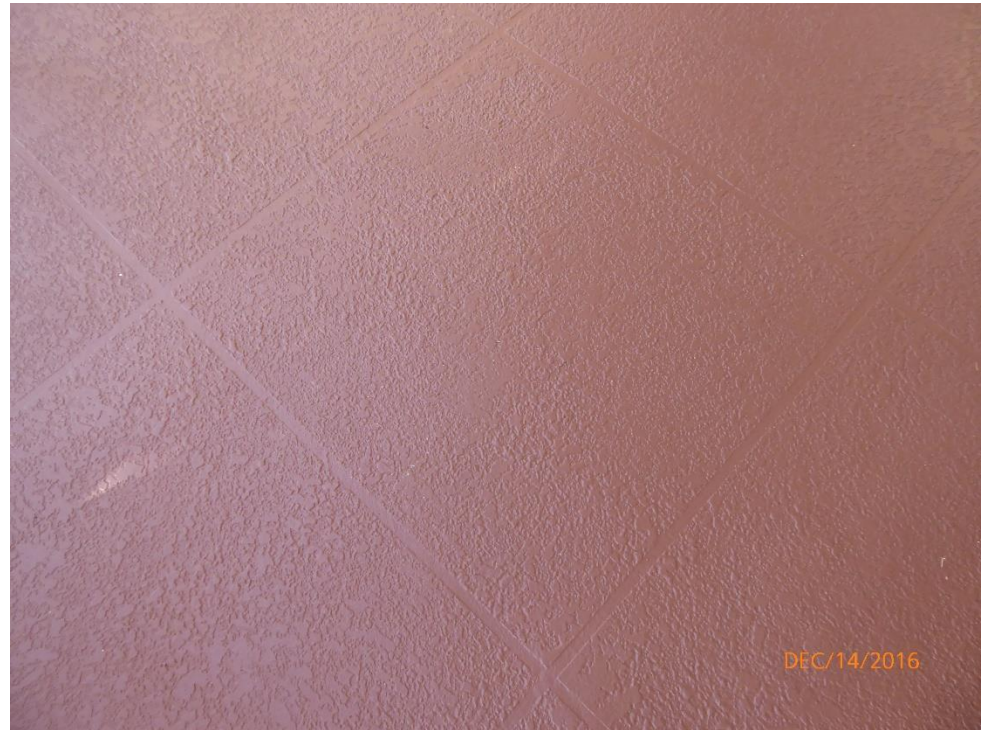
- Grout lines can both vary in color and texture

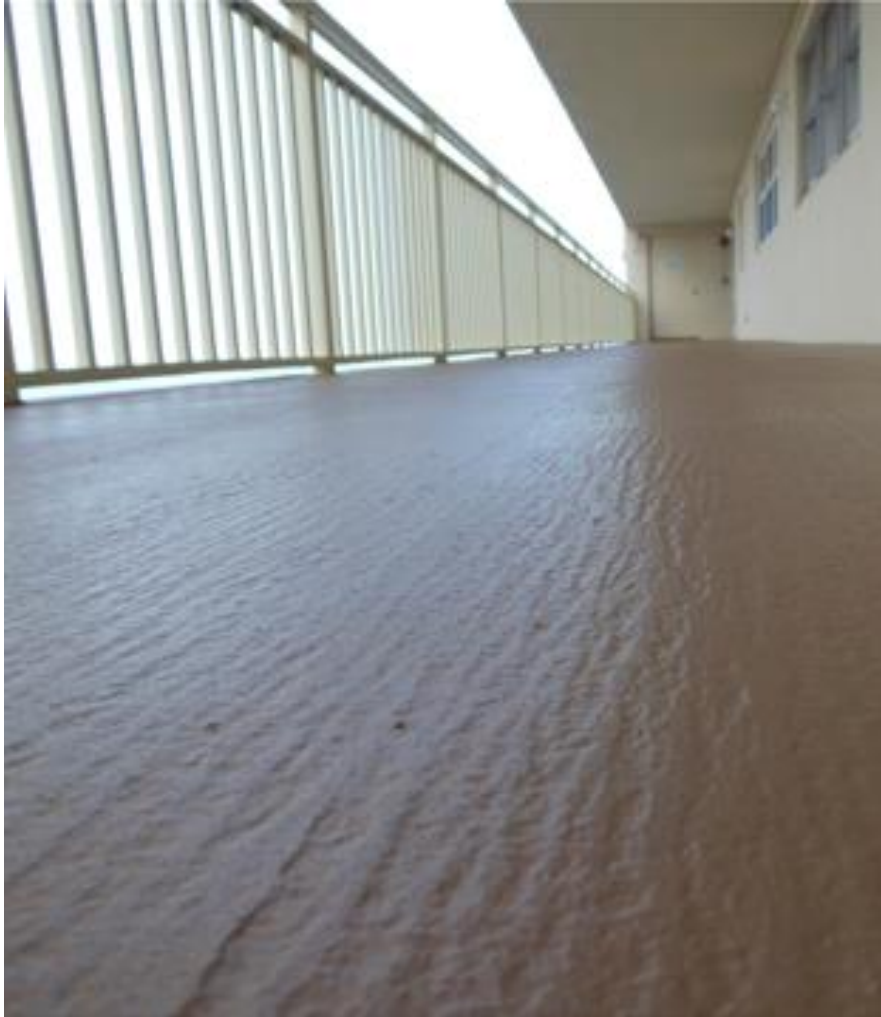
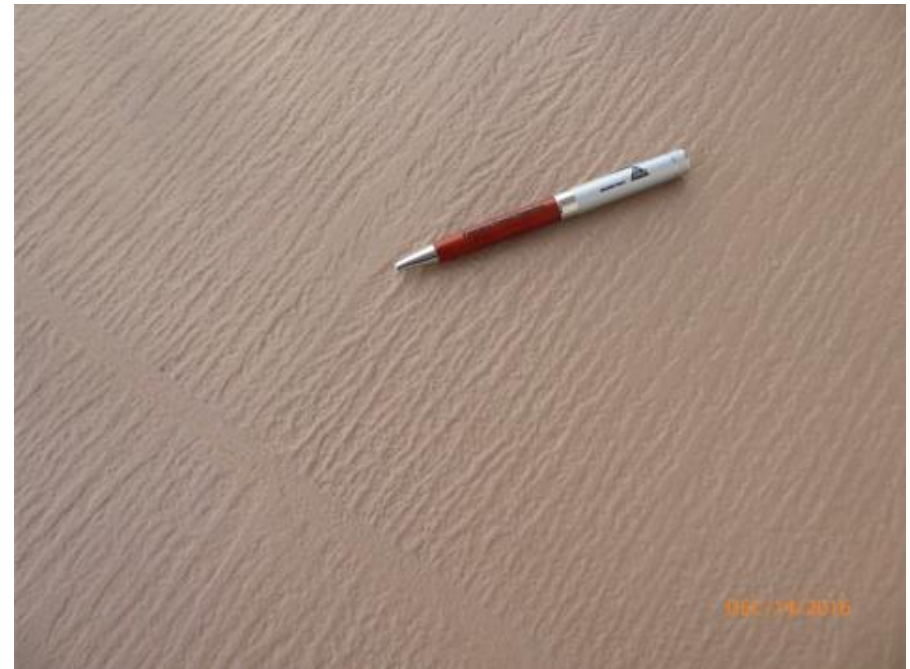
- Best to repair cracks with low-viscosity epoxy than urethane sealant
- Best to honor all joints
- Reinforcing embedding mesh available

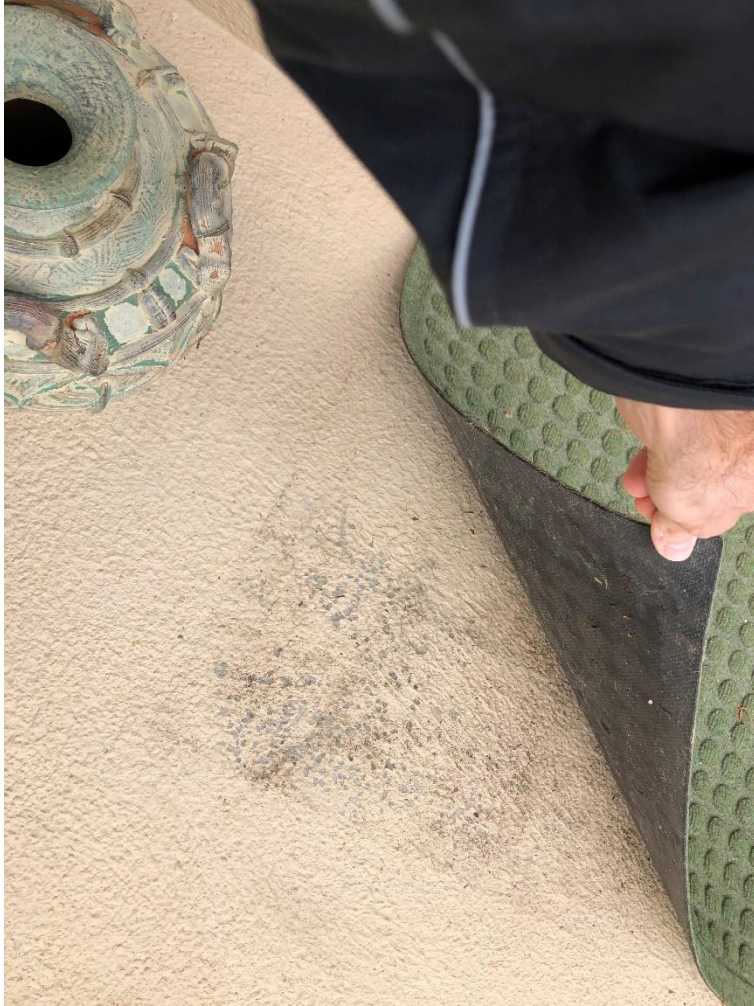
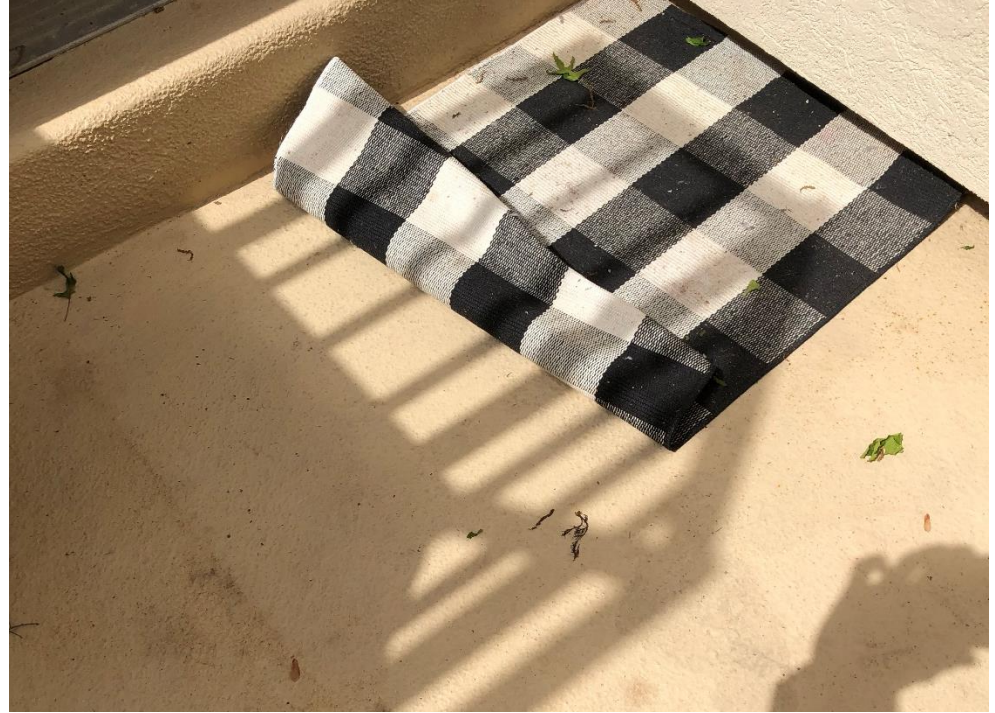
- Avoid trapping moisture
- Natural coir is breathable

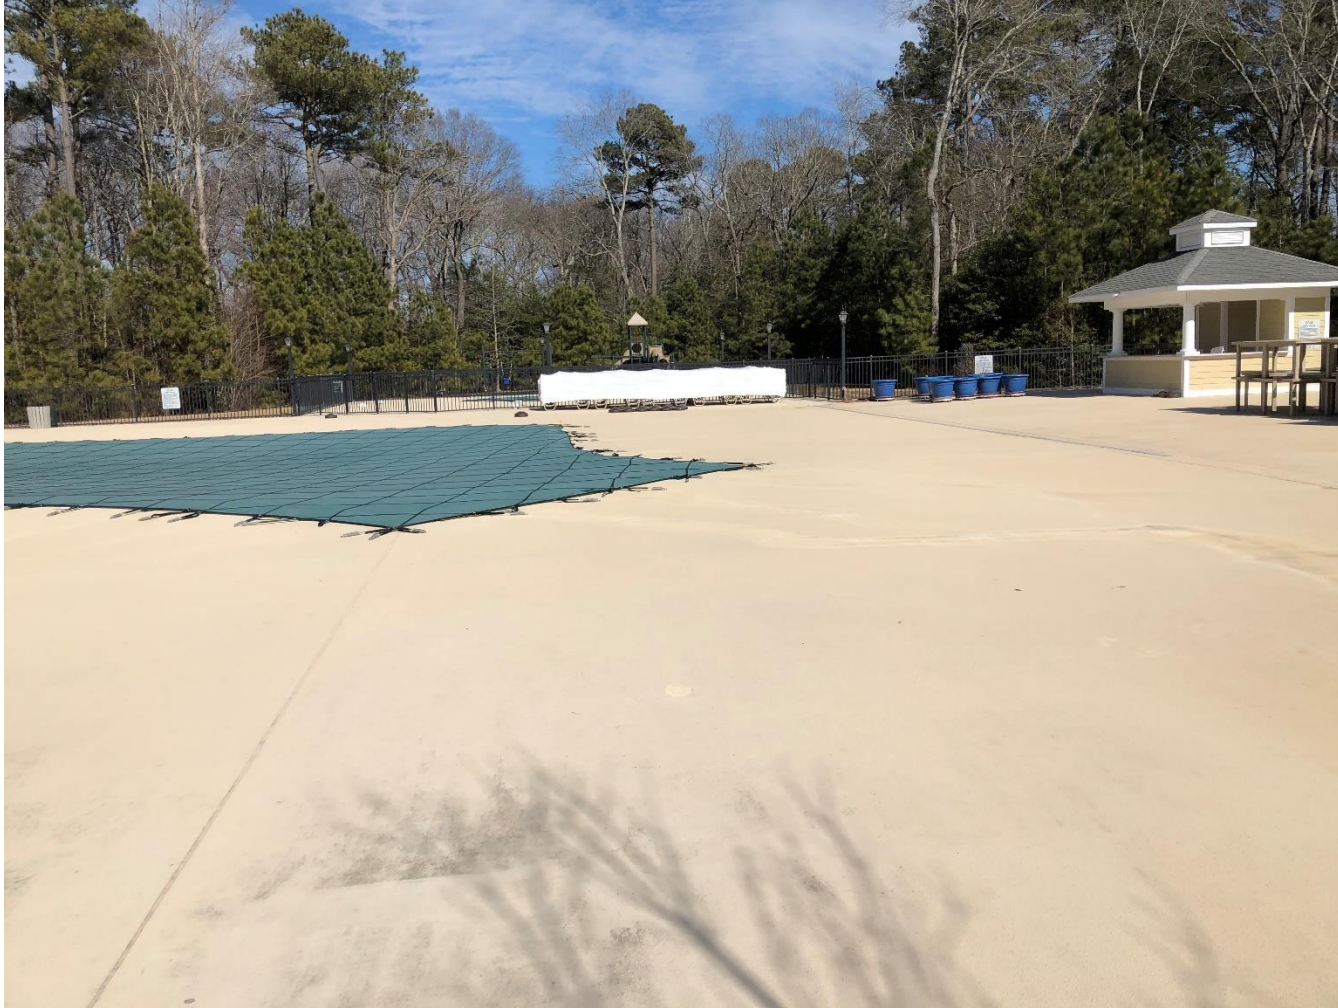
The Refuge, Selbyville DE 2015

- Photo taken 6 years after installation
- Cracks pretreated
- Joints honored

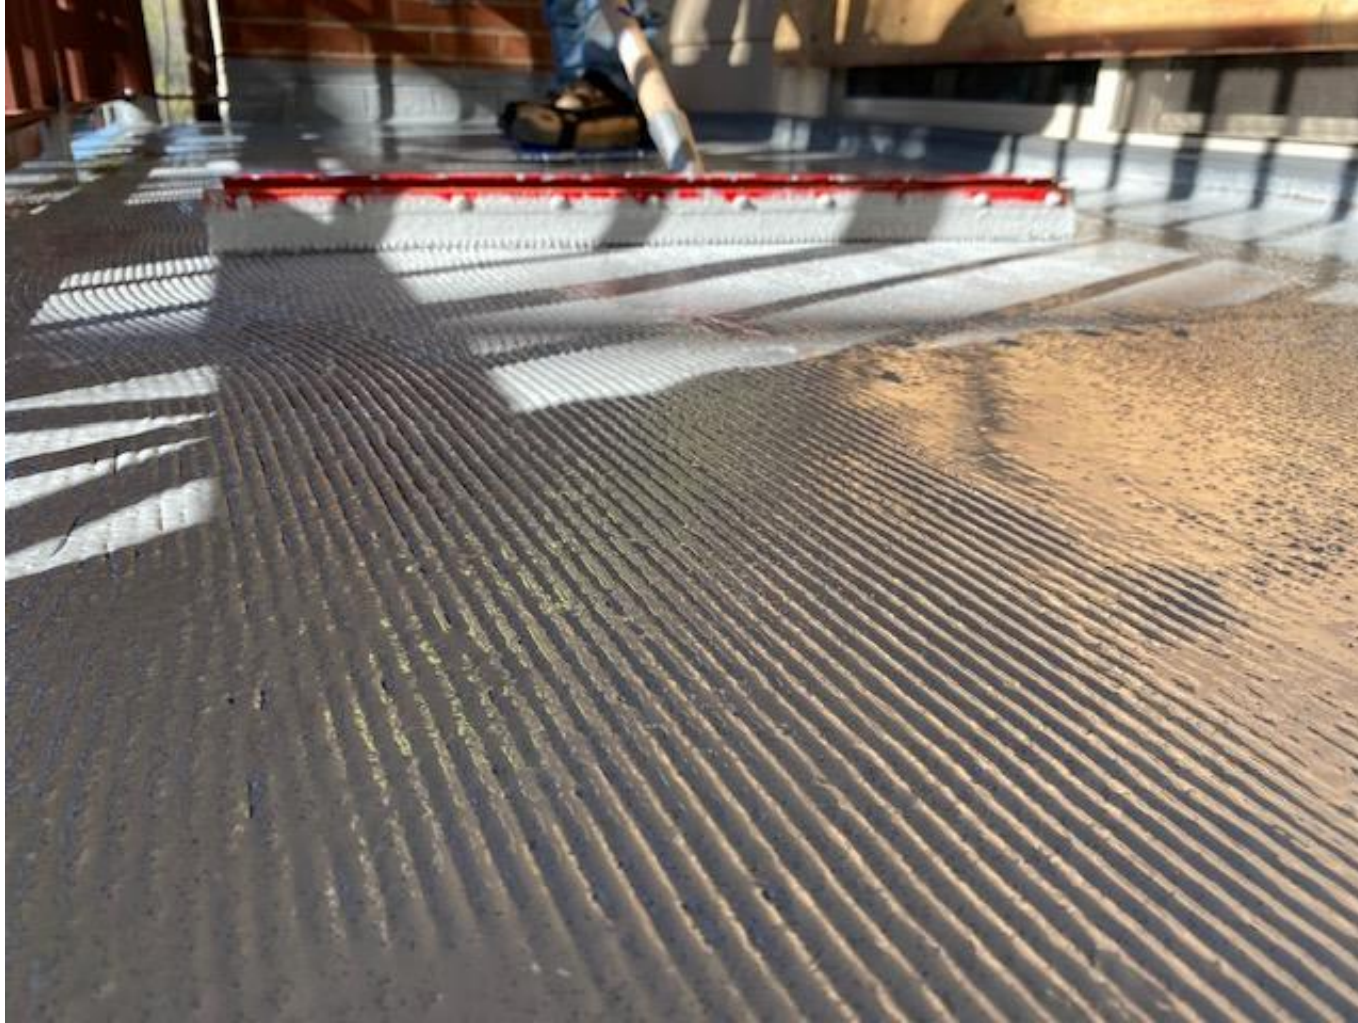
SINGLE COAT

- Spread by 1/4" notched squeegee at 50 sf/unit (1.33-gal unit)

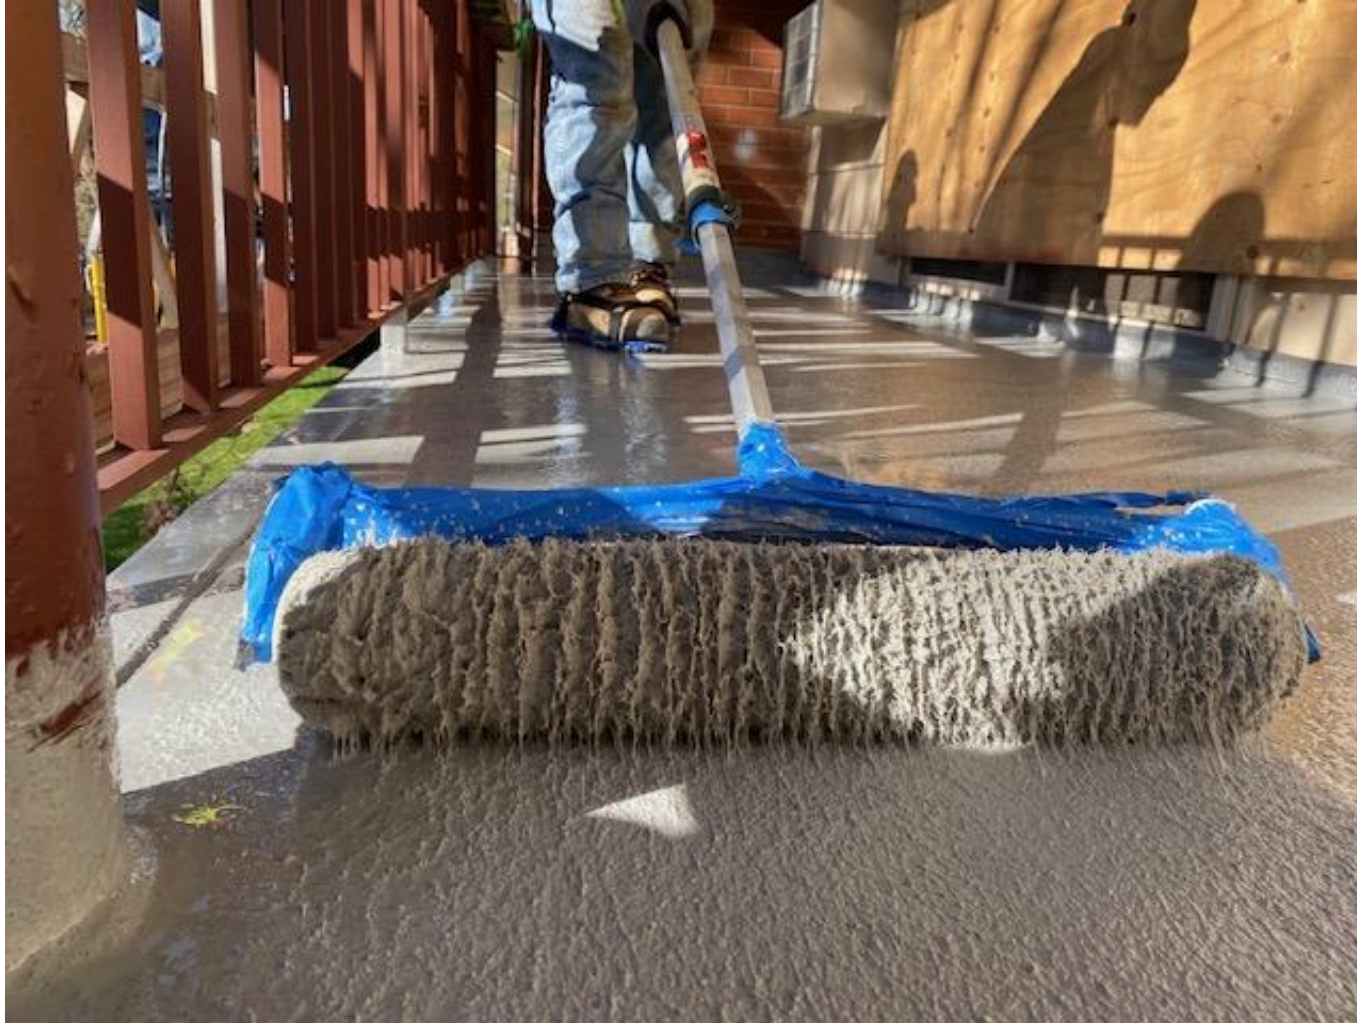
SINGLE COAT

- Back-roll twice (0° and 90°)

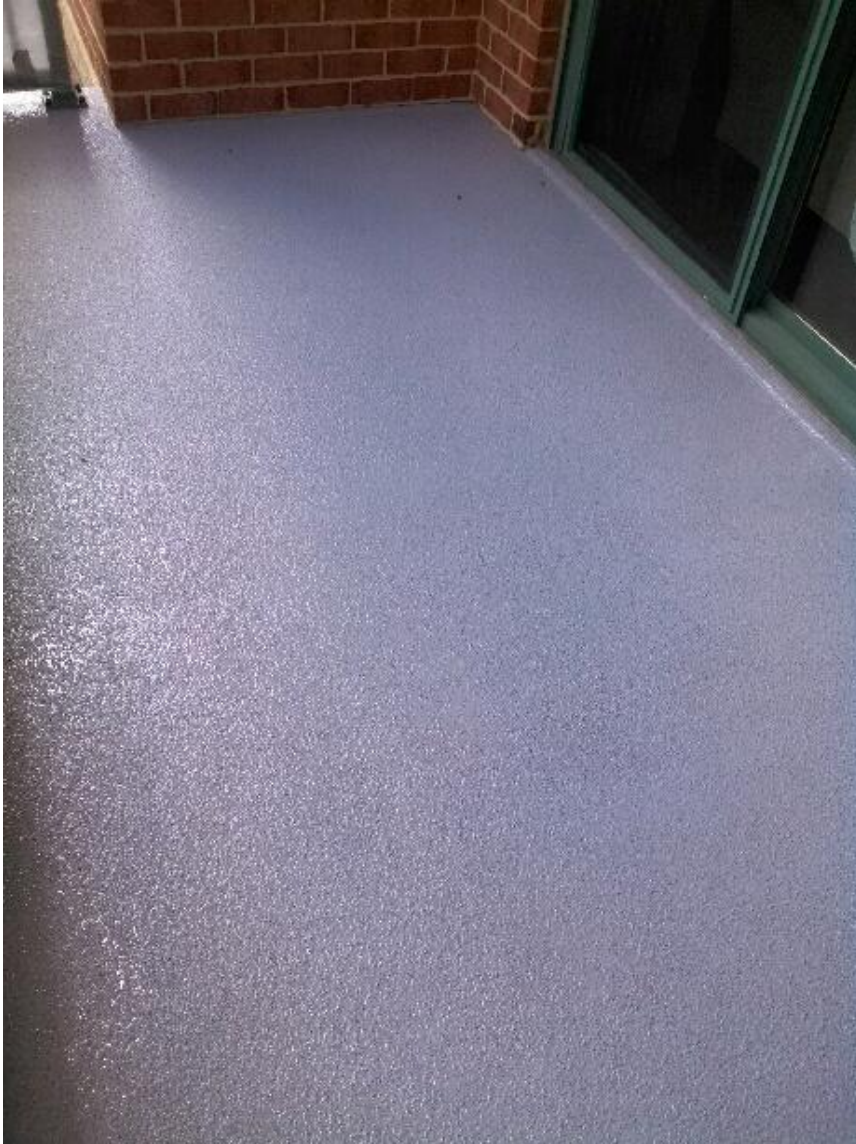
SINGLE COAT

- 35 mils
- All aliphatic resin
- Integral aggregate for improved durability and increased uniformity
- Return to service in 8 hours

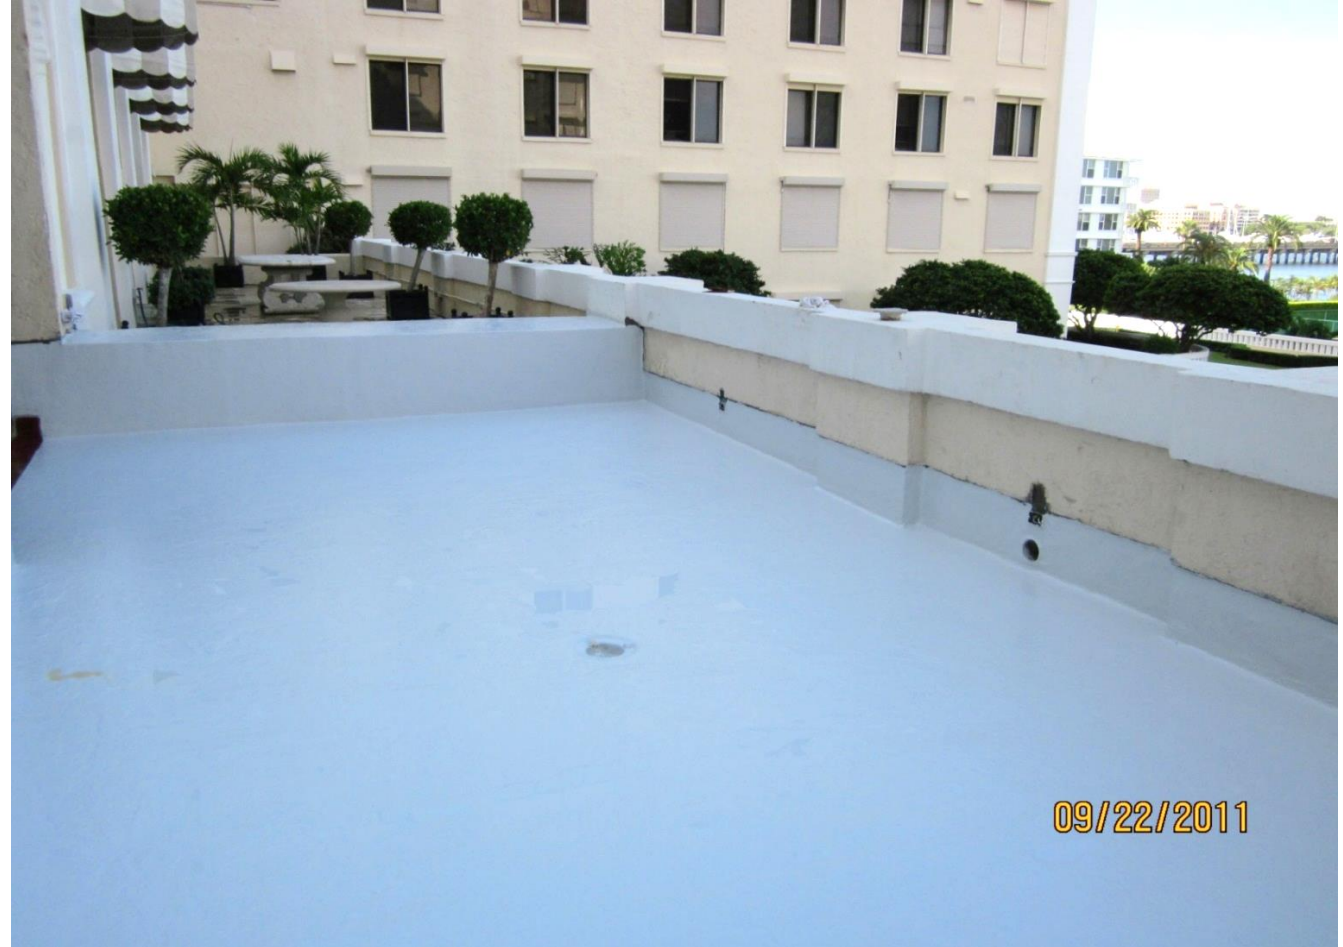
SIKALASTIC 325 LO-VOC

- Polyurethane coating
- Waterproofing
- Elastomeric
- Aliphatic
- Lo-VOC
- **Fully reinforced**
- Premium waterproofing ideal for balconies over occupied space
- Up to 20-year Limited Material Warranty

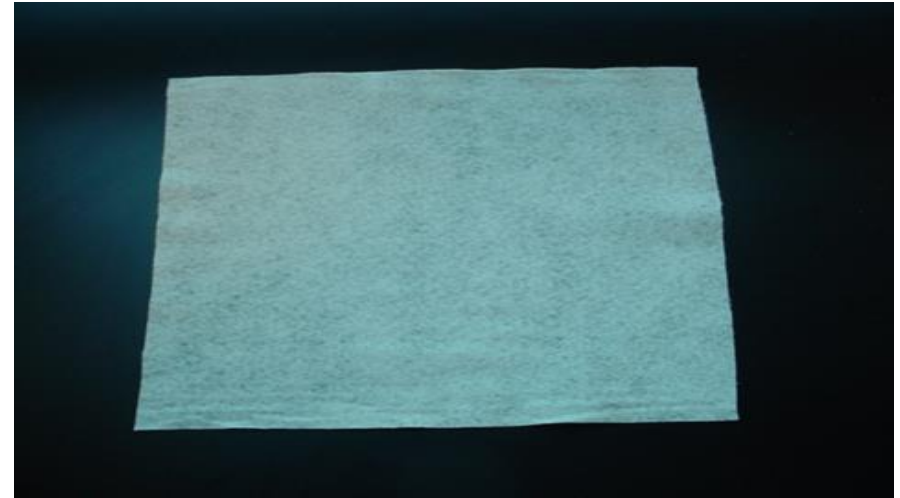
Polyester Fleece:

- Woven
- Non-conformable
- Must be cut, lapped, and tends to result in 'tenting' around details and bridging across substrate high points
- Allows same day installation

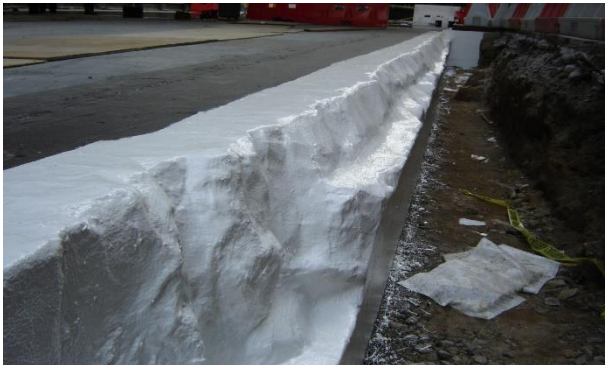
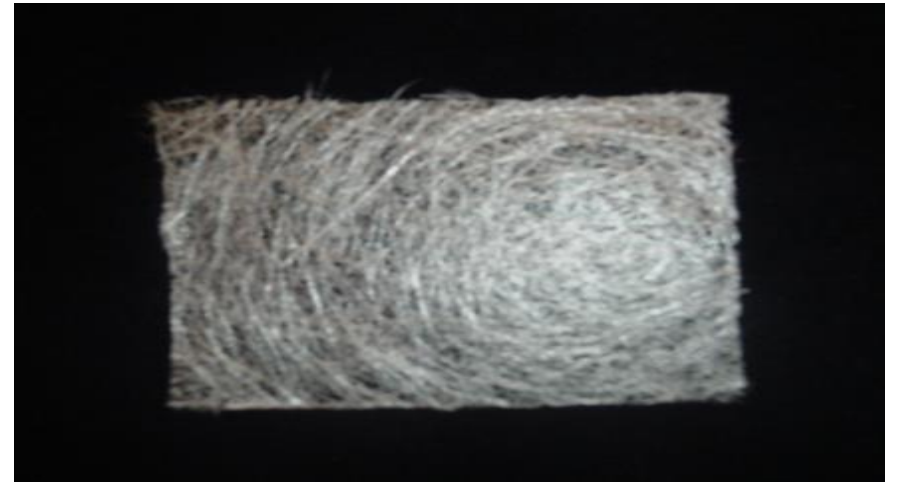
Fiberglass Reemat:

- Non-woven
- Conformable – fully bonded

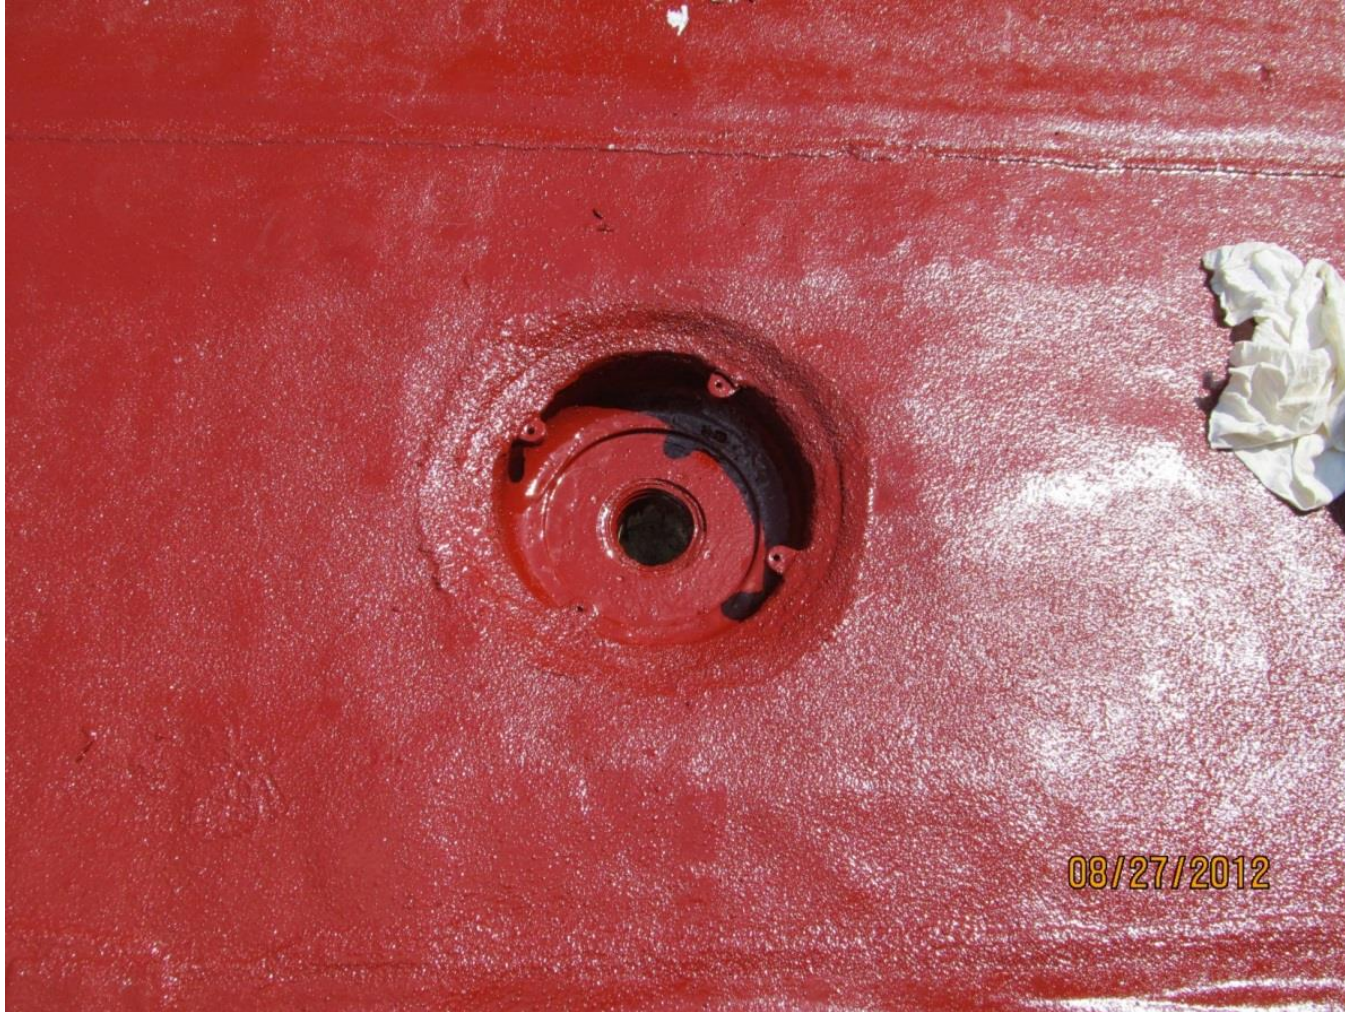
- Primer based on substrate
- **Sikalastic Primer** is 1-component and very fast curing for concrete
- **Sikalastic EP Primer** is 2-component for metal, wood, bituminous and concrete

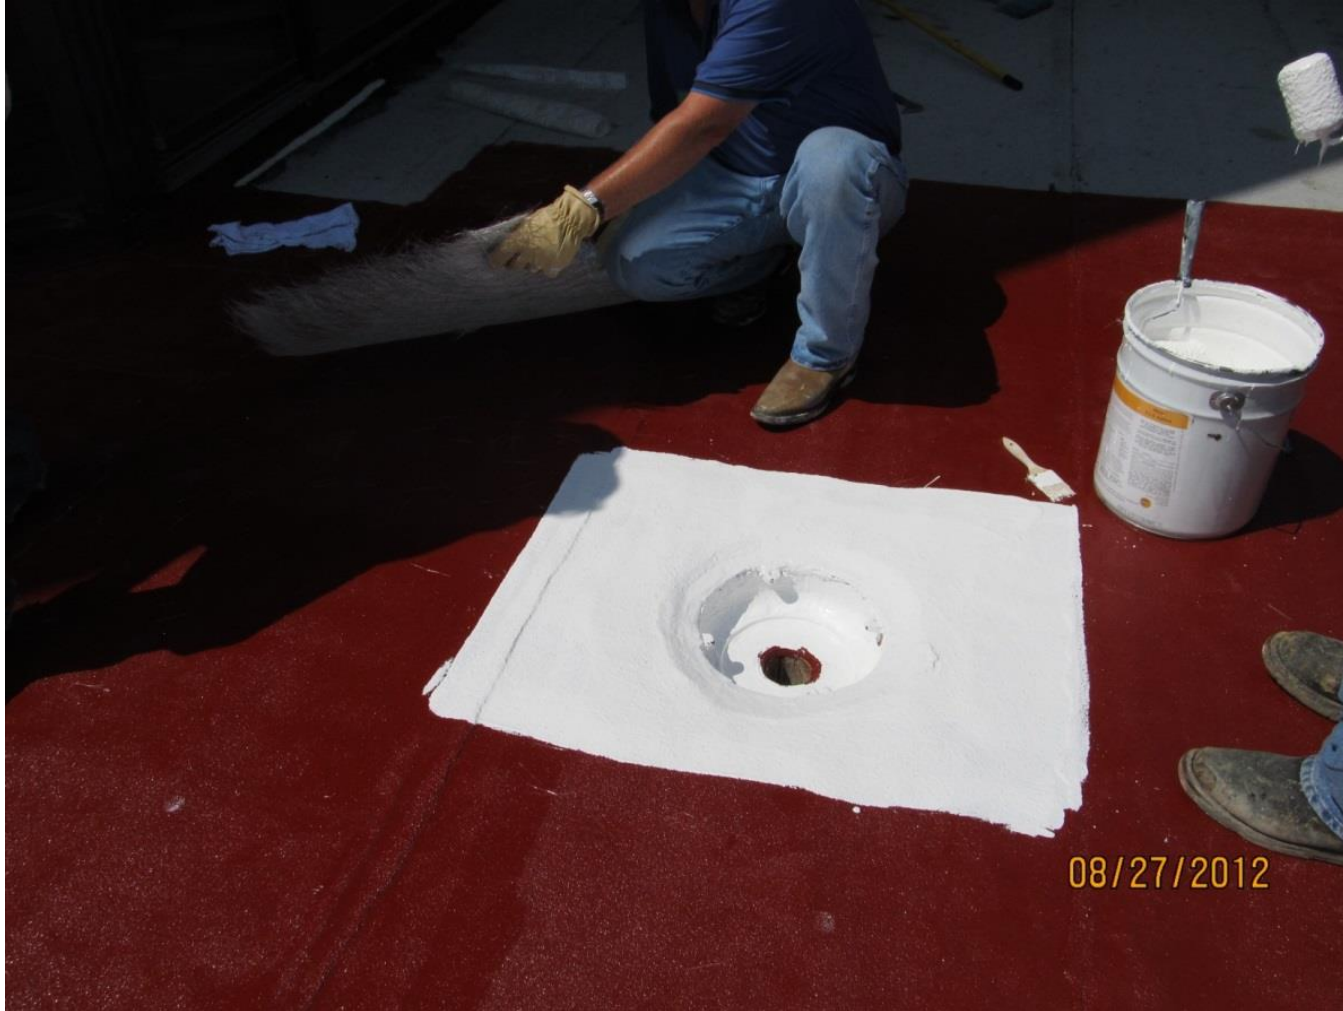
SIKALASTIC 325 LO-VOC

- Apply base coat by roller at 45 mils (35 sf/gal)
- 1-component
 - ✓ No mixing
 - ✓ No pot life
- Moisture triggered chemistry is rain resistant in 10 minutes
