CONCRETE PROTECTION

RANDALL KRATZ – DISTRICT MANAGER MD/DC/VA
SIKA CORPORATION – REFURBISHMENT, SEALING & BONDING
WITH SIKA SINCE 1991
GRADUATE DREXEL UNIVERSITY - COMMERCE & ENGINEERING
410-336-3757

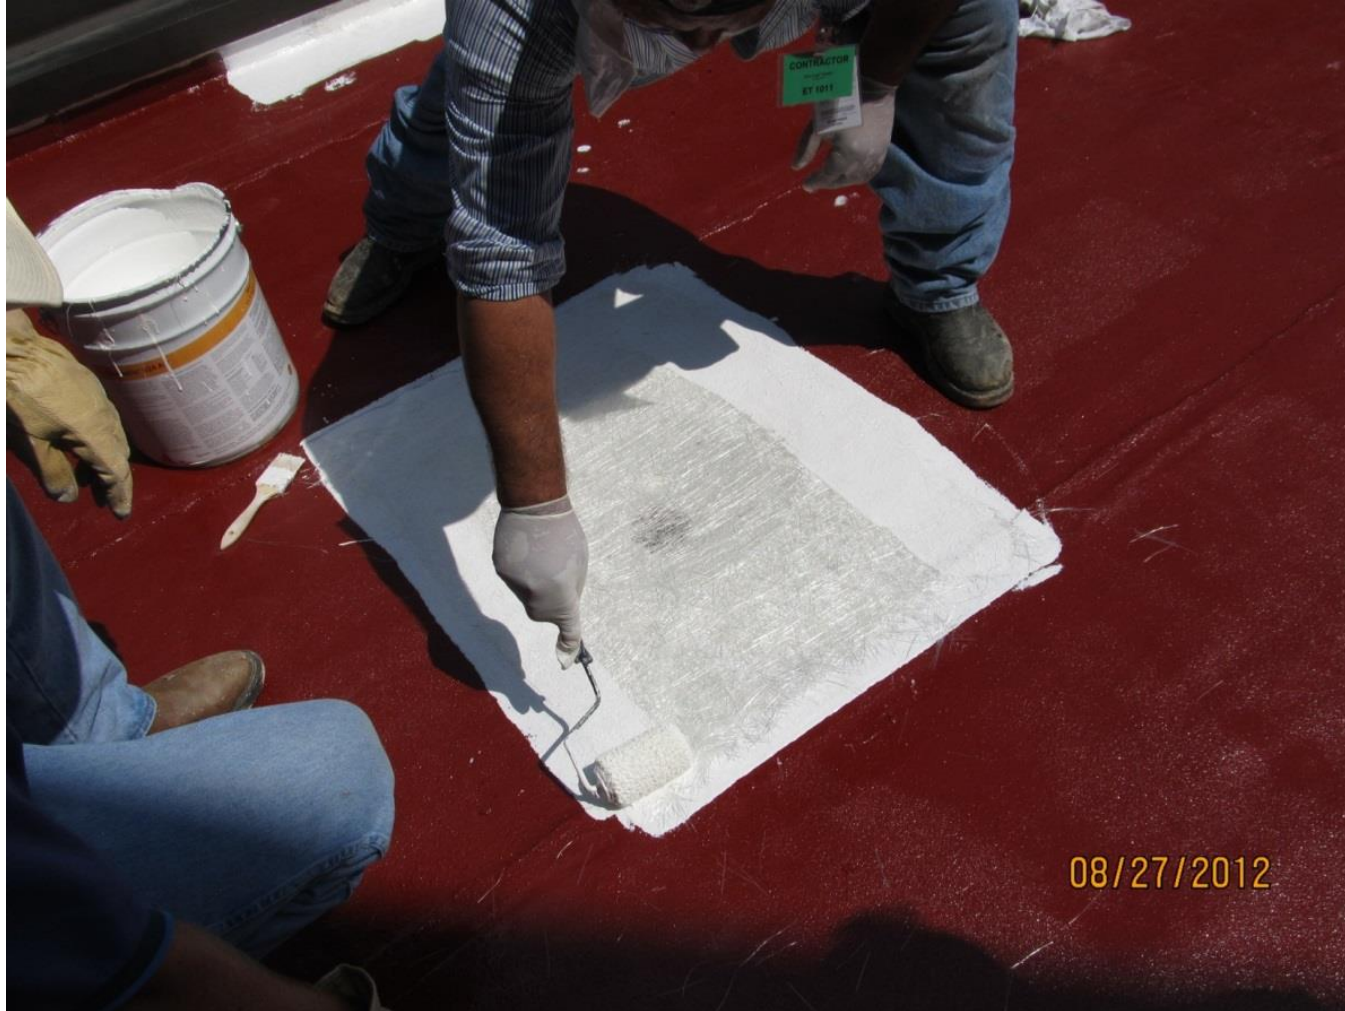
SIKALASTIC 325 LO-VOC

- Embed **Sika Reemat** reinforcement into base coat
- Best to do details first, then the field
- **Sika Reemat** roll is 49" by 295'

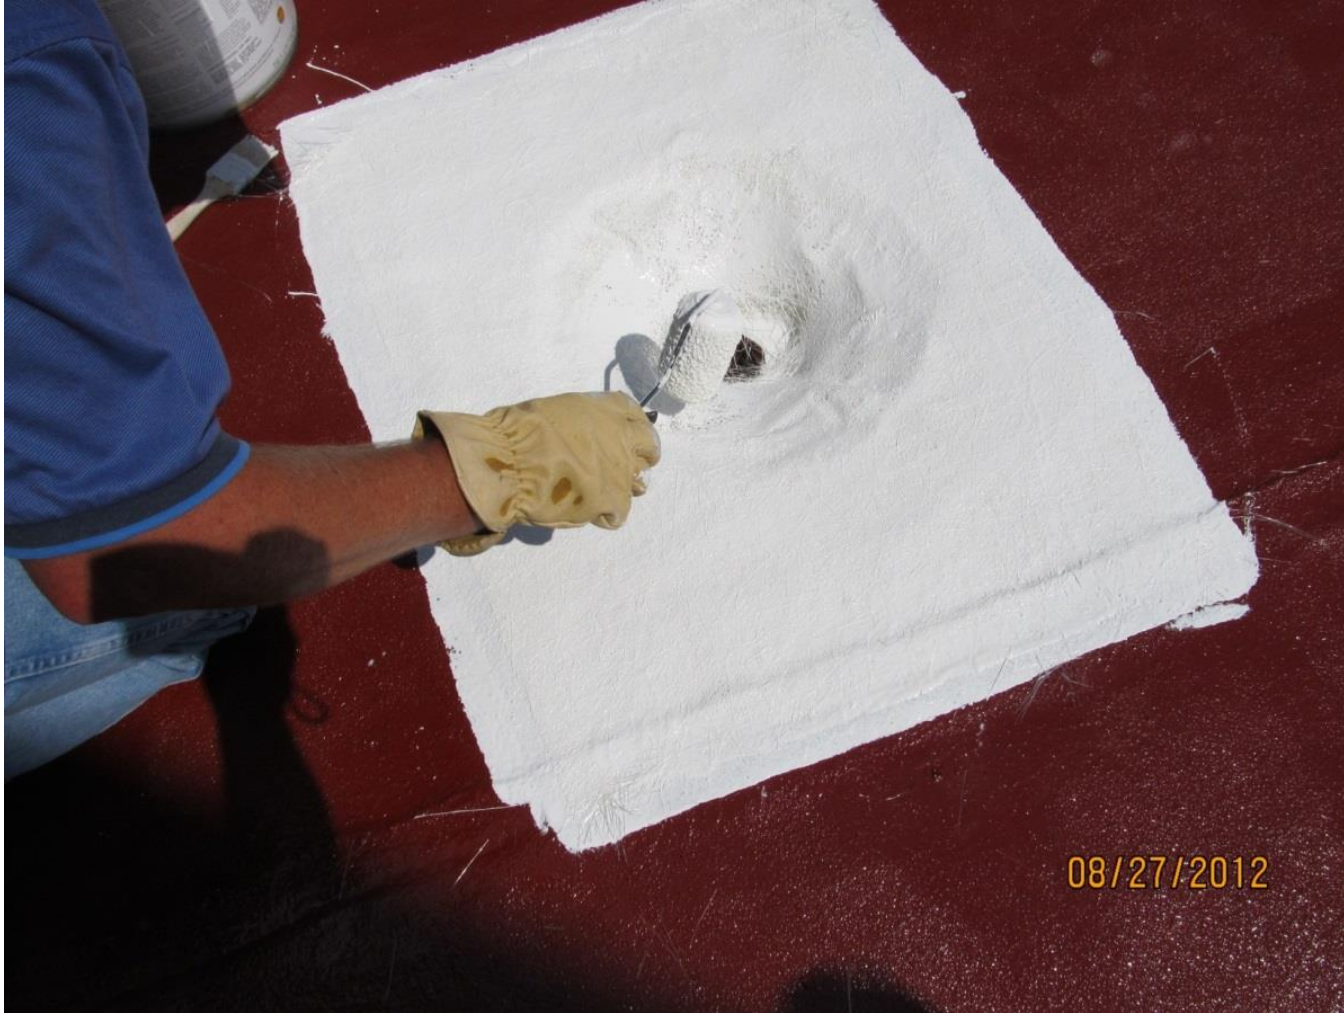
- As **Sika Reemat** fiberglass reinforcement is worked into the base coat, the fibers become independent

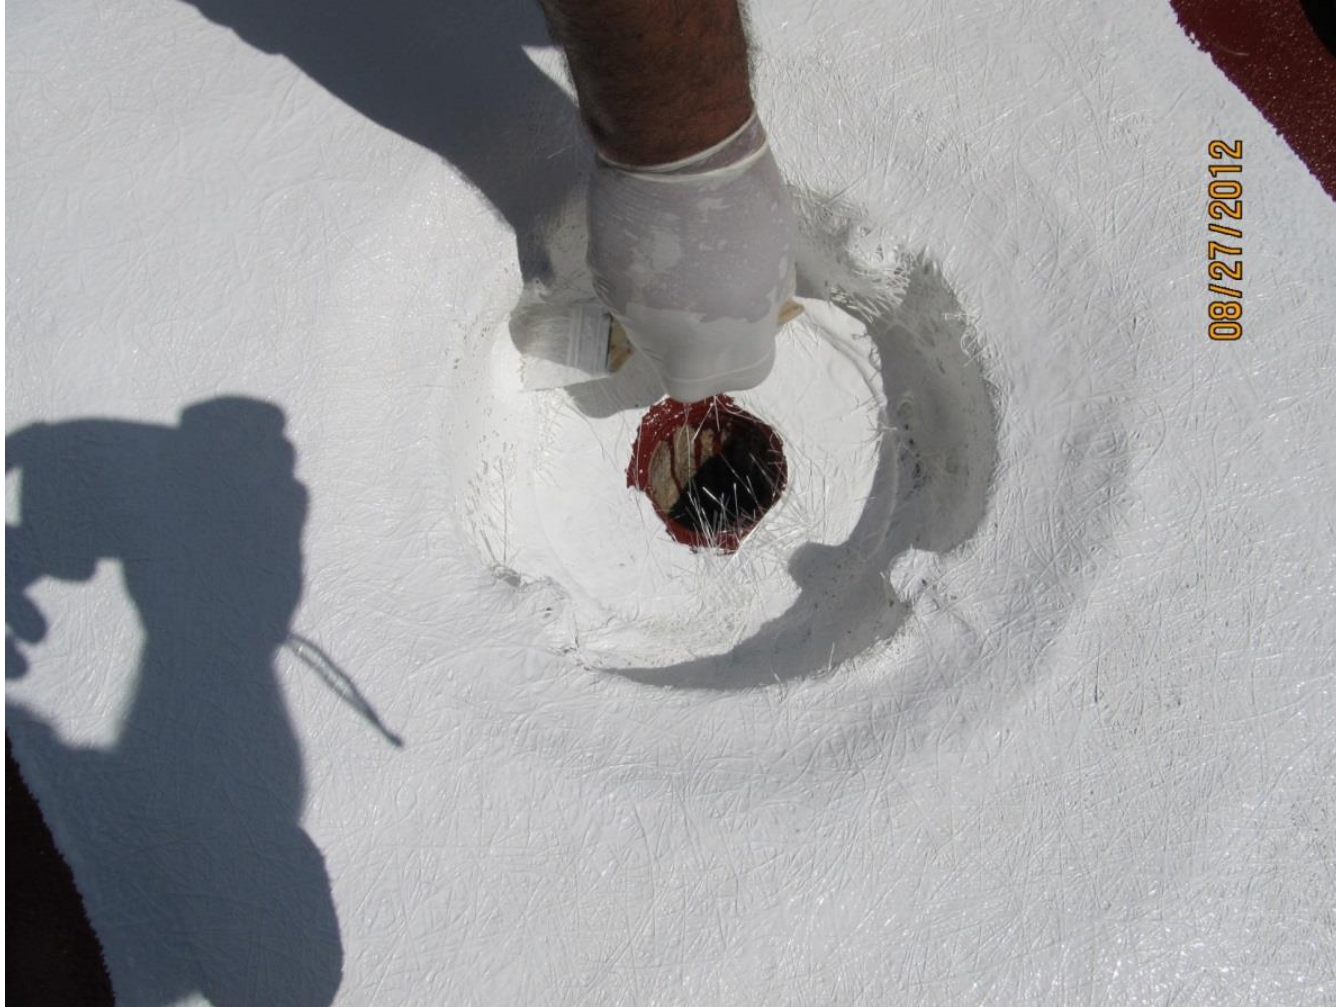
SIKALASTIC 325 LO-VOC

- Complete conformity to substrate is achieved
- No visible laps, seams, or tenting
- Much easier and more effective than woven polyester
- Fully bonded with no possibility of lateral moisture migration

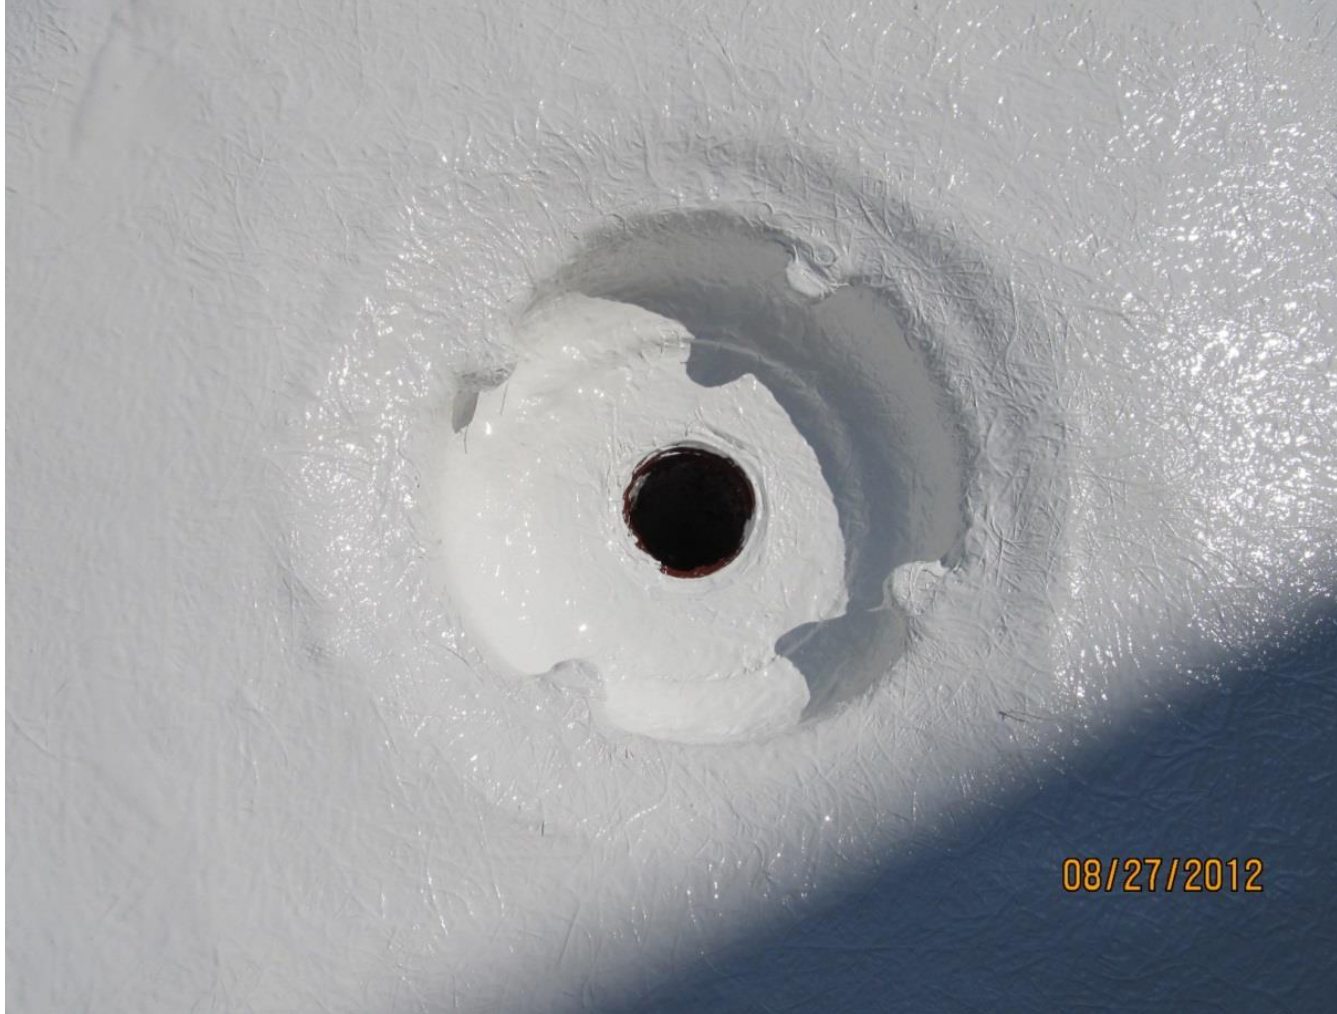
SIKALASTIC 325 LO-VOC

- Top coat is applied at 50 mils (32 sf/gal) for a 20-year limited material warranty waterproofing system

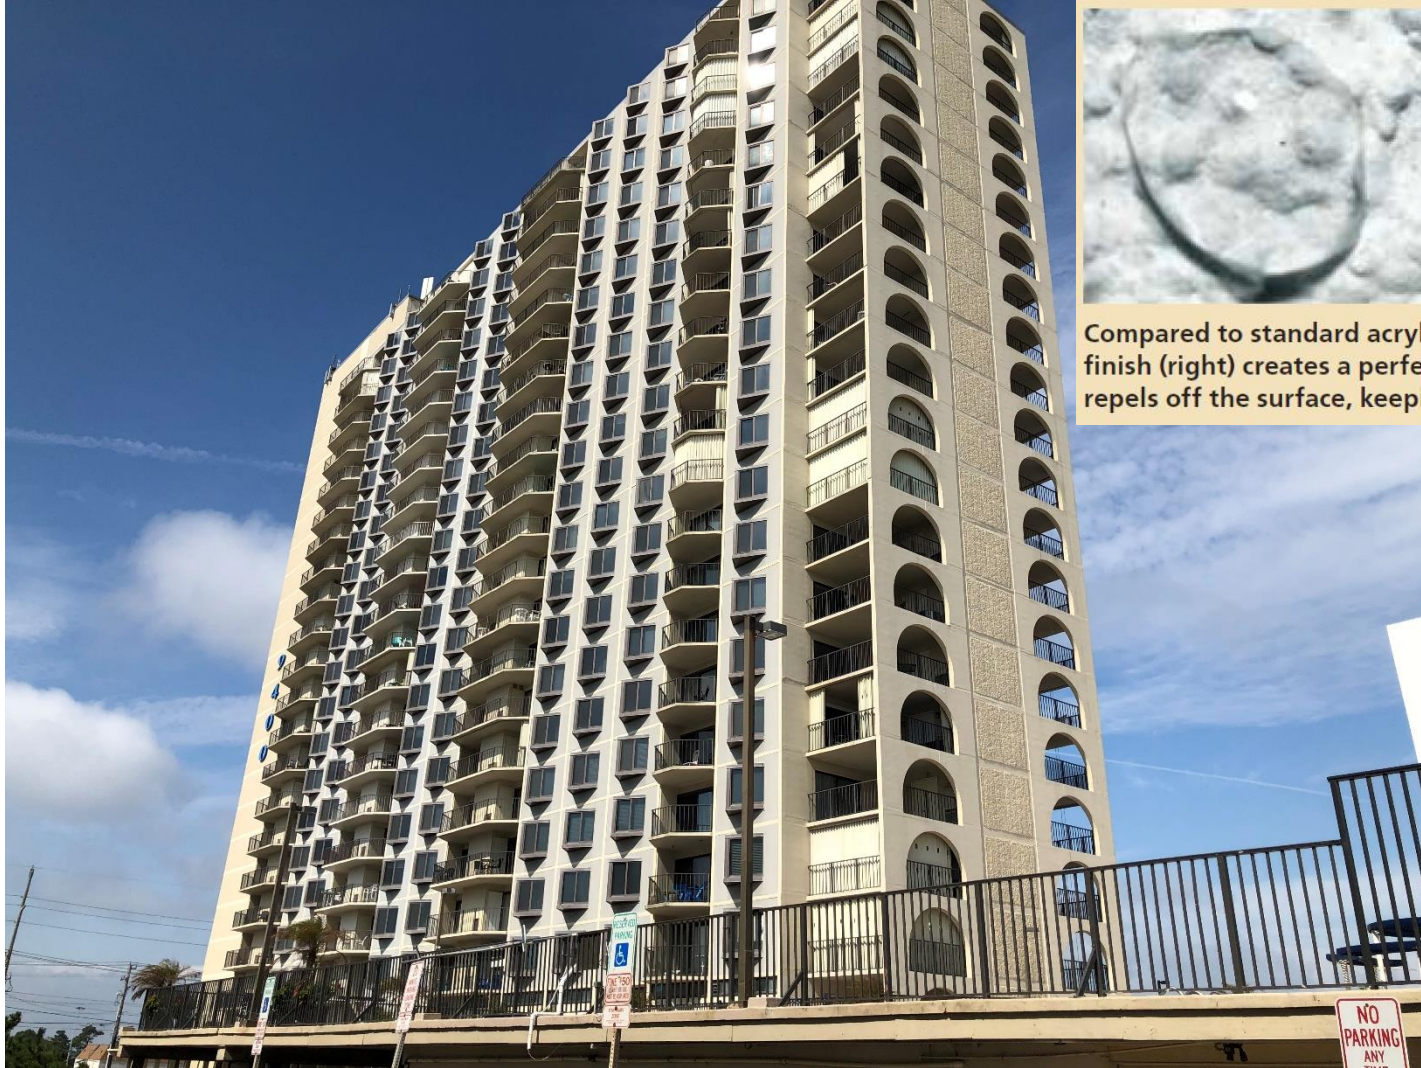
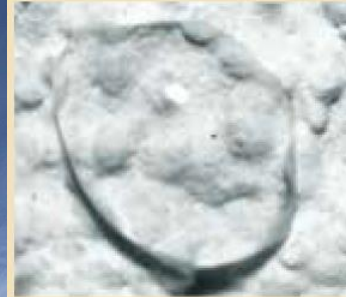
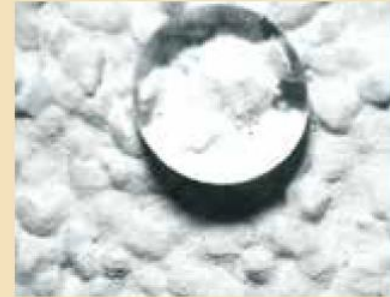
Compared to standard acrylic finishes (left), the AquaSol™ finish (right) creates a perfect spherical bead of water that repels off the surface, keeping it dryer and cleaner.

- Repels water to stay cleaner
- Reflects more UV light to remain cooler
- Reduces energy costs

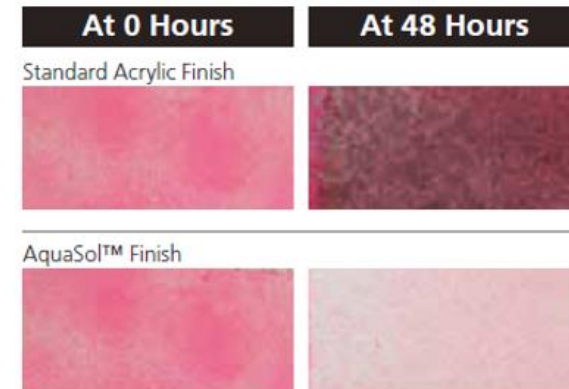
Rhodamine B Dye, which is formulated to imitate pollutants (known as smog), is applied to a standard acrylic finish and AquaSol™. After 48 hours of UV exposure, the Dye (pollutants) are decomposed demonstrating the pollution reducing effects.

The pollution reducing effects of AquaSol™ are best demonstrated above. As UV rays from sunlight hit the AquaSol™ surface, organic and inorganic pollutants are destroyed through an accelerated oxidation process called photocatalysis.

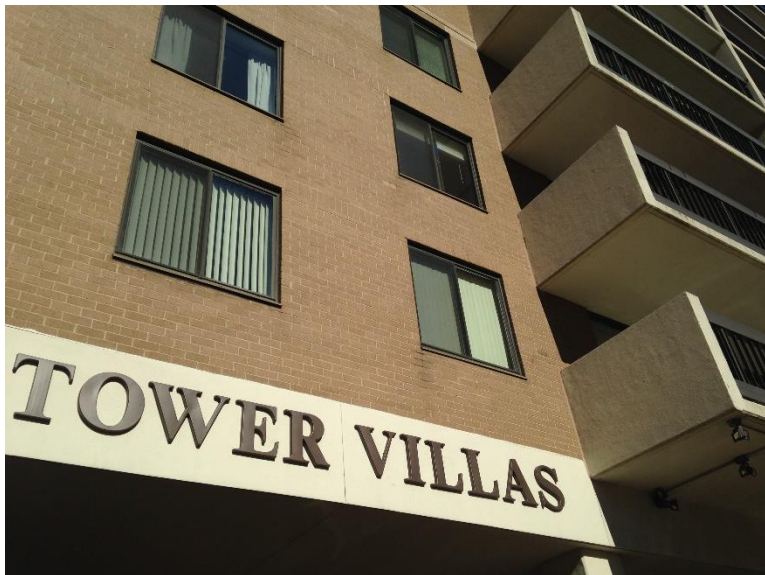
- Coating at 15 years old
- Actively protecting
- Looks good except where planter runoff occurs on face of balconies
- Could just power wash clean

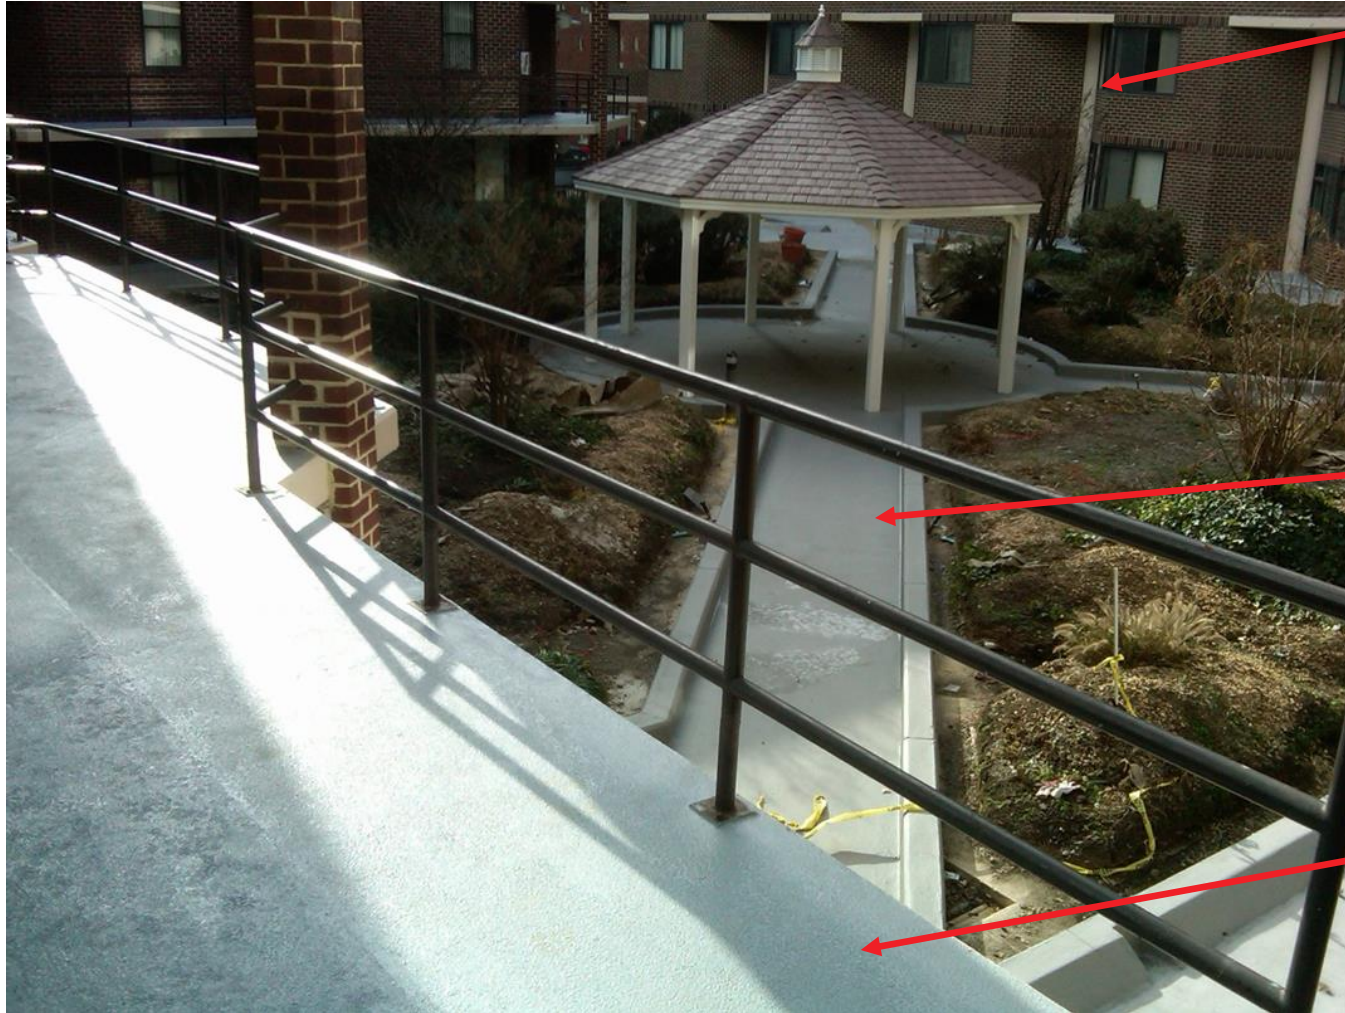
Sika Thorocoat 400 on vertical elements and soffit of decks

Sikagard FlexCoat System for on-grade traffic

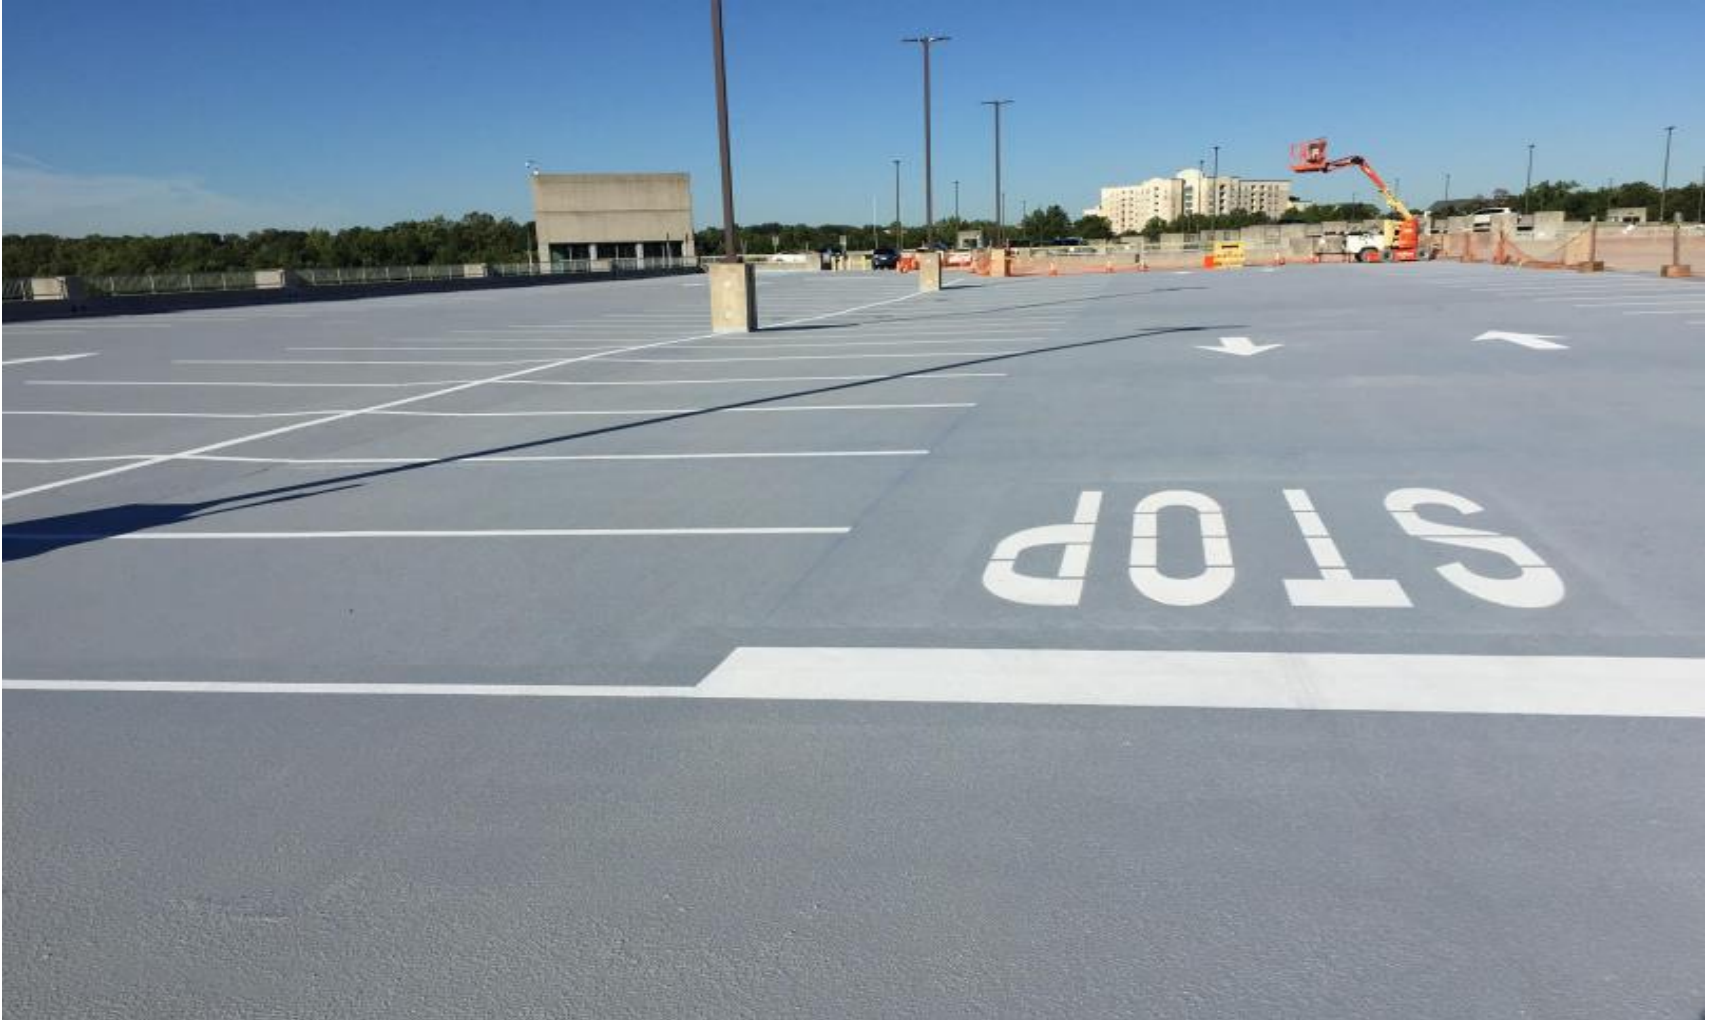
Franconia-Springfield Metro Station, VA 2015

SIKALASTIC TRAFFIC BEARING MEMBRANE (TRADITIONAL)

- Primer, urethane base coat, urethane seeded wear coat, urethane seeded top coat

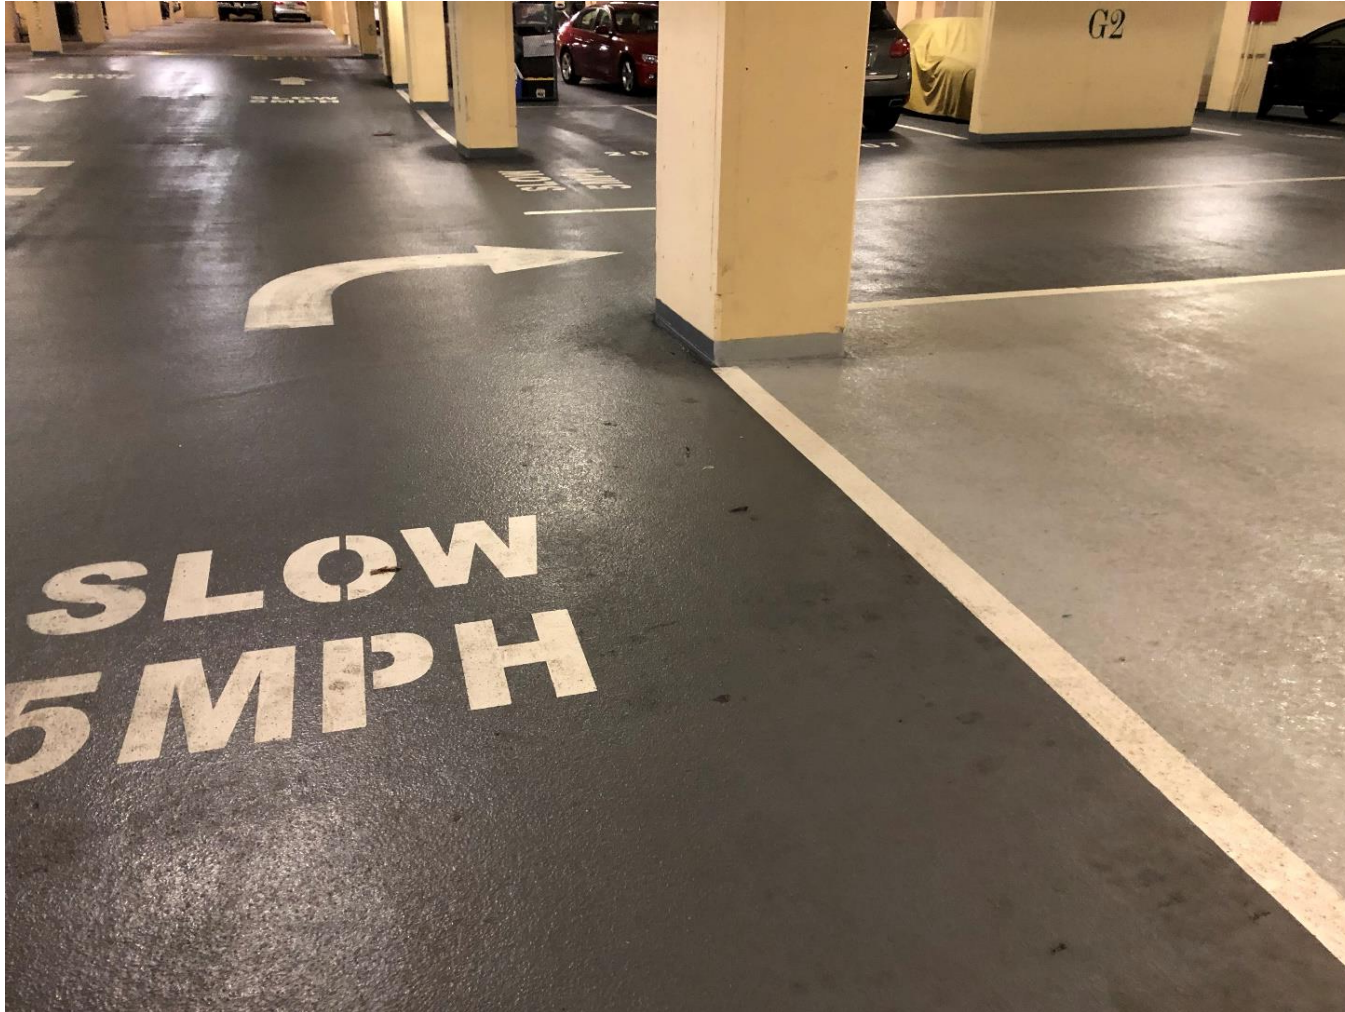
Northampton Place, Alexandria VA 2016

- Seamless, durable waterproofing protection
- Sikalastic Primer
Sikalastic 720
Sikalastic 745 AL
Sikalastic 745 AL

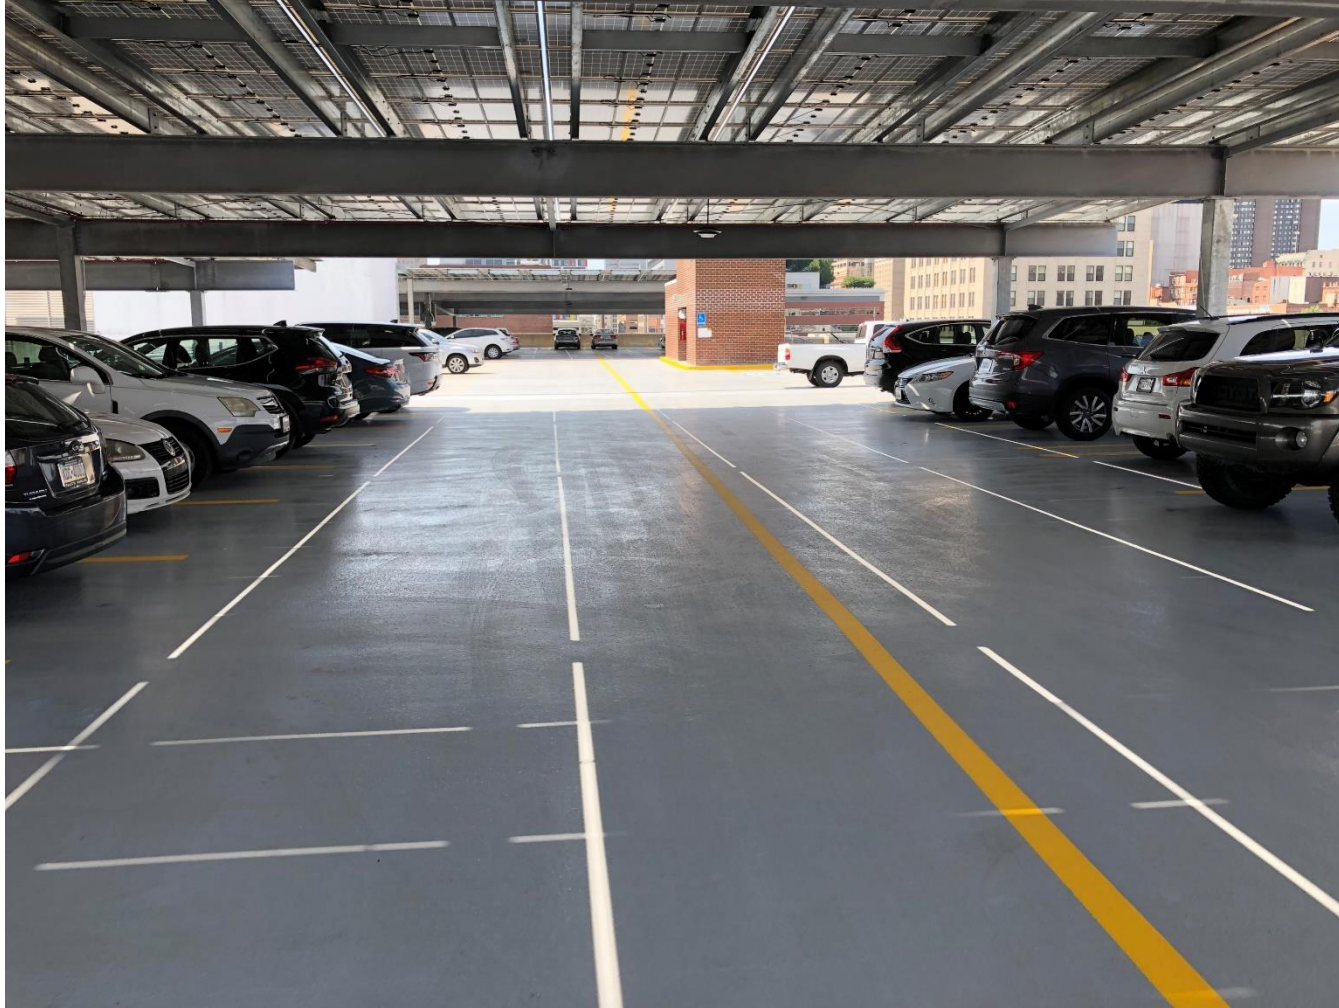
601 Calvert Street, Baltimore 2018

SIKALASTIC DECK PROTECTION

- Seamless, durable waterproofing protection
- Sikalastic Primer
Sikalastic M270
Sikalastic TC275
Sikalastic TC295

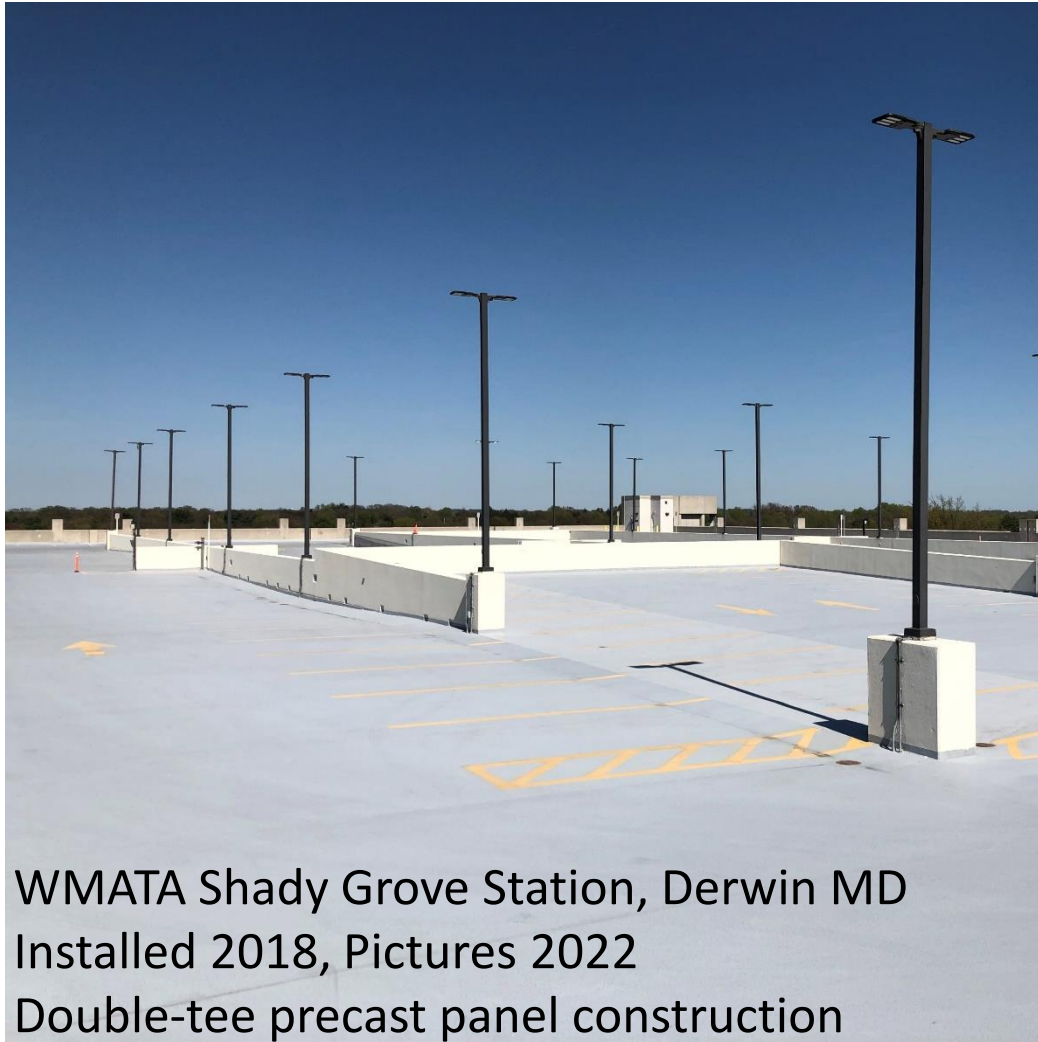
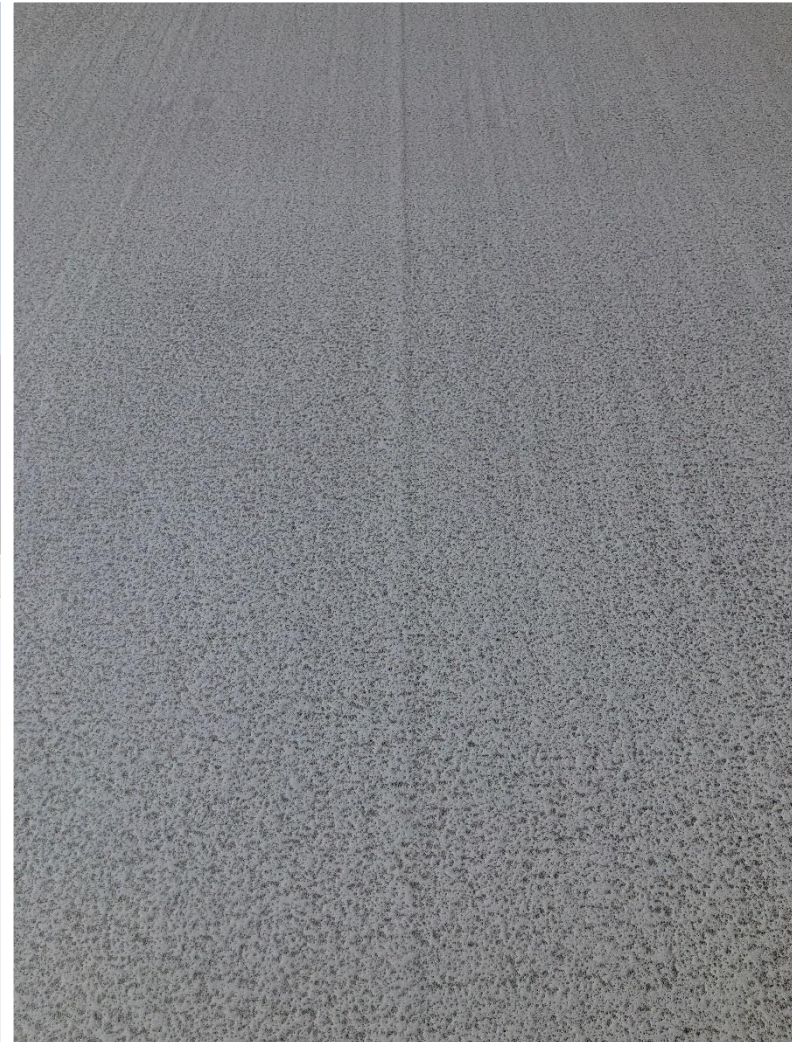
SIKALASTIC TRAFFIC BEARING MEMBRANE (TRADITIONAL)

- Primer, urethane base coat, urethane seeded wear coat, urethane seeded top coat
~ 23 mils ~ 14 mils ~ 18 mils

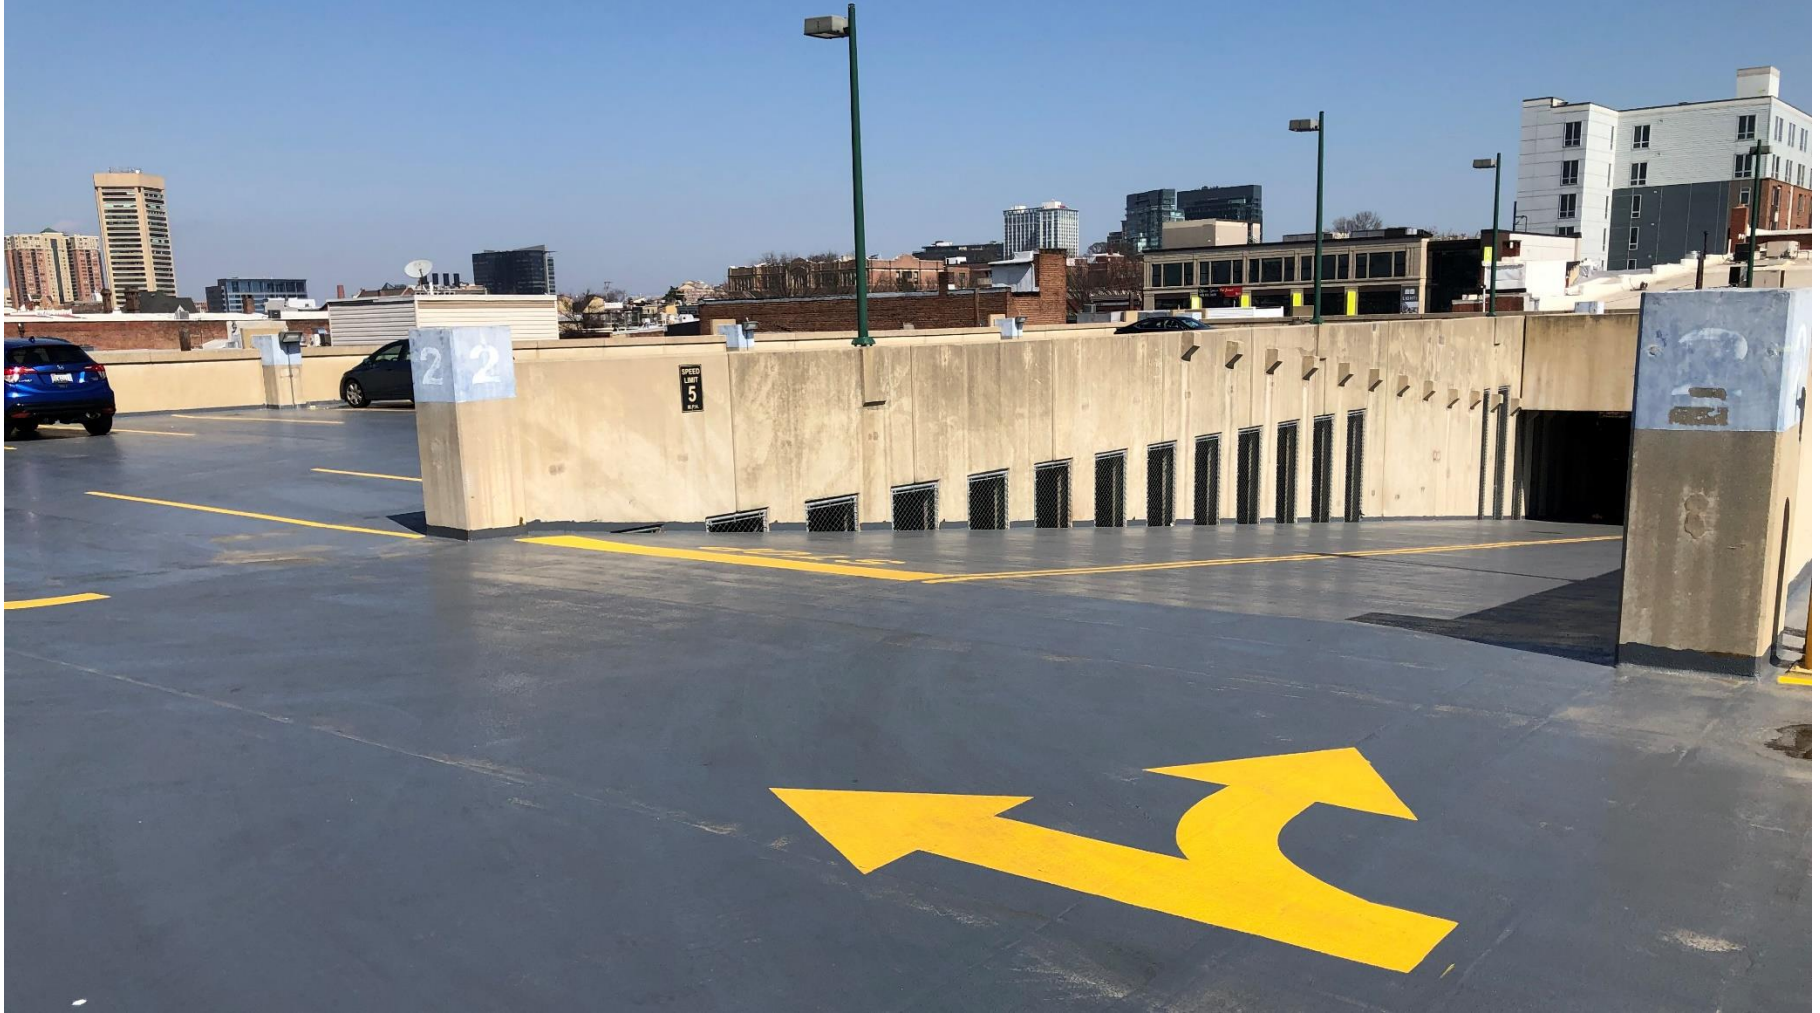
40 E West Street, Baltimore 2022

SIKALASTIC 720 ONE SHOT

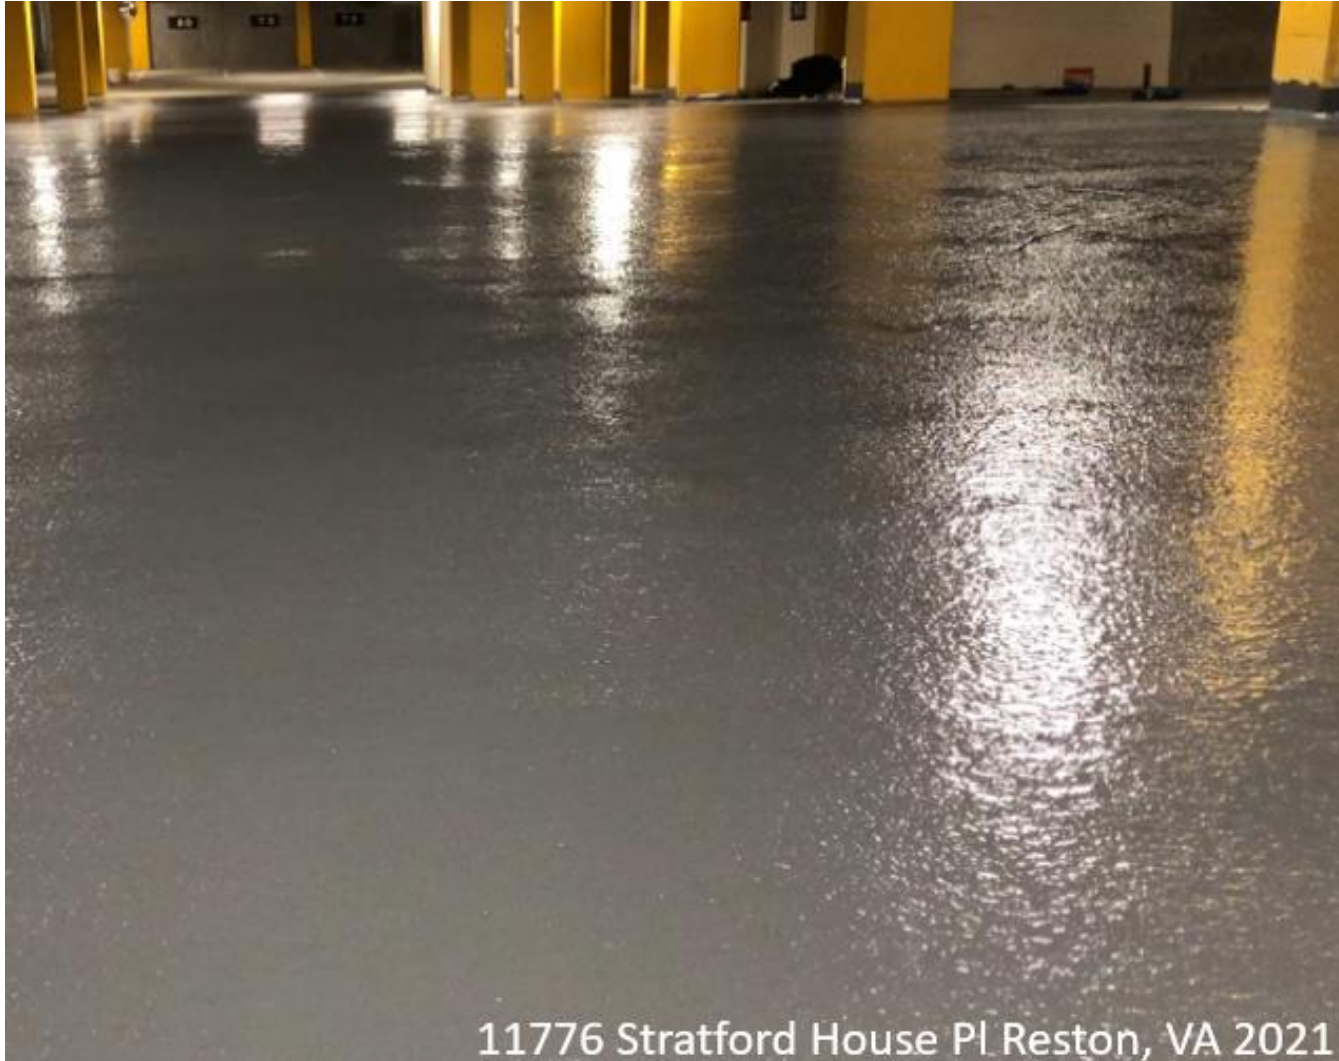
11776 Stratford House Pl Reston, VA 2021

SIKALASTIC 720 ONE SHOT

- Primer, **Sikalastic 720 One Shot**

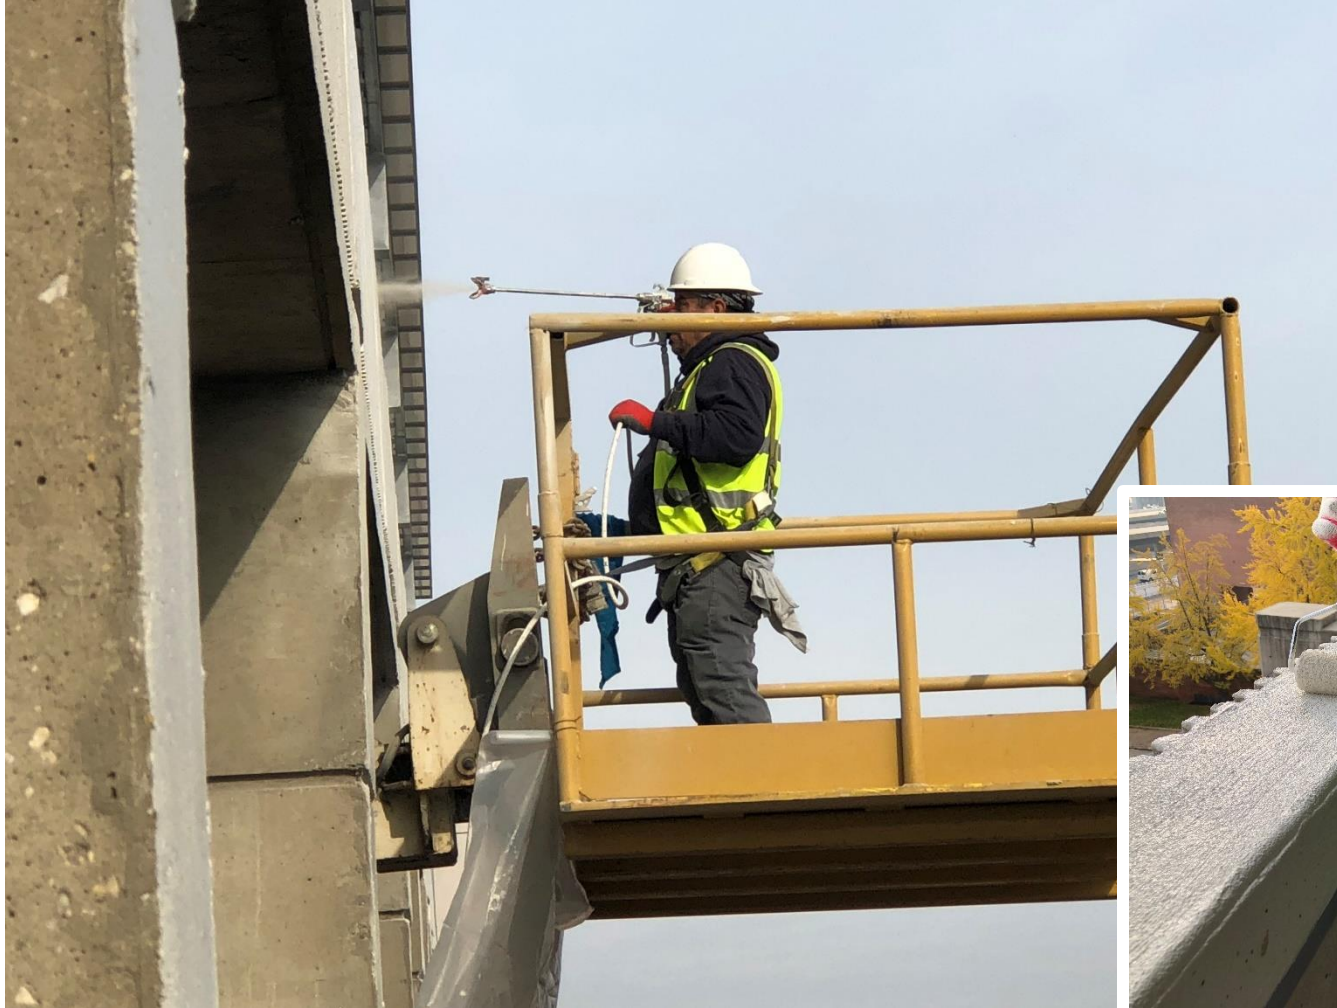
601 Calvert Street, Baltimore 2018

SIKA WALL PROTECTION

- Seamless, breathable waterproofing protection
- Sika Thorolastic 750

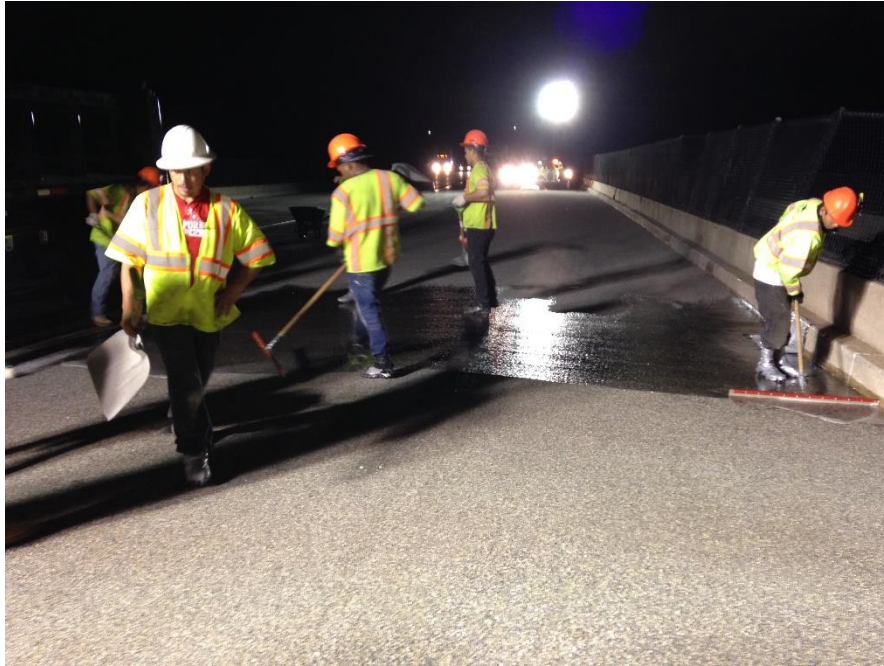
I-95 MD, 2015

- Epoxy fully-seeded system, epoxy fully-seeded system

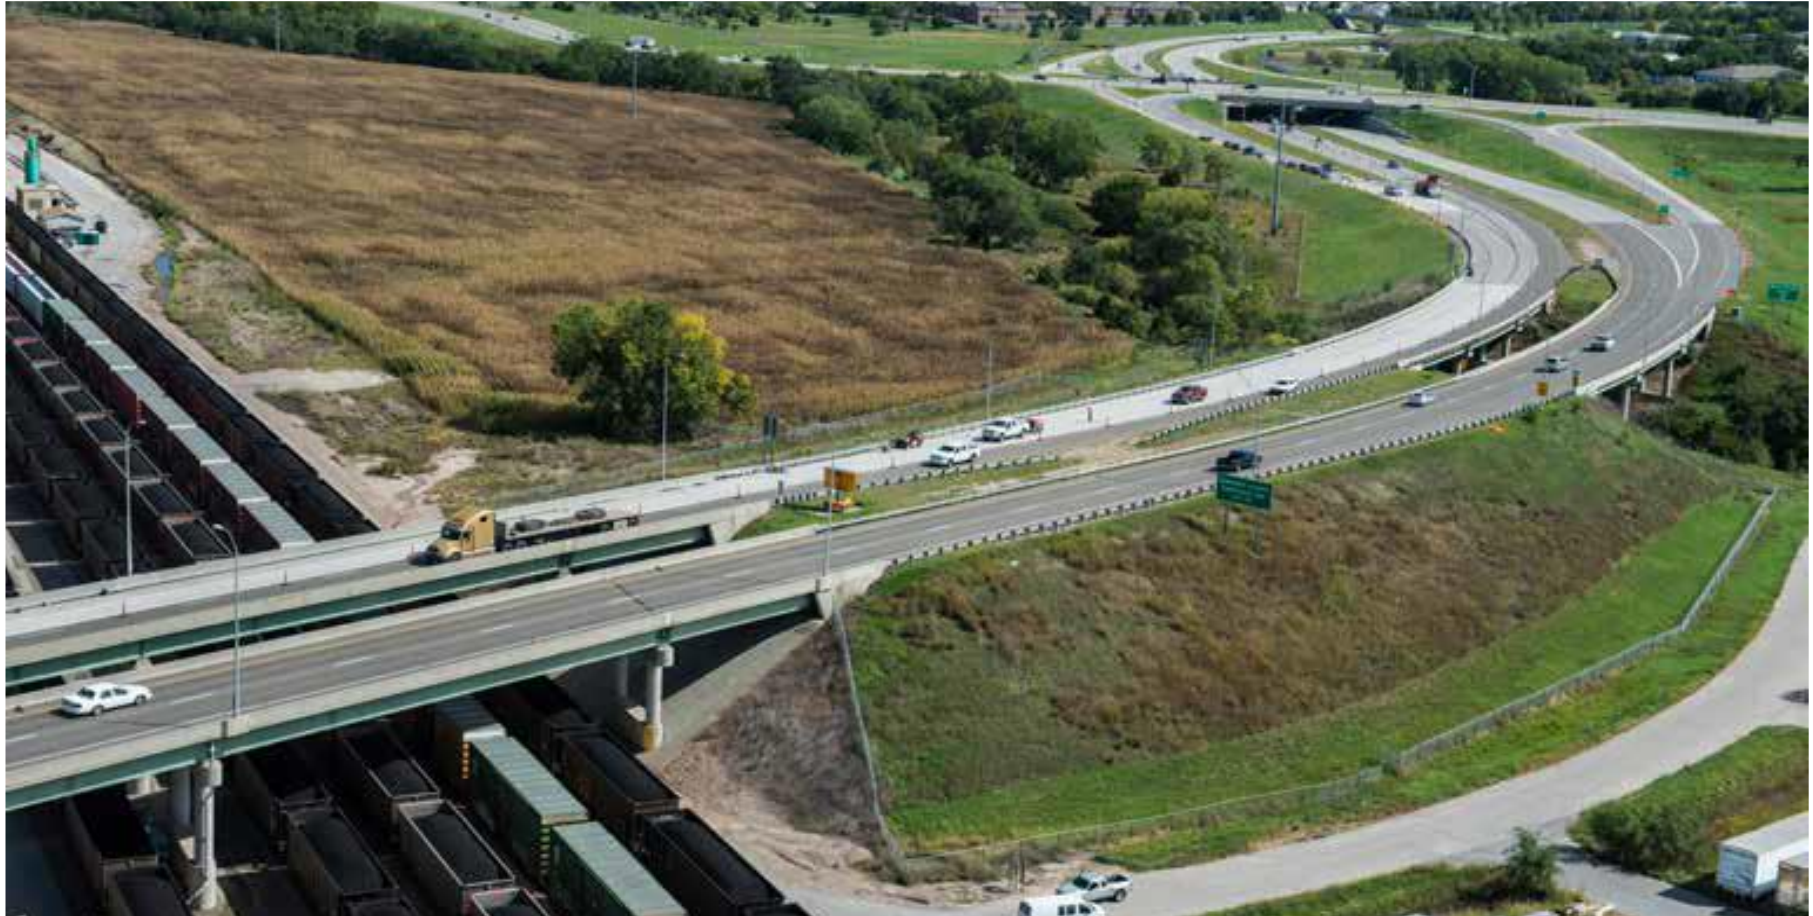
US-77, Lincoln Nebraska 2015

- Epoxy fully-seeded system

- 1 coat on roads (50 mils)
- 2 coats on bridges (100 mils)
