CONCRETE PROTECTION

RANDALL KRATZ – DISTRICT MANAGER MD/DC/VA
SIKA CORPORATION – REFURBISHMENT, SEALING & BONDING
WITH SIKA SINCE 1991
GRADUATE DREXEL UNIVERSITY - COMMERCE & ENGINEERING
410-336-3757

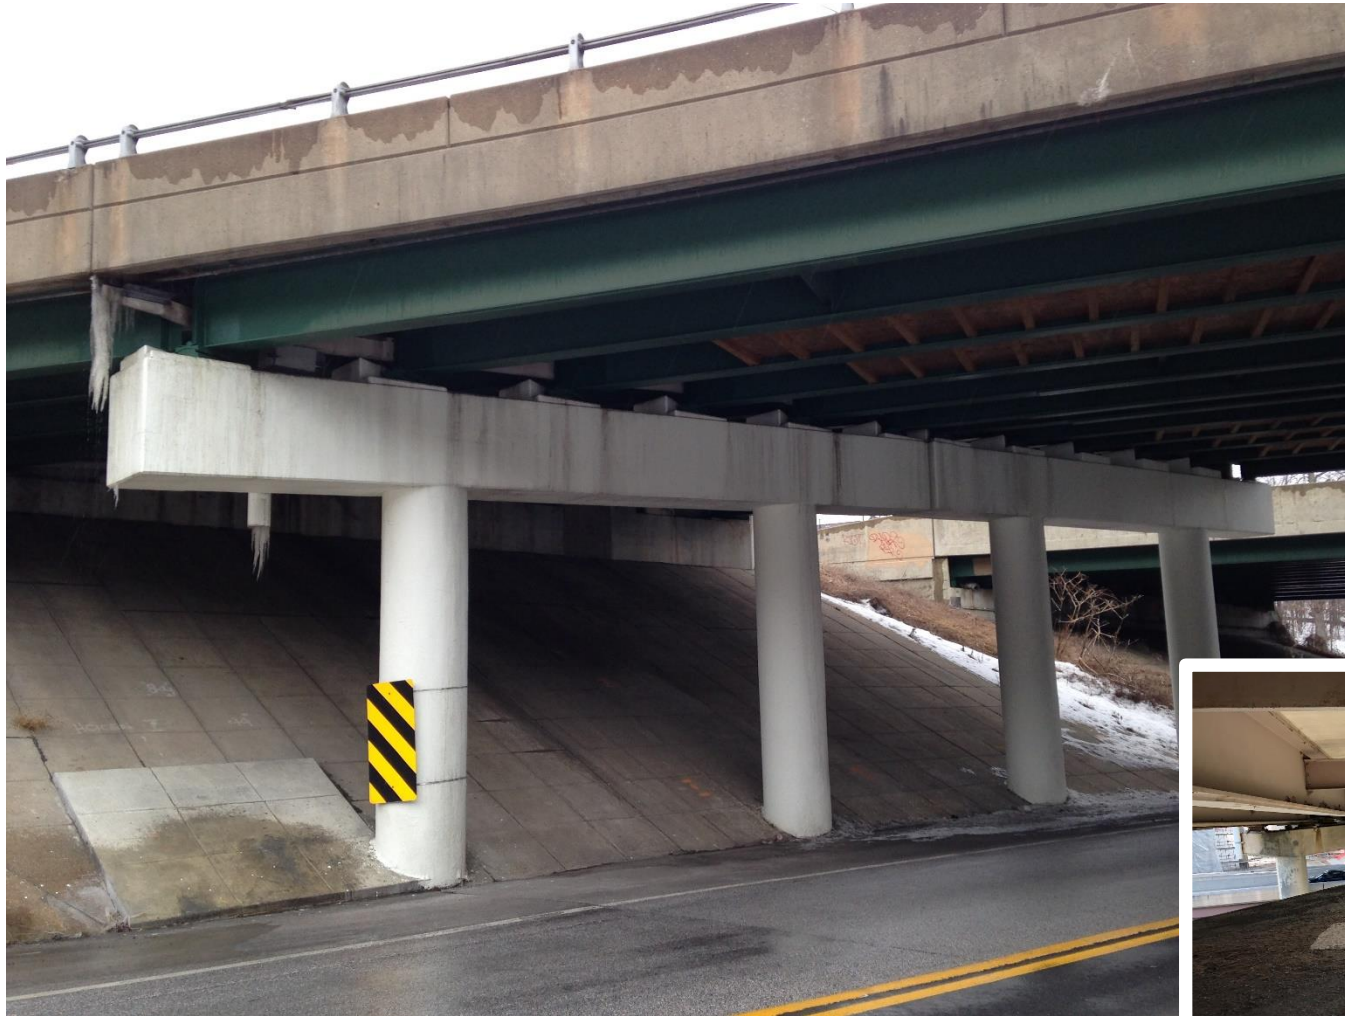
- Substructure protection
- Waterproofing
- Sikalastic polyurethane on top of pier cap
- Sika breathable acrylic on rest

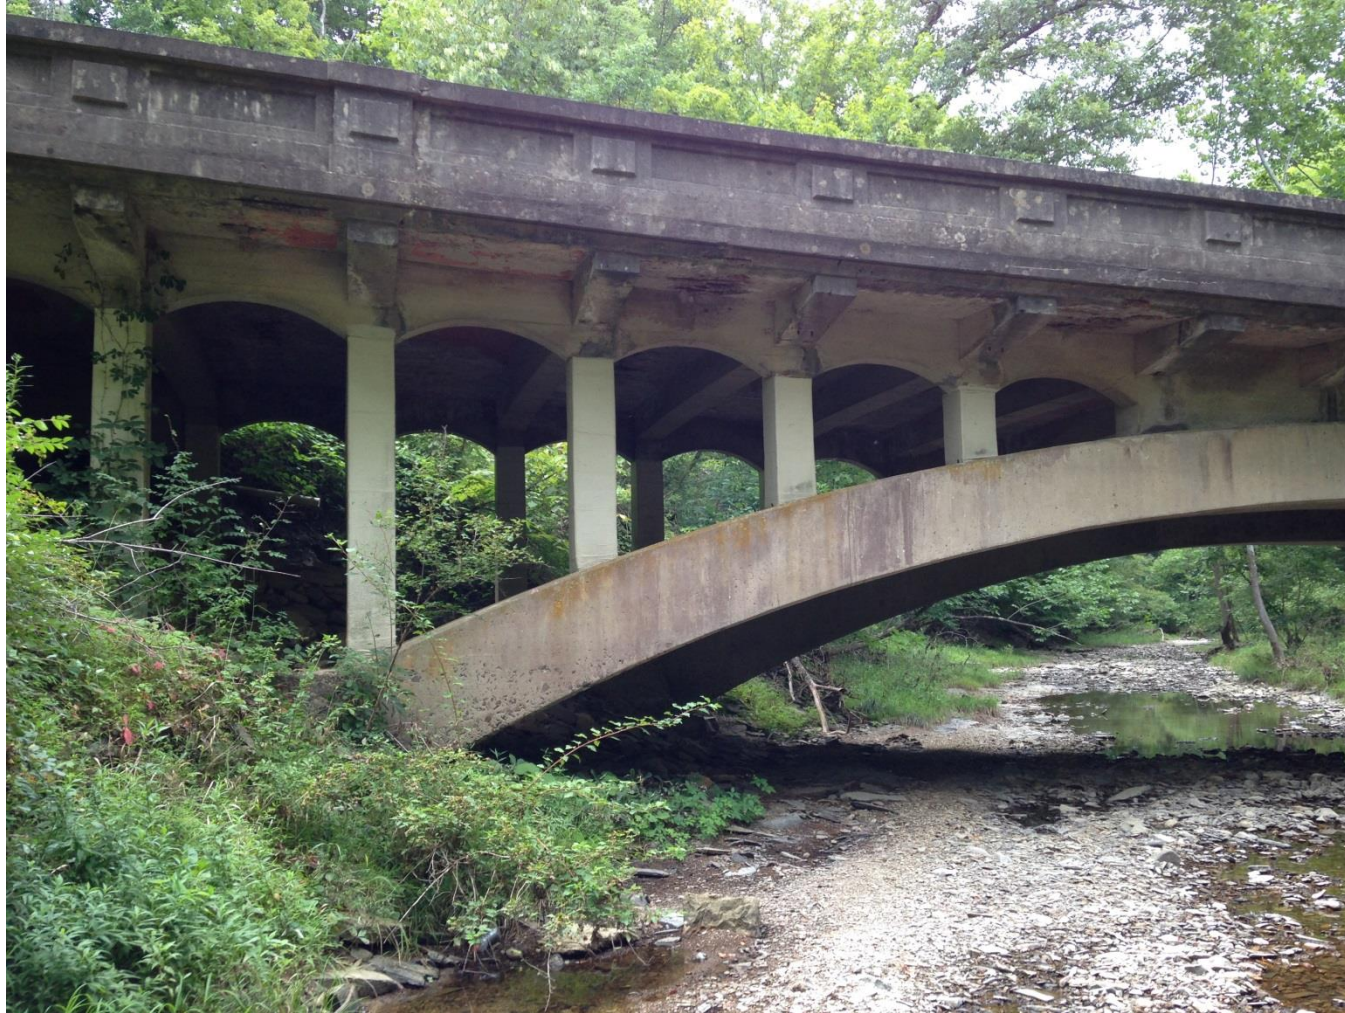
15 Mile Creek, Garrett County MD
Installed 1998, Picture 2016

- Substructure protection
- Waterproofing
- Sikalastic polyurethane on top of pier cap
- Sika breathable acrylic on rest

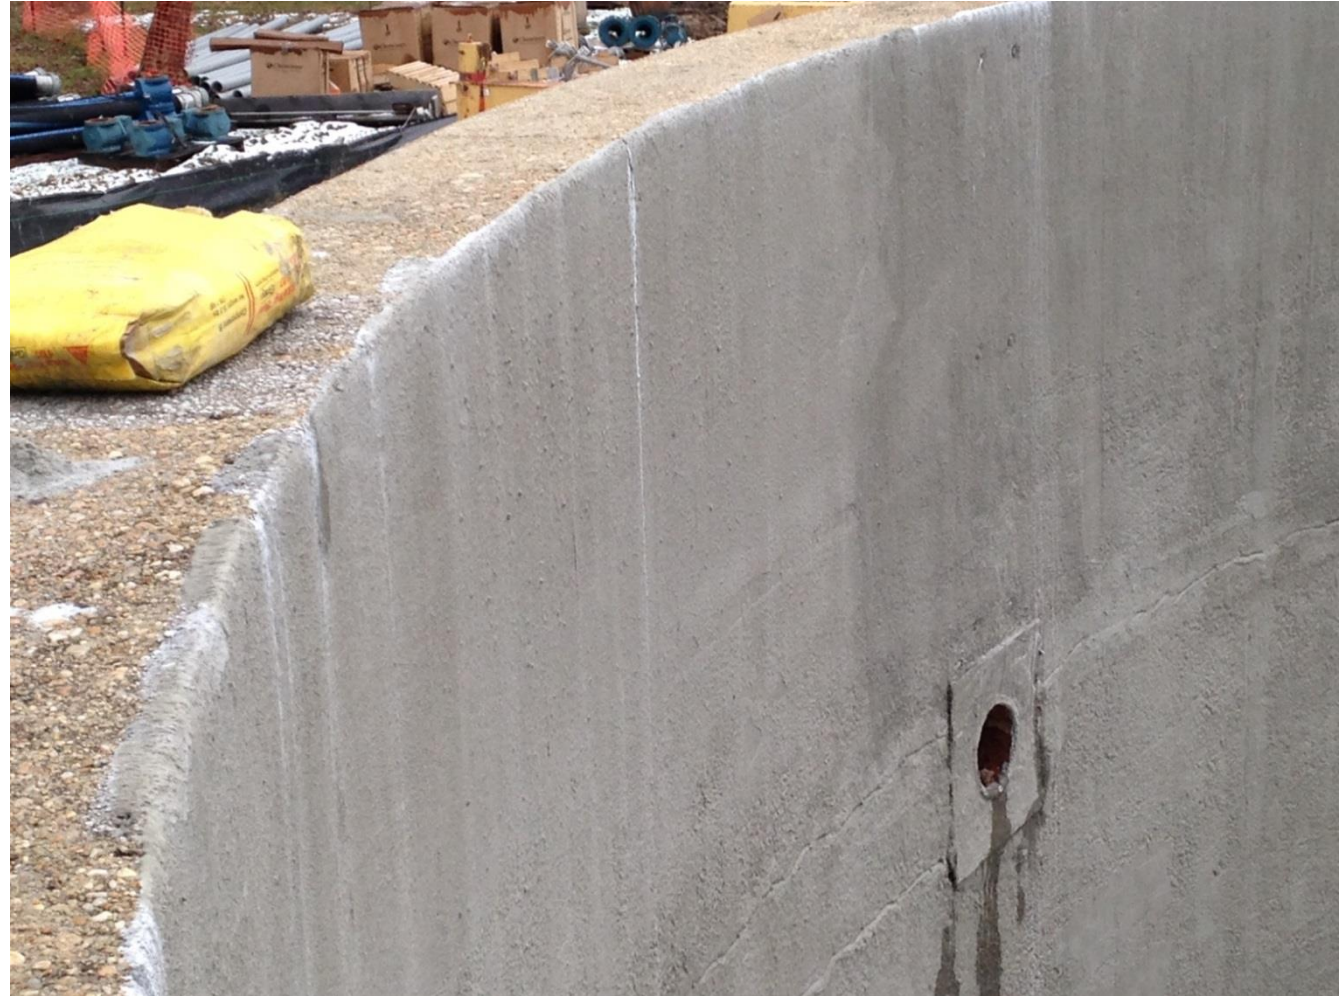
Aberdeen Proving Grounds 2009

- Polymer-modified, cement-based coating
- Waterproofing
- Constant immersion service
- Breathable
- Tolerates fine cracks ~ 15 mils (1/64" wide)
- Fills in bug-holes and surface irregularities

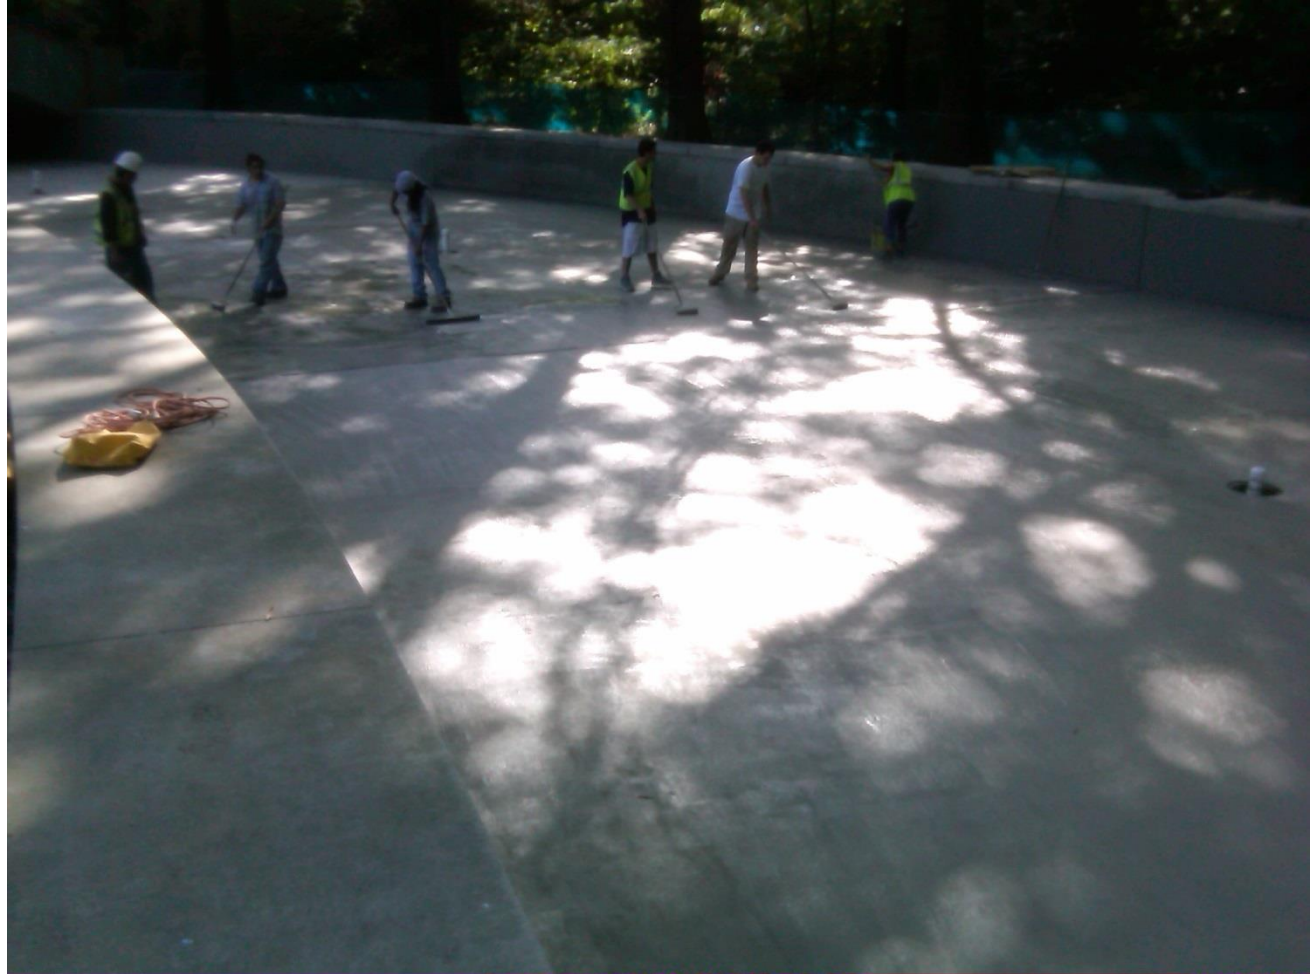
Theodore Roosevelt Monument Reflecting Pool 2011

Apply by

- Roller
- Squeegee
- Trowel
- Brush
- Spray

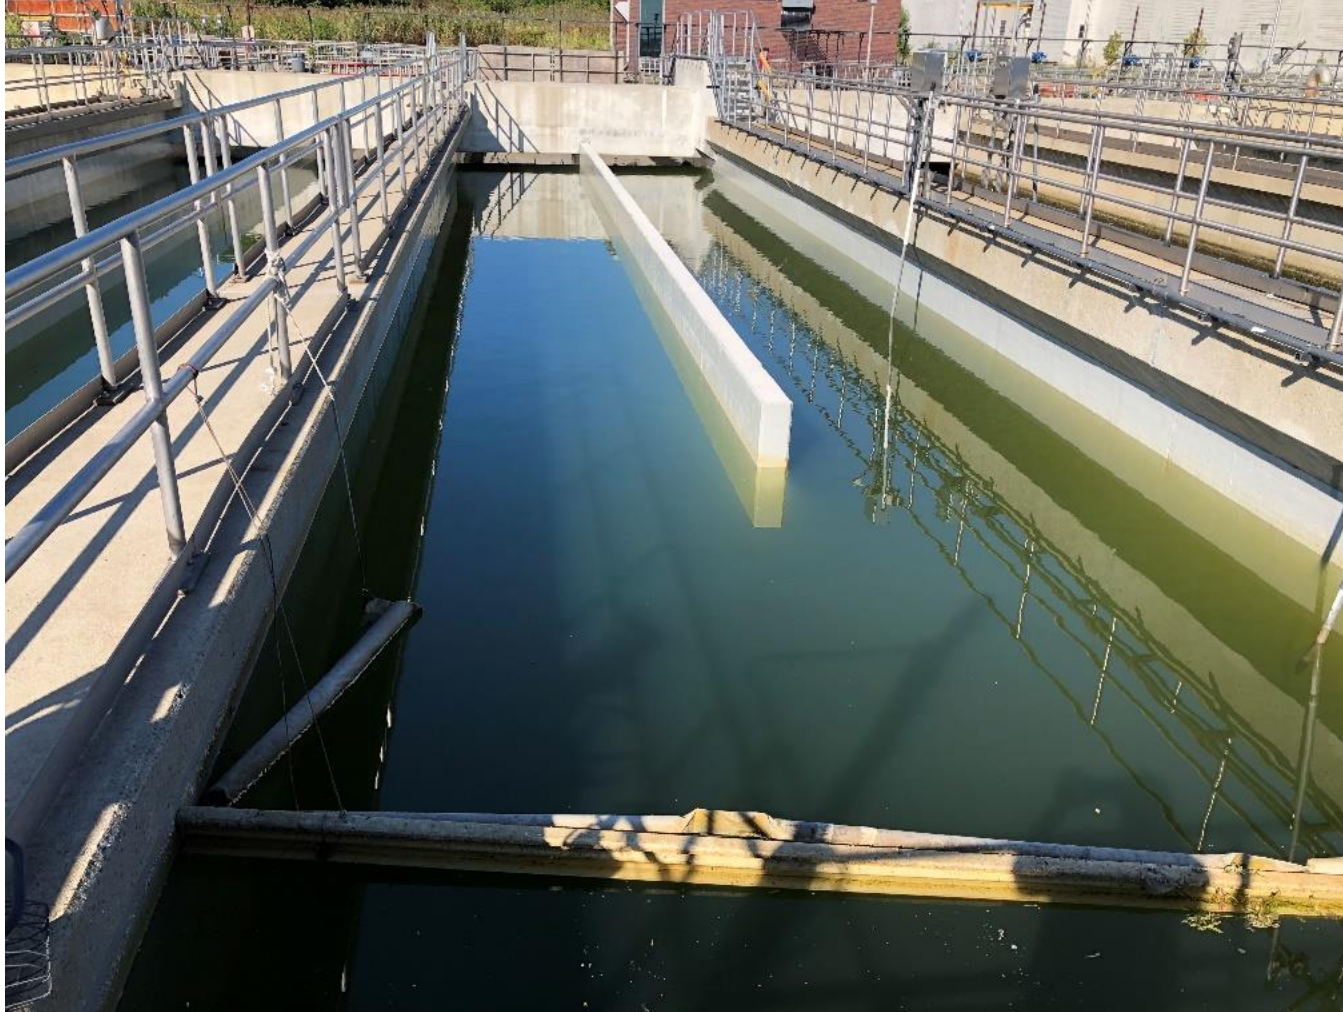
Patapsco WTP, Baltimore 2019

- Epoxy and epoxy novolac coatings
- Waterproofing
- Constant immersion service
- **Chemical resistant**
- Durable
- ANSI Standard 61 Potable Water Approved

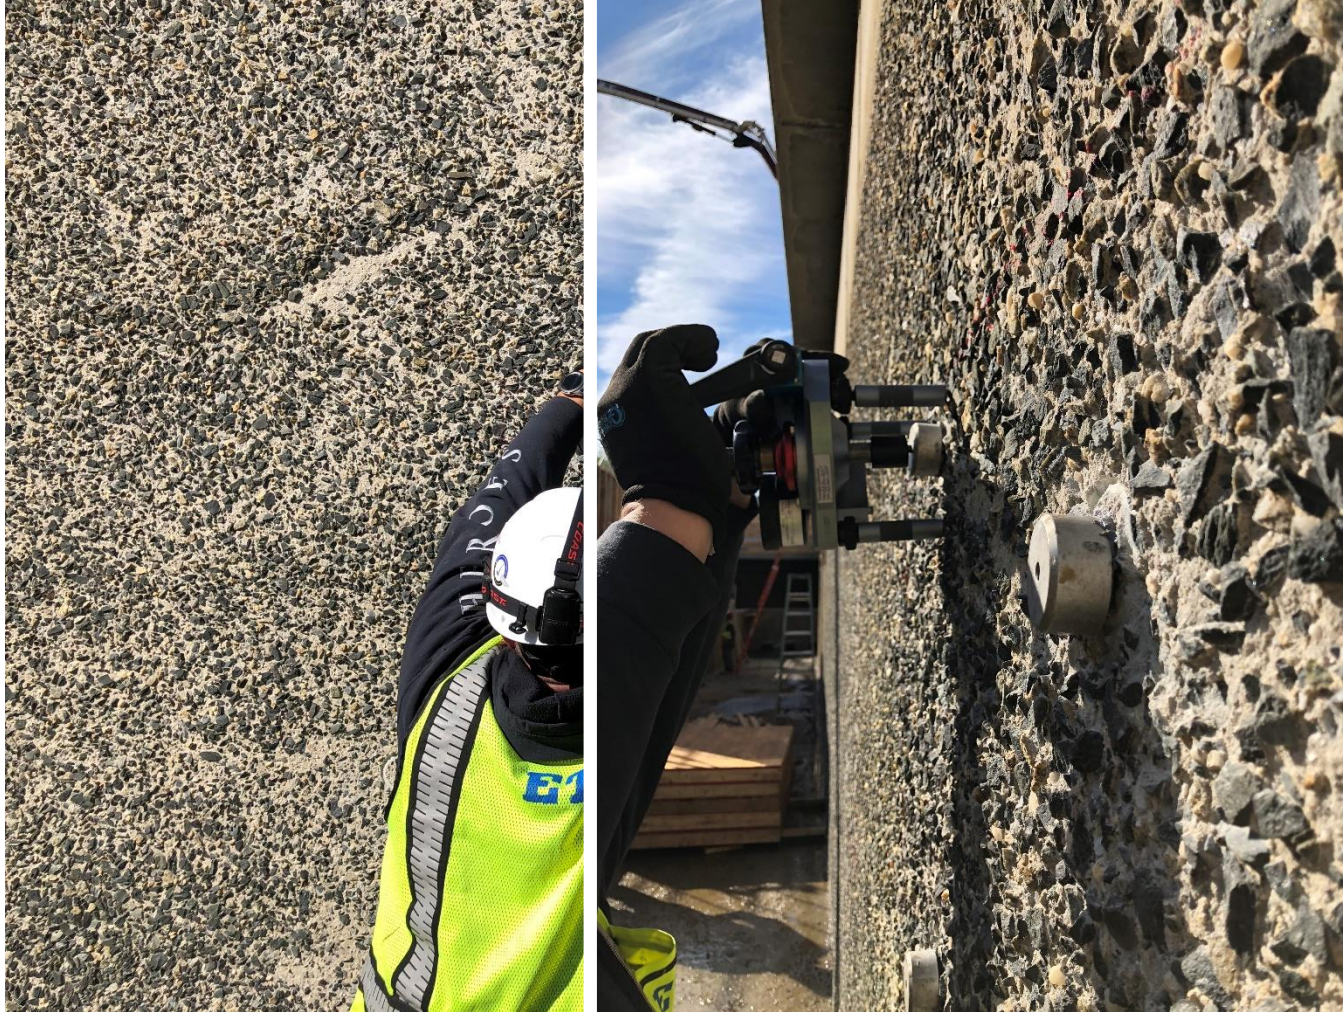
SIKAGARD 62 AND SIKAGARD 600

- Epoxy and epoxy novolac coatings
- Waterproofing
- Constant immersion service
- **Chemical resistant**
- Durable
- ANSI Standard 61 Potable Water Approved
- Prevent deterioration

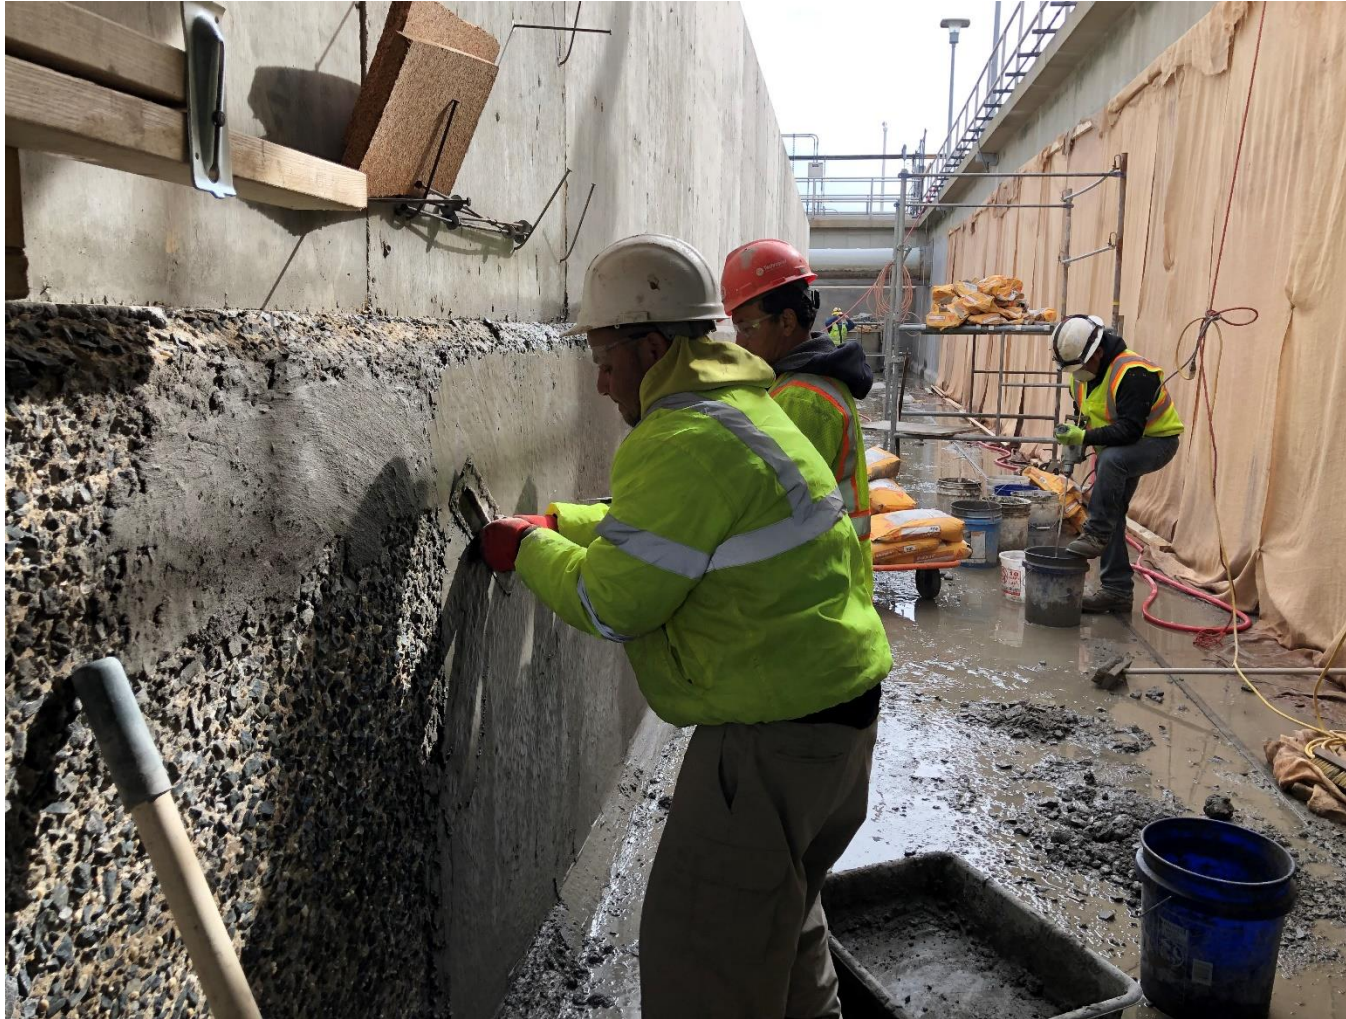
Patapsco WTP, Baltimore 2019

SIKAGARD 62 AND SIKAGARD 600

- Epoxy and epoxy novolac coatings
- Waterproofing
- Constant immersion service
- **Chemical resistant**
- Durable
- ANSI Standard 61 Potable Water Approved
- Prevent deterioration
- Avoid high-cost repairs

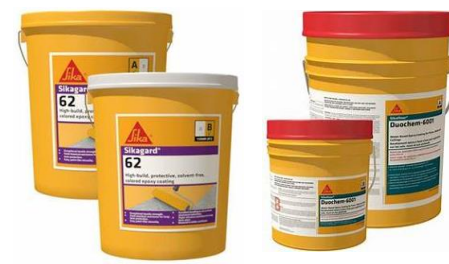
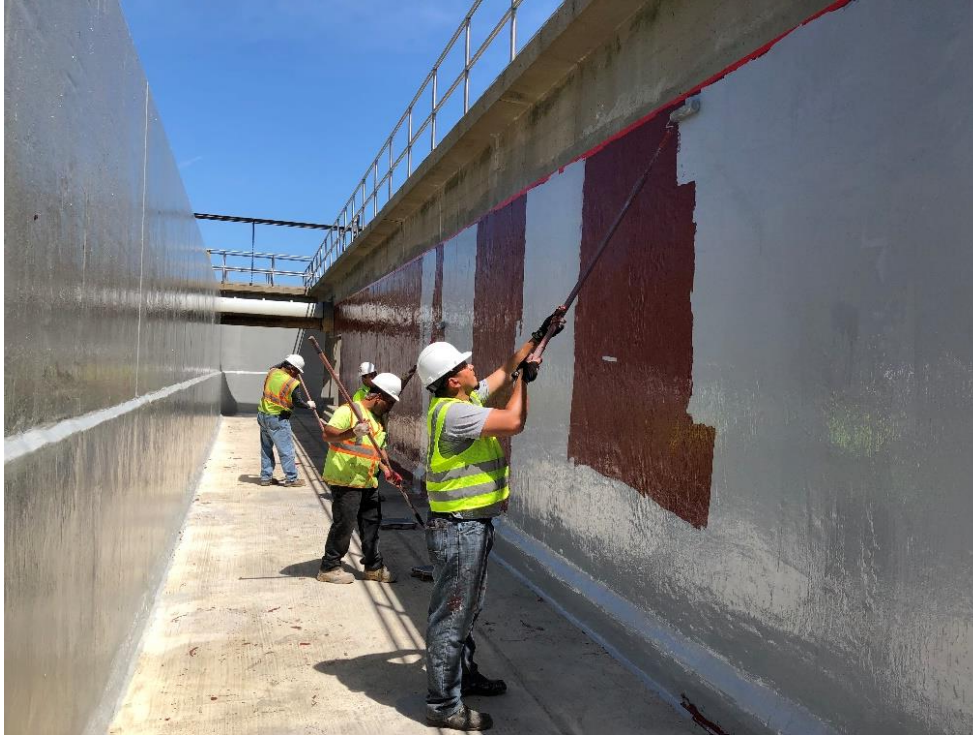
Patapsco WTP, Baltimore 2019

SIKAGARD 62 AND SIKAGARD 600

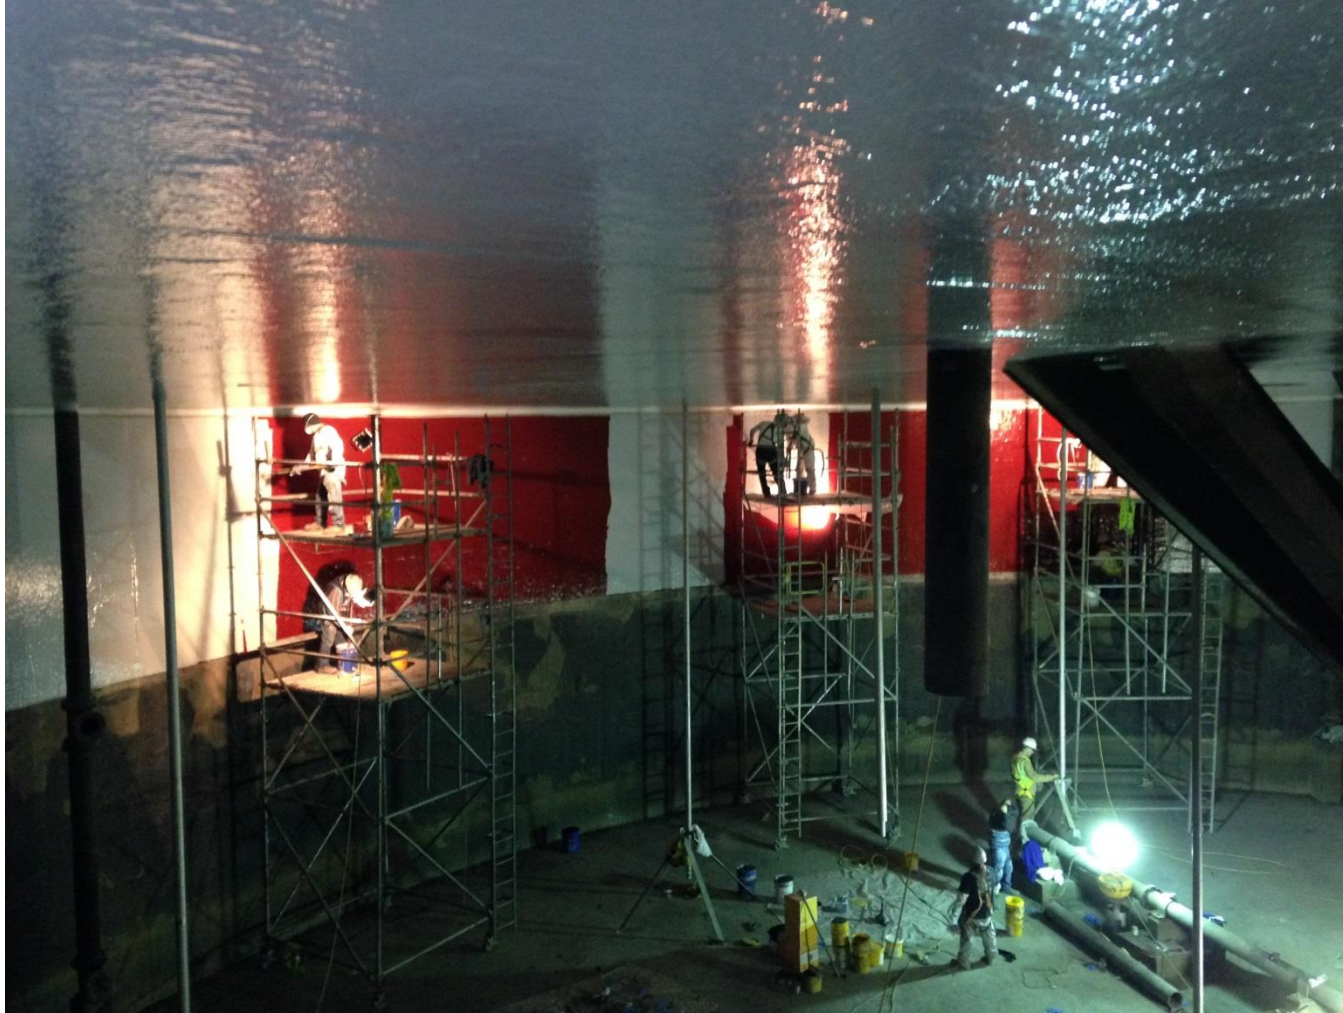
Back River WWTP, Baltimore 2014

SIKAGARD 62 AND SIKAGARD 600

- 20 mil typical build
- Red coat/gray coat assists in verifying thickness of each coat
- Red coat/gray coat for half-life indicator

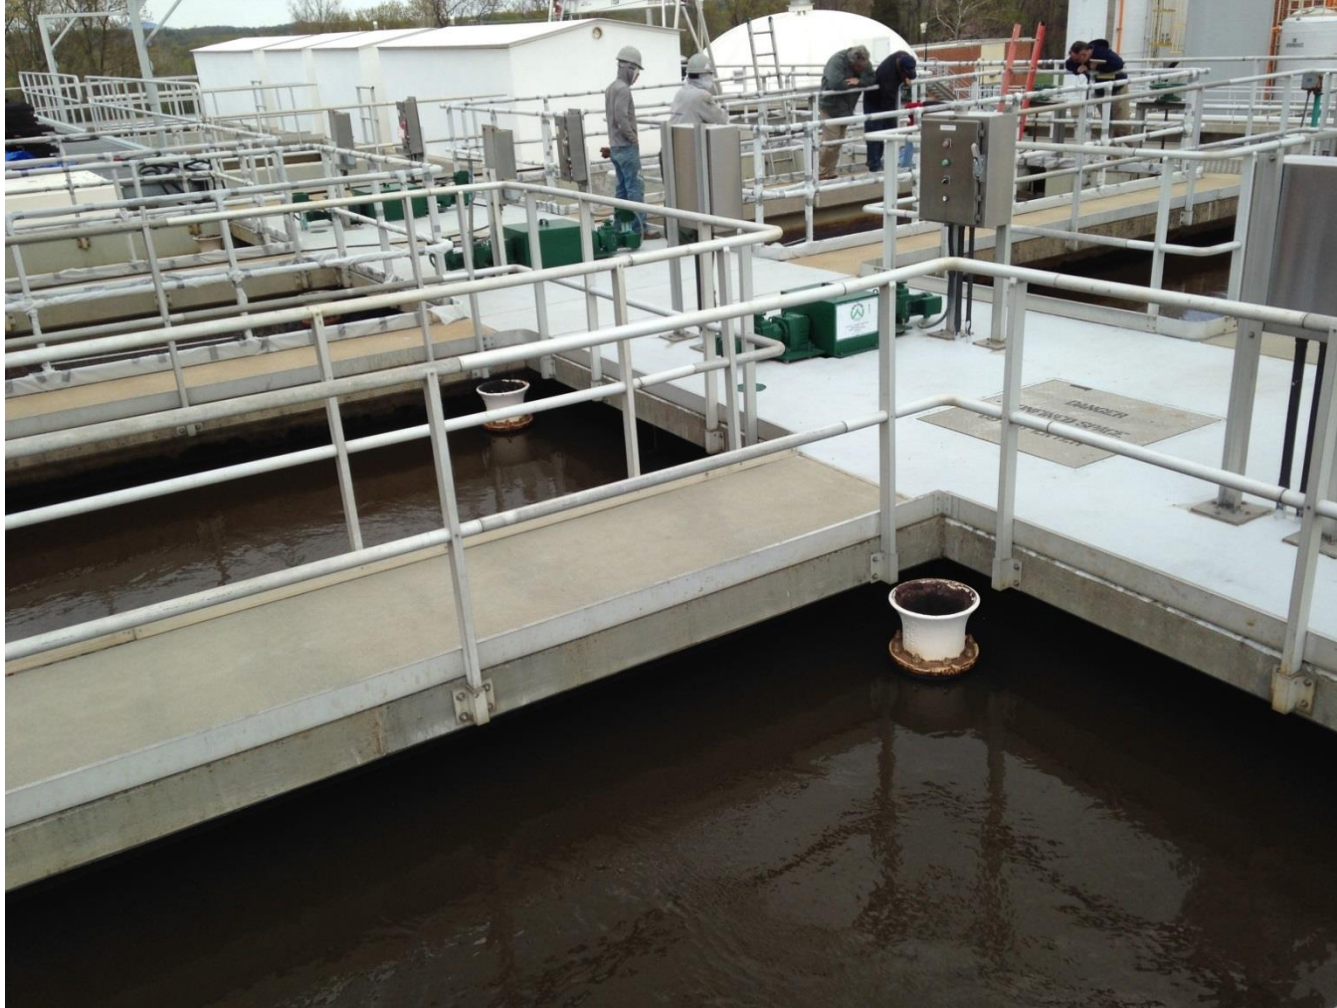
Leesburg WWTP, VA 2015

SIKAGARD 62 AND SIKAGARD 600

- Long service life
- This plant had Sikagard 62 already in service for over 30 years

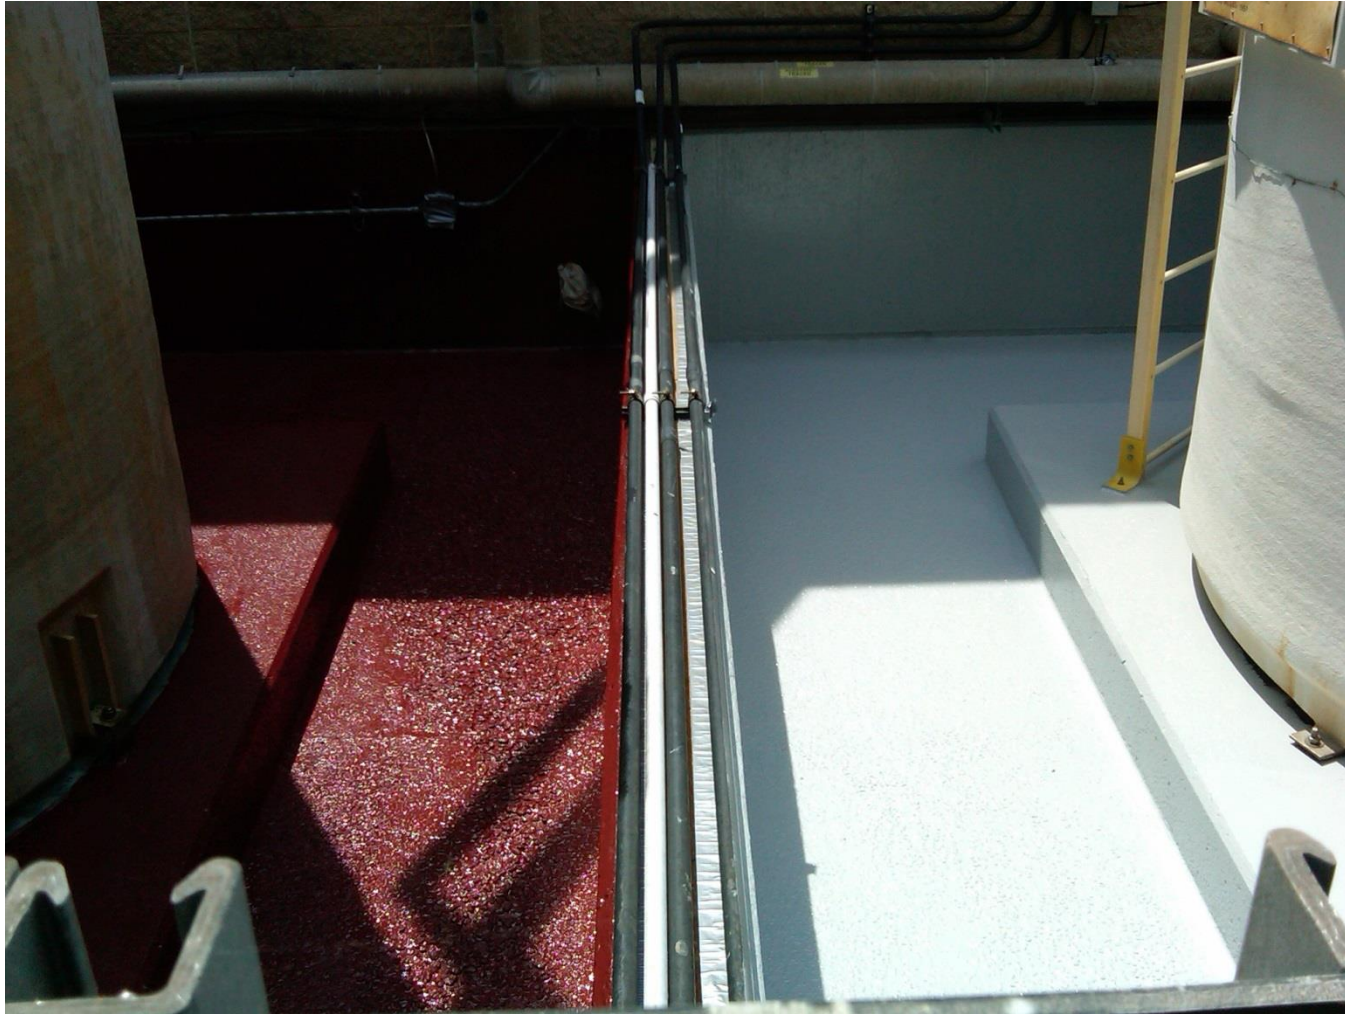
Secondary Containment

SIKAGARD 62 AND SIKAGARD 600

- Chemical(s)
 - Concentration(s)
 - Temperature
 - Contact time
-
- Need for chemical resistance outweighs breathability

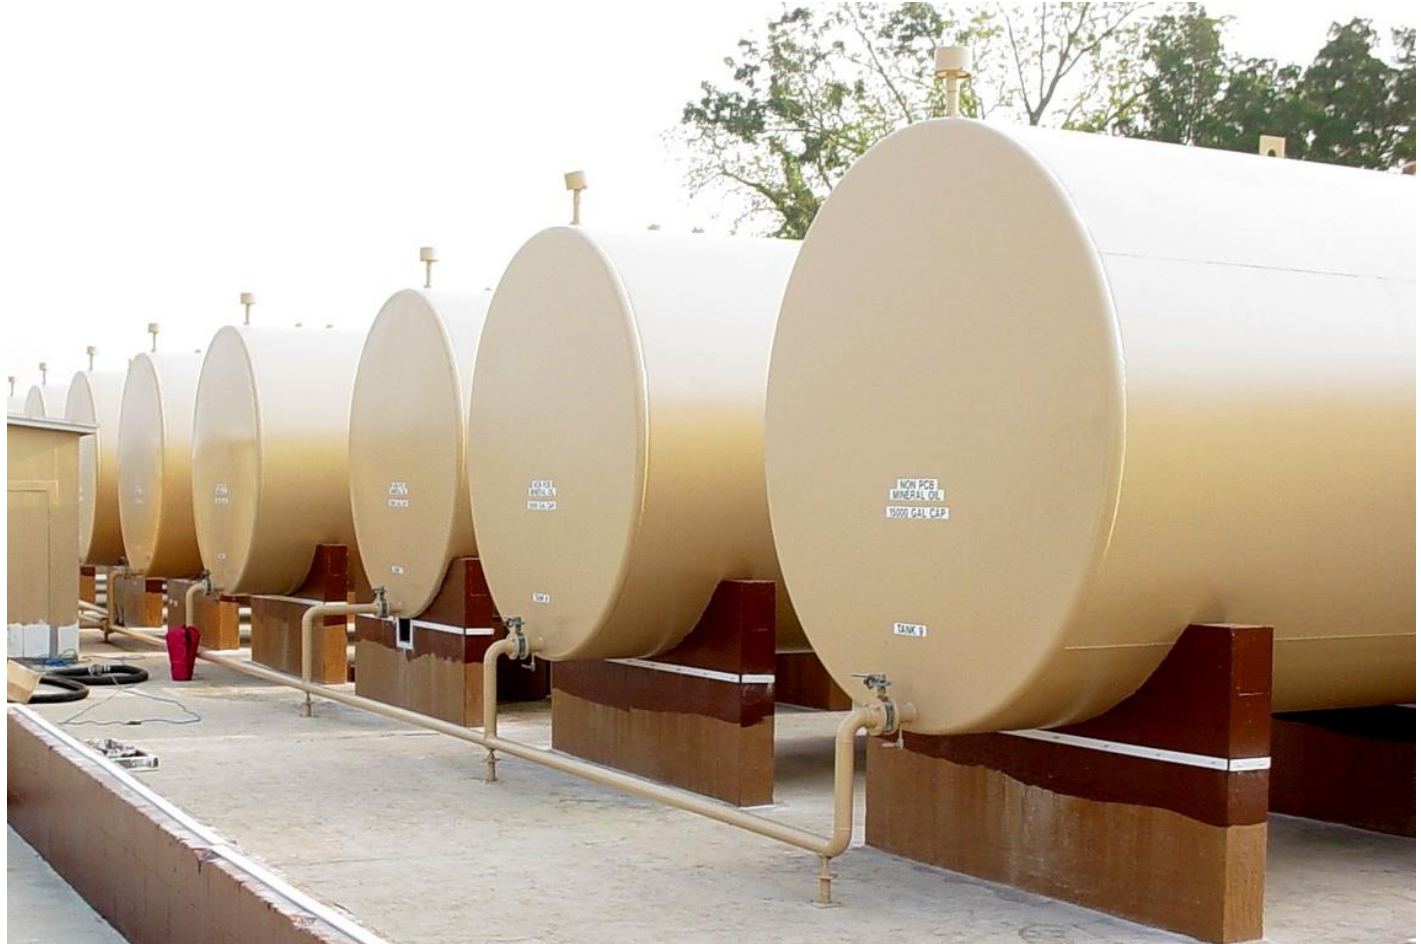
Secondary Containment

- Epoxy-novolac for strong acids pH 1-3
- Higher acid concentrations
- Higher acid temperatures
- Prolonged acid contact

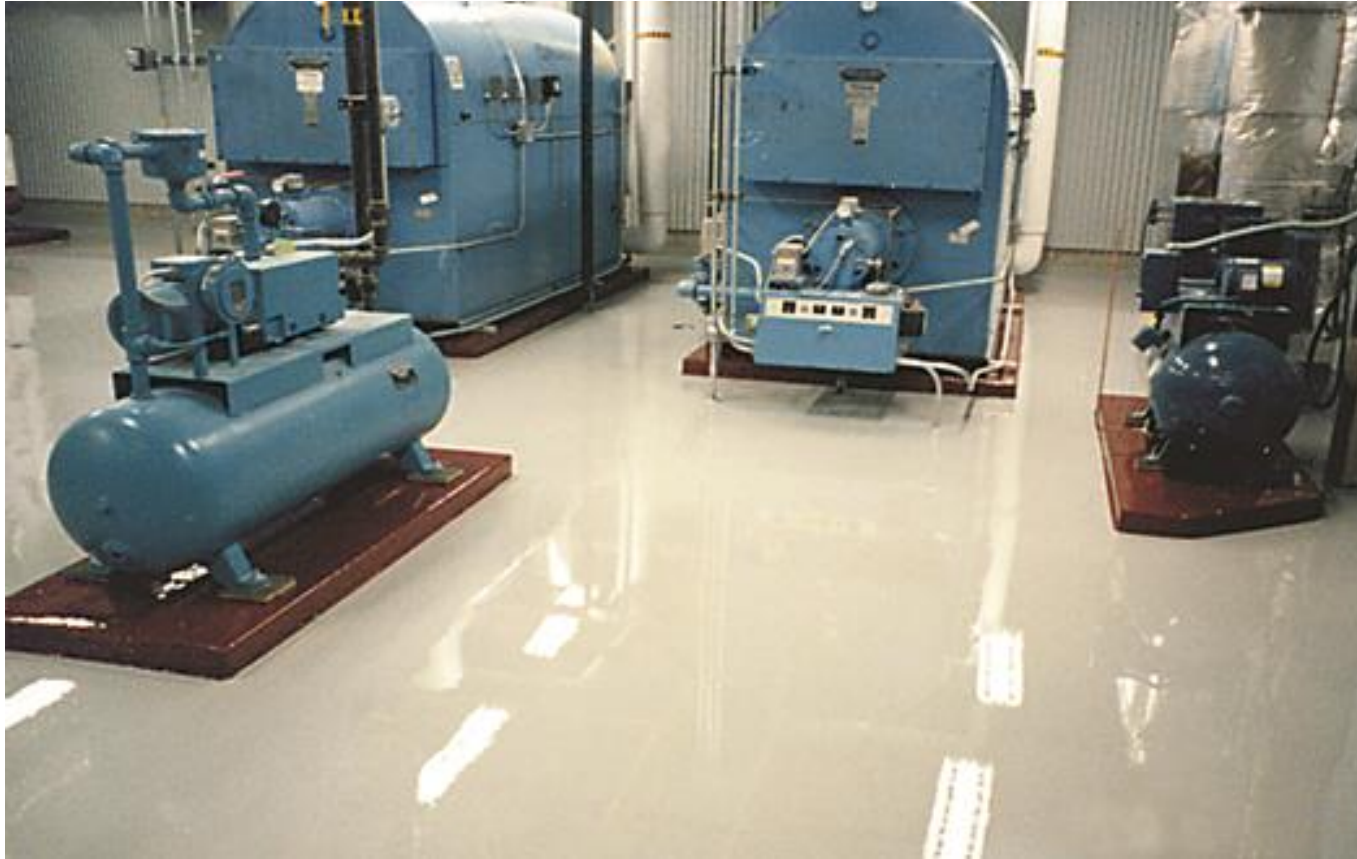
SIKAGARD 62 AND SIKAGARD 600

- Excellent for interior flooring

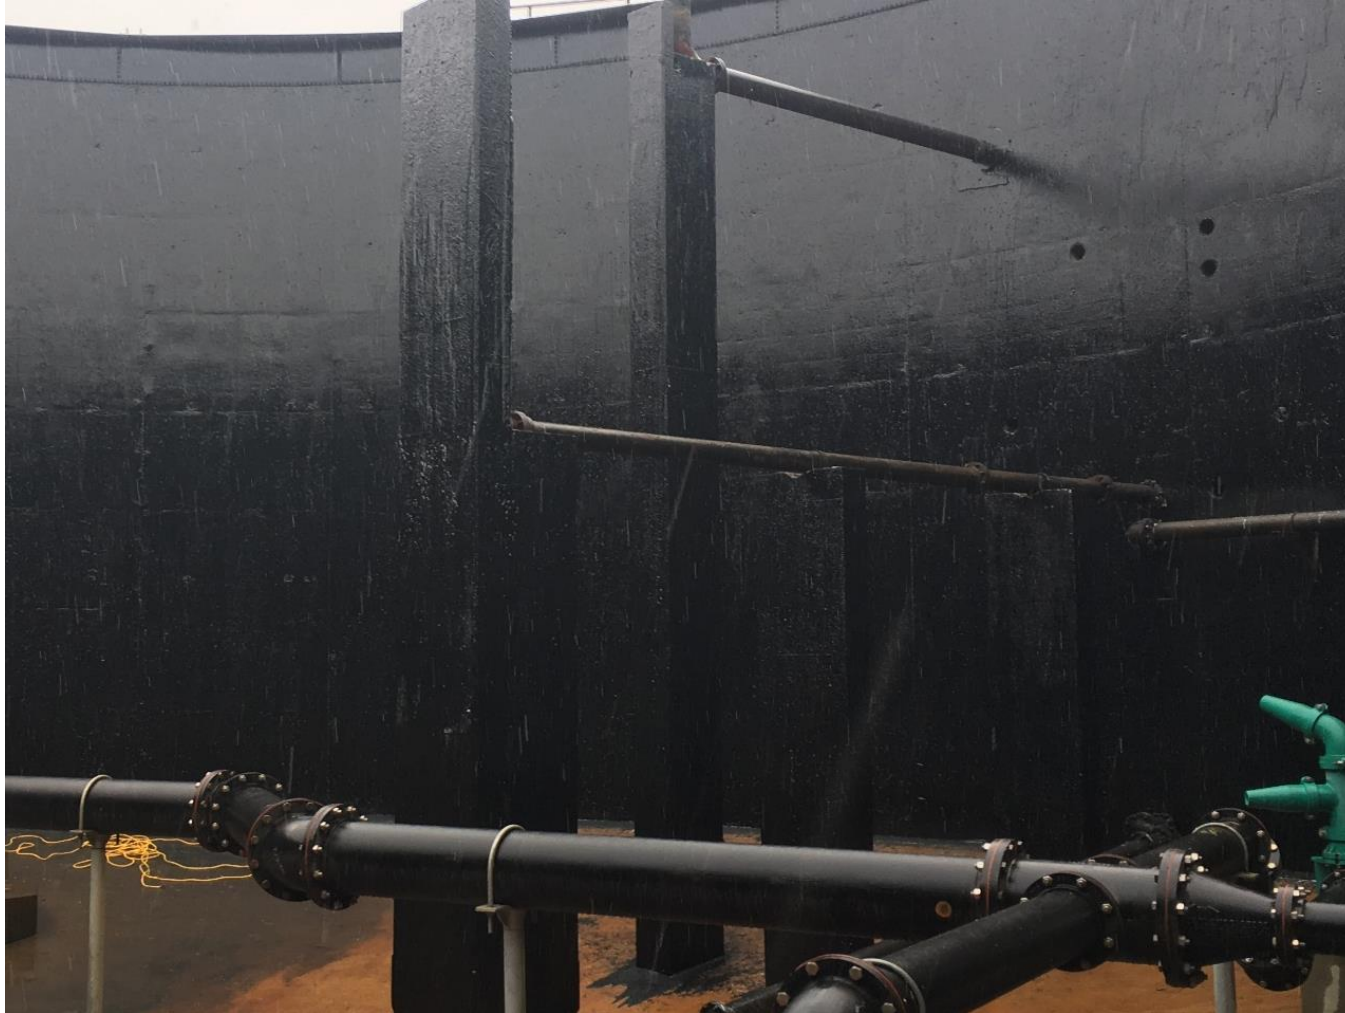
SIKAGARD 7600

- Bitumen-modified polyurethane coating
- Waterproofing
- Constant immersion service
- Chemical resistant
- **Elastomeric tolerating cracks up to 1/8" wide**
- Durable
- ANSI Standard 61 Potable Water Approved
- UV light resistant

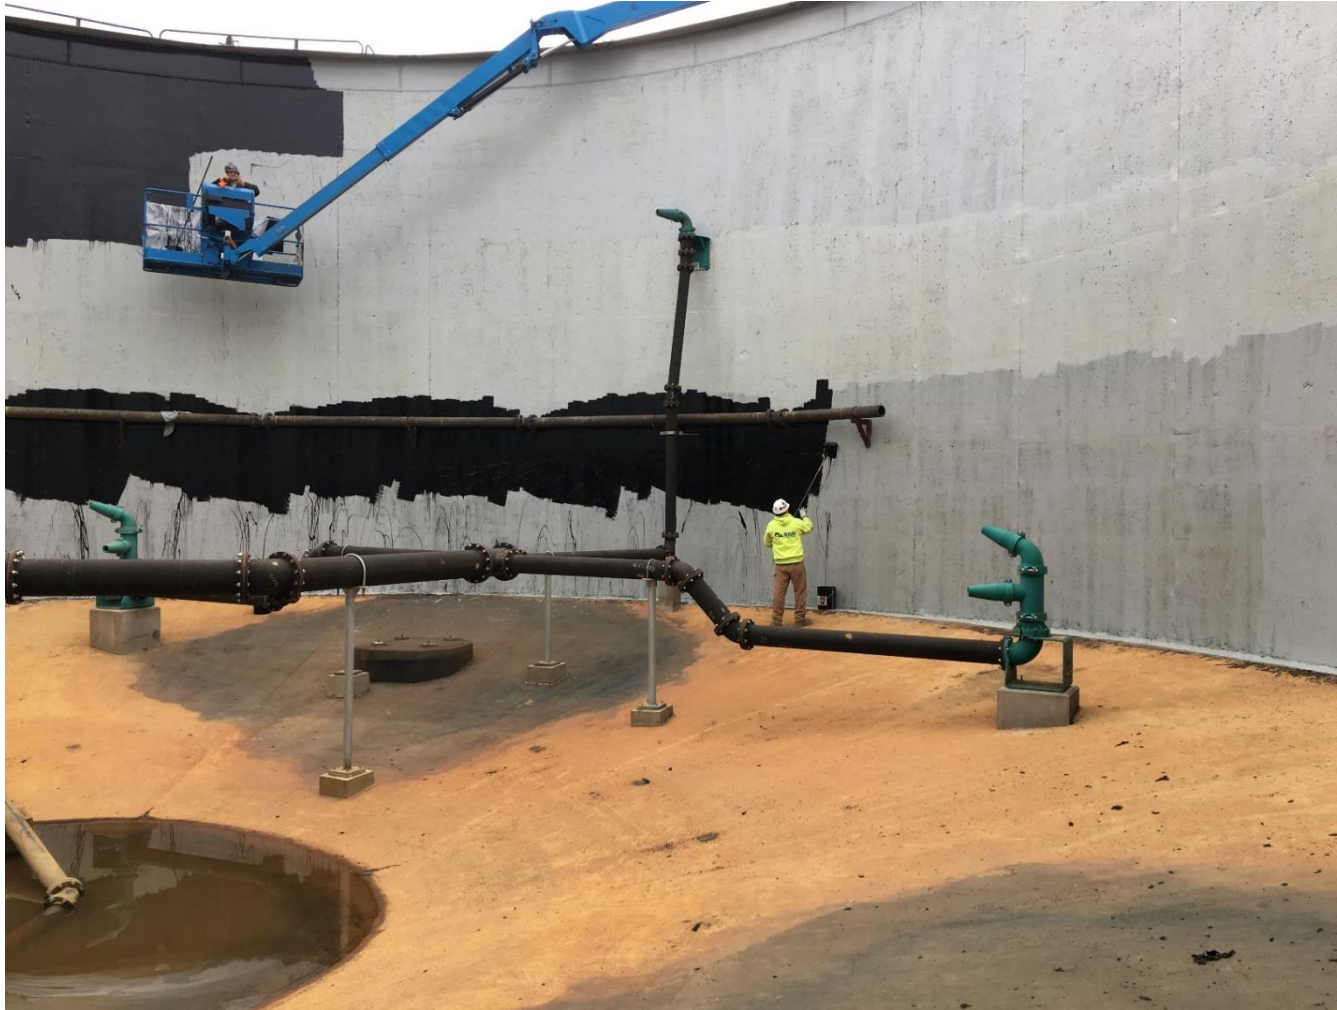
SIKAGARD 7600

- Roll, squeegee, brush, or spray apply
- HG and VG grades

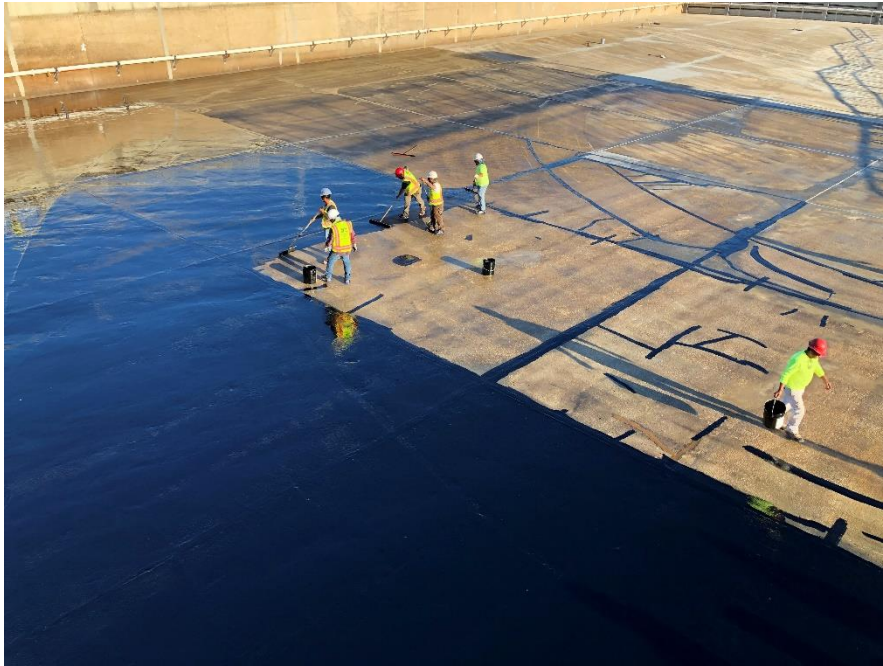
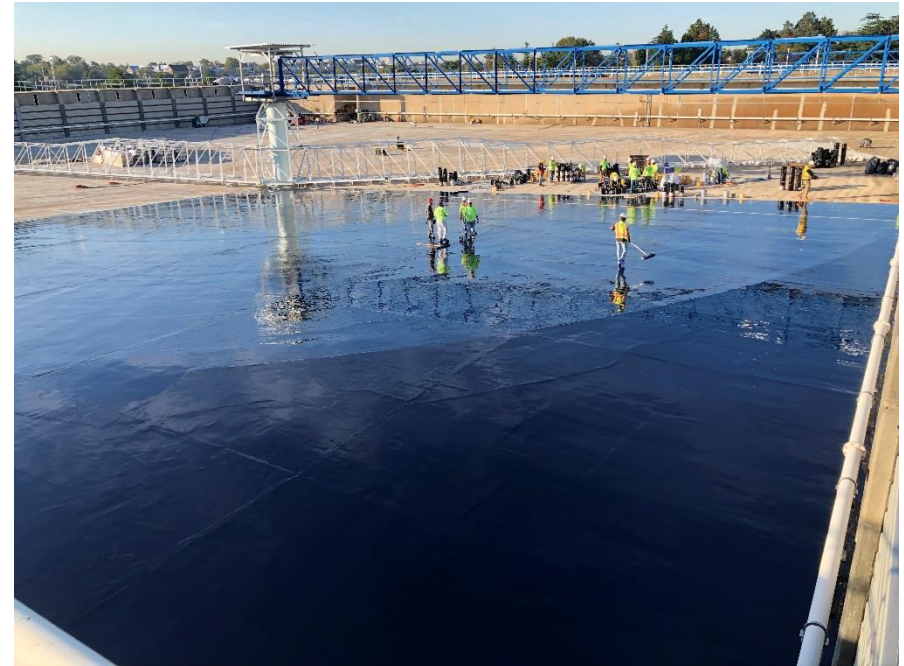
Montebello WTP, Baltimore 2021

SIKAGARD 7600

- Typical 60, 90, and 120 mil builds
- Seamless over cracks and joints
- 20+ years of service

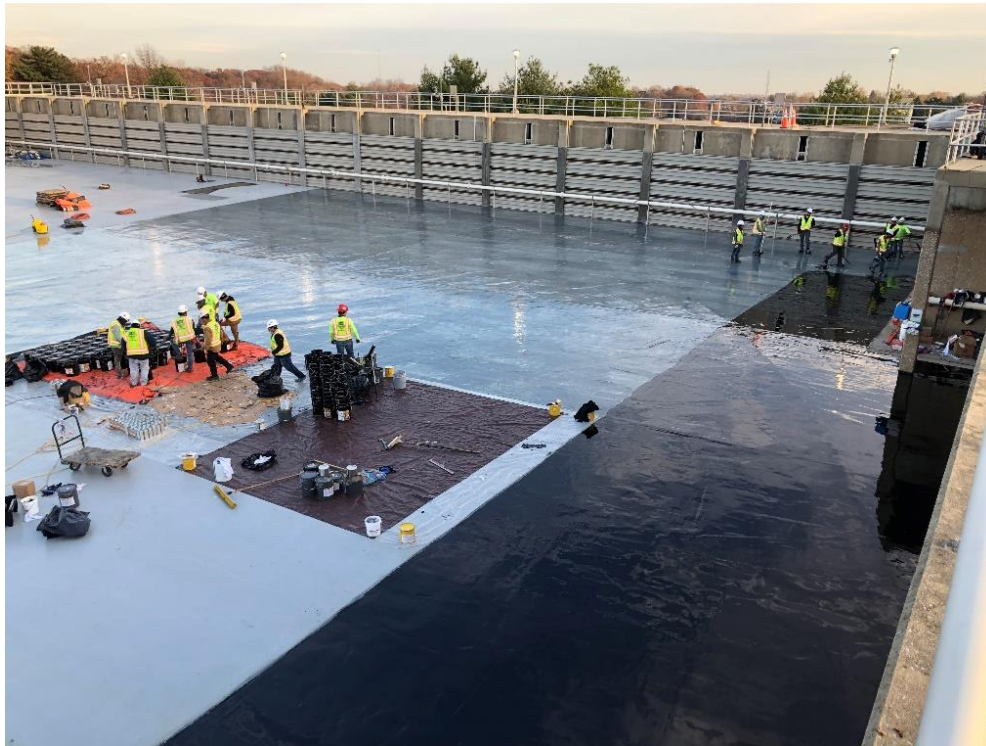
SIKAGARD 7600

- Can be top coated
- Elastomeric, chemical resistant, immersion service
