SIKA® AT WORK

INTERSTATE 85 BRIDGE COLLAPSE

AFTER A MASSIVE FIRE A SECTION OF I-85 REQUIRED A MAJOR REFURBISHMENT

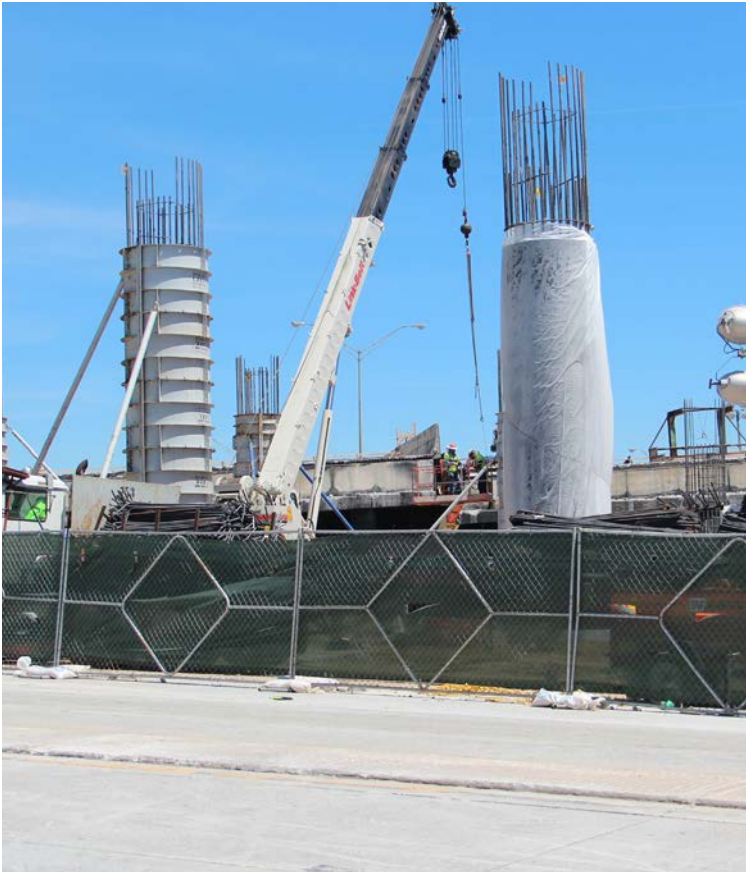
C.W. Matthews Contracting Company was chosen as the contractor for the repair

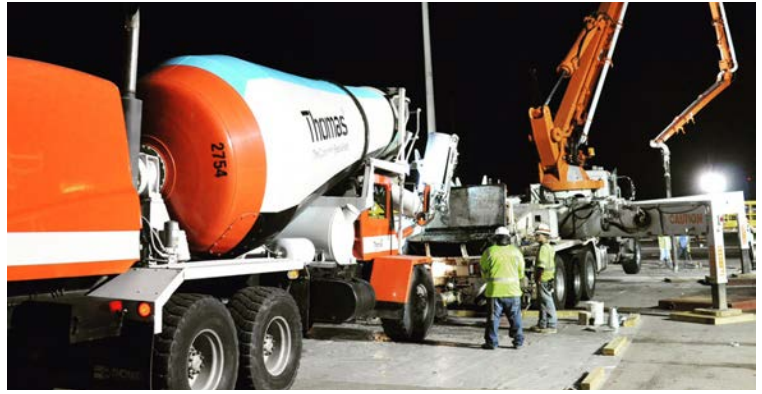
Thomas Concrete provided the concrete during the repair process

- Thomas Concrete used 40,000 pounds of Sika® Control® NS in the deck, a newly released product at the time of construction.
- Sika® ViscoCrete® - 2100 was also utilized to achieve the strength in less than 7 days, without the use of accelerators.
- The repair was completed in just six weeks, a full month ahead of schedule. This also meant tremendous cost savings considering the estimated USD 850,000 for each additional day that the closed bridge would have cost.

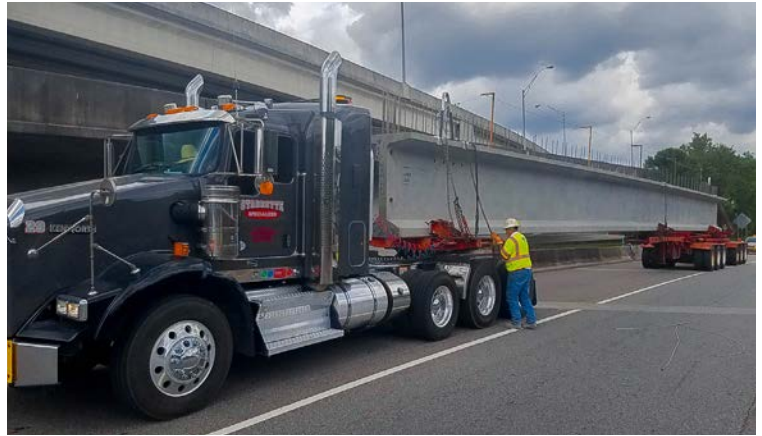
Prestressed concrete girders were brought in for the repair

The highway was fast-tracked by the Georgia DOT. It was all hands on deck. Mix approvals were sped up, materials were delivered in one or two days instead of weeks. Standard Concrete Products even started casting replacement beams within days of the collapse, and they started delivering just after two weeks. Other contractors that Standard Concrete Products worked with agreed to delay receiving their beams to make way for this important project. Another Sika Customer, Thomas Concrete, was selected to cast the columns and bridge deck.
