# Project Profile

Creighton Hall  
Omaha, Nebraska

Décor Roof System using  
60 mil Sarnafil® G410  
feltback membrane in lead  
grey

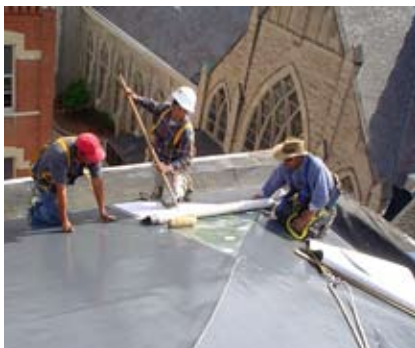
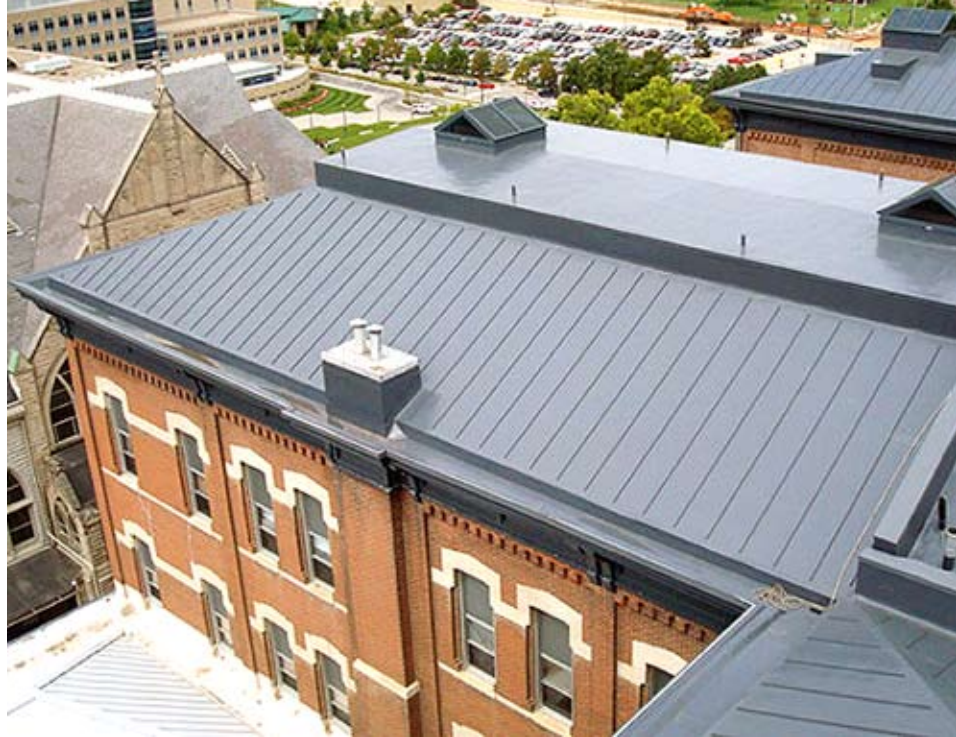
As might be expected with a 132-year old building, there was quite a bit of demolition and repair/replacement that had to be done on the roof before the new Décor system could be installed. Eight abandoned chimneys had to be removed brick by brick. The building also had several skylights that had to be removed and/or repaired, including a skylight near the penthouse that had to be redesigned in order to separate the skylight from the penthouse. All of the firewalls also had to be modified on the horizontal and vertical surfaces to accommodate the new membrane installation.

But the most challenging aspect was dealing with the large original integral tin system on the perimeter of the roof. "When they started to take the roof apart there were parts of the gutter where you could literally see daylight through them," Angeroth said.

Added Hughes, "We thought we were going to have to replace 100 linear feet of the gutter system – mostly replacing rotted plywood. But we found that 770 linear feet had to be replaced, and the structural cornices also had to be rebuilt." Cormaci Construction was called in to rebuild the gutters and then Boone Brothers installed Sarnafil metal lining in them. "This was very time-consuming because each piece had to be individually dimensioned, mapped, numbered, fabricated and then installed," Hughes explained.

Once the demo was complete and the gutters rebuilt, Boone Brothers got to work installing the Décor Roof System. New gypsum board was installed as a cover board, and the Sarnafil feltback membrane was adhered to that. Décor ribs were then installed to match the original standing seam appearance.
