# CASE STUDY

Project: Andover Water Treatment Plant  
Andover, MA.  
Owner: Town of Andover, MA.  
Specifier: Town of Andover, MA.  
Year: 1997

### THE PROBLEM

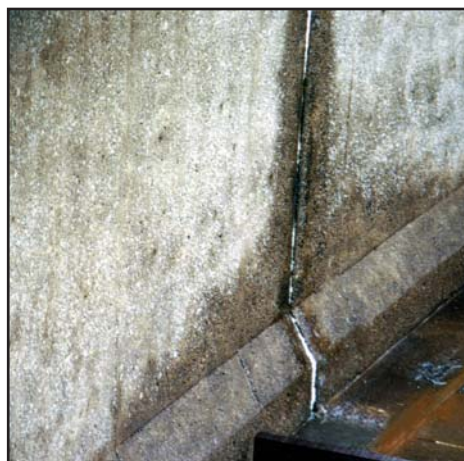
The 24 MGD Andover Water Treatment Plant included four sedimentation tanks that were put on-line in 1974. The tanks which measured approximately 120 ft. long by 18 ft. wide by 16 ft. deep, were suffering from severe concrete erosion below the water line caused by an aggressive water chemistry. Concrete that is exposed to water with a pH of 6 or less, produces new calcium compounds which are very soluble and can easily erode. The presence of low pH water at Andover had weakened, and in many cases dissolved the top 1/4 to 1/2 inch of cement matrix. Ignoring the problem was unacceptable since further erosion of the cement matrix would have necessitated large scale repairs or total replacement within a few years.

Above the water line in the splash zone, the concrete had spalled from the effects of freeze/thaw cycling. Additionally, the joints in the concrete tank were leaking and were spalled at the edges.

The first step in the rehabilitation process was to repair the joints. In order to rebuild the joints with a repair mortar, the water leakage had to be stopped first. To accomplish this task, the contractor injected SikaFix HH polyurethane foam grout into the leaking joints. The water-reactive foam expands when contacted by water, thereby creating a compression seal within the confines of the joint. Once the leakage was stopped, the spalled joint edges were then repaired using SikaTop 122 Plus polymer modified repair mortar.

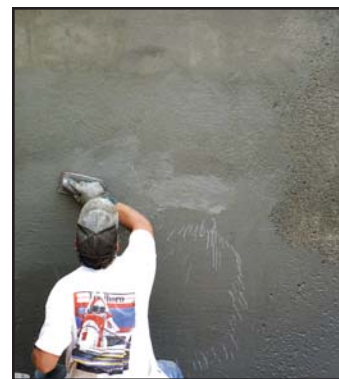
The next step involved patching the spalls above the water line with a high density/low permeability repair mortar. After saw-cutting the edges of the spalled areas, the contractor selected Sika MonoTop 615 to patch the spalls. MonoTop 615 was selected because it is an easy to apply, extremely dense and freeze/thaw resistant mortar.

The key objective of the project was to ensure long-term protection to the tank walls. To restore and protect the tank walls from the erosive effects and chemical attack of the water within the tank, SikaTop Seal 107 was sprayed on all wall surfaces. SikaTop Seal 107 is a polymer-modified, protective and waterproofing cementitious coating which significantly reduces the ability of water to penetrate into the concrete. By decreasing the ability of water to penetrate the concrete, the potential for freeze/thaw damage and surface erosion caused by chemical attack was minimized.
