Project Profile

Corporate Headquarters of Spiegel, Inc.
Downers Grove, Illinois

Distinctive Roof Calls for Beauty and Brawn

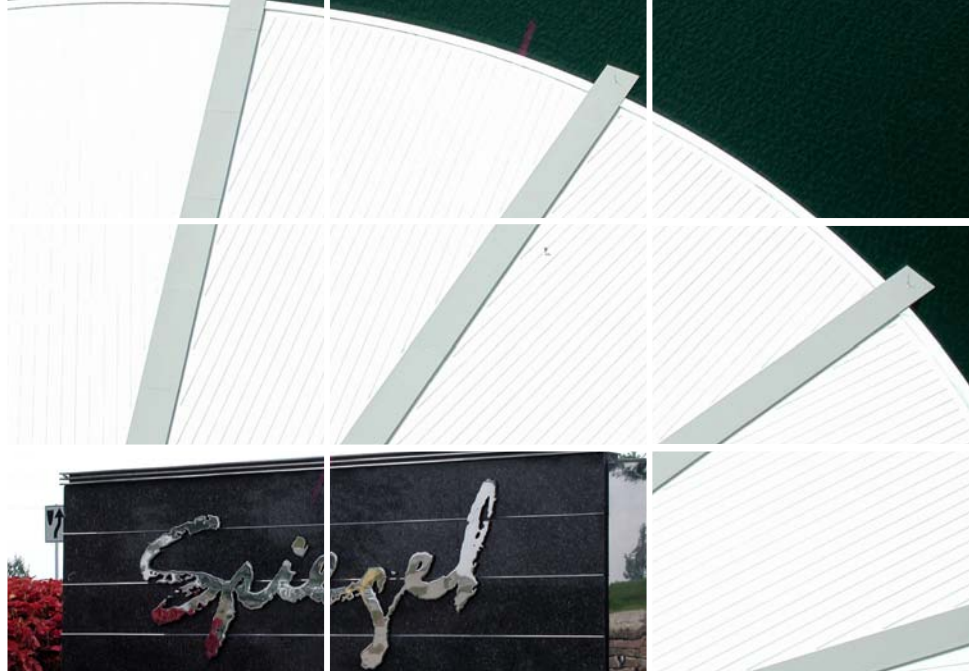
The Sarnafil Décor Roof System on Spiegel Inc.'s Corporate Headquarters in Downers Grove, IL

Sarnafil's Décor Roof System offers the appearance of a metal roof but features the watertight integrity of a hot-air-welded membrane. The system combines Sarnafil's proven single-ply thermoplastic vinyl membrane with Décor Profiles and Battens to mimic the look of a standing seam metal roof. The Décor ribs come in ten-foot sections that are connected and permanently fused to the membrane using the Sarnafil Sarnamatic hot-air welder and a patented welding kit. The Décor system is available in six standard colors and an unlimited number of colors to meet every design need.

There were other issues as well. "The first layer of the insulation was mechanically fastened, and then American Roofing put the second layer on using Olybond foam adhesive," Loden said. "However, the joints between the iso boards were telegraphing through the membrane, and the building owners didn't like the appearance." To deal with their concern, American Roofing and Repair mechanically fastened both layers of the ISO and then put Dens Deck over the insulation set in Olybond. The Décor feltback G410 60 mil membrane was then adhered and the ribs were permanently fused to the Sarnafil membrane using a hot air welder.
