# Market Application Focus

Concrete Repair &amp; Protection

Chloride &amp; Carbonation Induced Corrosion

**Project:** Philadelphia School District Bus Maintenance Garage-Broad Street  
**Owner:** Philadelphia School District  
**Specifier:** Maitra Associates, NJ  
**Contractor:** Masonry Preservation Group  
**Year:** 2006

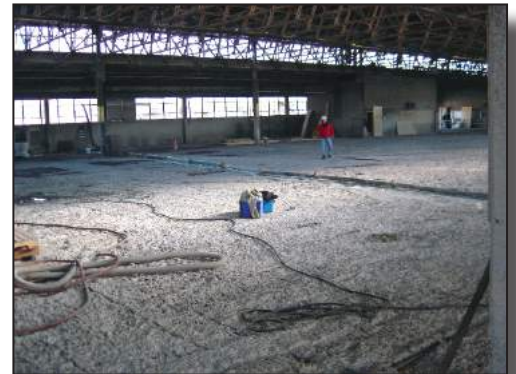
Built in the early 1960's this garage serves as a repair and cleaning facility for the buses of the Philadelphia School District. The structure is a two story building with a waffle slab and masonry wall construction on the exterior. Each level consists of about 60,000 square feet of open space. Exposure of the concrete to deicing salts and water had resulted in extensive spalling on the top surface of the deck. Noticeable corrosion was seen on the underside of the waffle slab due to carbonation and water ingress. The slab was also under designed in certain areas for the weight of the buses. The spalling and corrosion on the top of the slab was extensive. The root cause of the problems on the top surface was rebar corrosion accelerated by water and on the underside was carbonation.

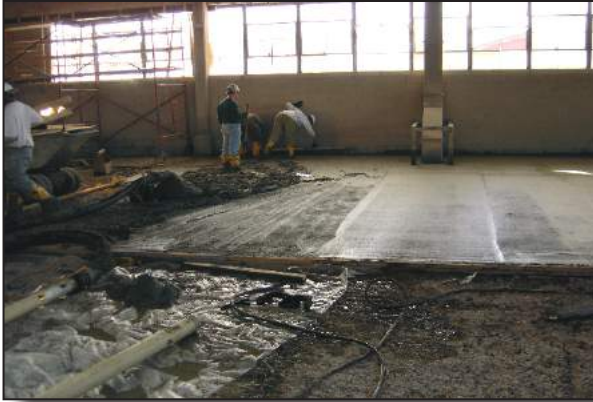
# Sika's System Approach to Concrete Repair and Protection

## Anti-Corrosion Primer and Bonding Agent

**Sika Armatec® 110 EpoCem®** - protects rebar in areas of inadequate cover.

## Single Component-Concrete Mix

**Sikacrete® 211** - a single-component portland cement based concrete which contains factory blended aggregate. This product is available in 80 lb. bags and 2000 lb. supersacks.

## Hard Wearing Epoxy Overlay

**Sikadur® 22 Lo-Mod** - epoxy resin that provide a hard wearing, slip resistant wearing surface. This overlay system seals the concrete and provides waterproofing protection.

## Structural Strengthening Systems CFRP

**Sika CarboDur®** - a proven system of external strengthening using epoxy-bonded Carbon Fiber Reinforced Plastic (CFRP) laminate strips. Stronger than steel, yet lightweight and non-corrosive, this system can solve unique strengthening problems in a variety of concrete structures.

## High Performance Repair Mortars

**SikaTop® Plus Mortars** - two component polymer modified materials containing Sika FerroGard® 901 corrosion inhibiting admixture.

**Sikacem®** mortars are machine applied by dry/wet process shotcrete techniques for repair applications.

## Corrosion Inhibitors

**Sika FerroGard® 903** as a dual action corrosion inhibitor, will reduce corrosion currents by penetrating through the concrete and forming a protective coating on the embedded steel bars.

## Anti-Carbonation Coatings

**Sikagard® 550W Elastocolor and 670W** - protect concrete facades from the damaging effects of carbon dioxide (carbonation), water and pollutants. Either crack-bridging (550W) or rigid (670W), both are high-performance protection coatings, available in a variety of decorative colors.
